# Fire Risk Assessment

## 1-7 & 8-17 Parkside View

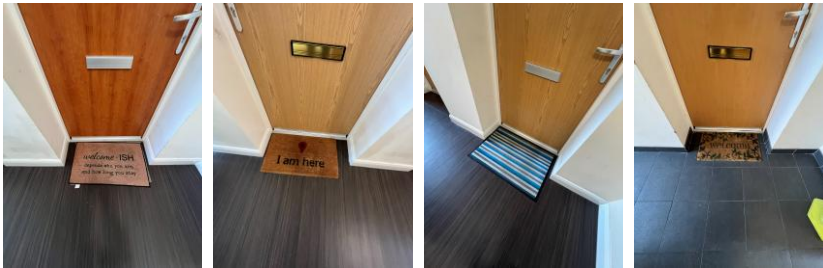
- 3) All corridors, landings, and staircases are of adequate width and kept clear to ensure safe egress during a fire. Escape routes are adequately protected against the spread of fire and smoke, and the building contains no internal communal doors other than the final exit doors.

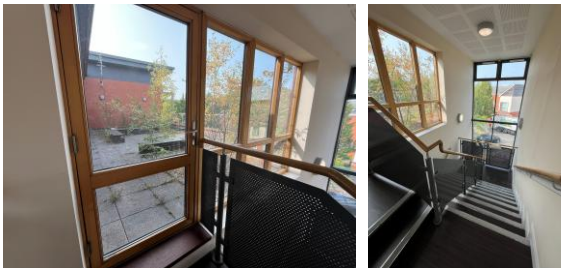
- 12) The final exit doors have a door entry system installed. This system is designed to fail safe which allows the door to demagnetise the lock in an event of a power failure and allow easy access out the building.

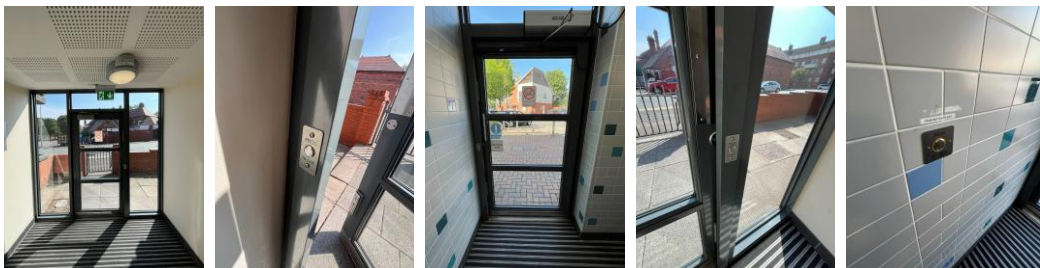
- 13) Emergency door release points are located at both main entrance's corridors for both blocks. This system allows user to manually release the door in an emergency.

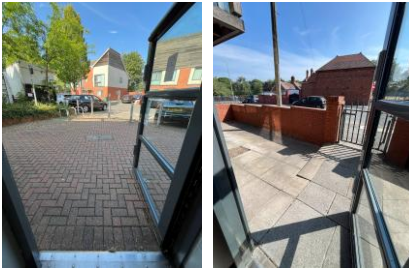
- 15) During the inspection of the second-floor lobby, a small metal table and two chairs were observed adjacent to Flat 7. Additionally, several live potted plants were present on this floor level. Following a review of the layout and positioning, the associated risk of fire loading and means of escape obstruction was determined to be low

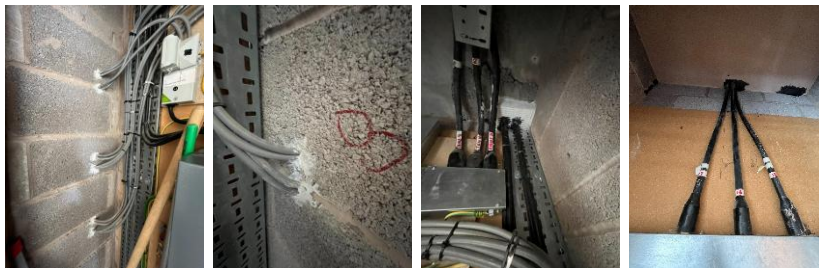
- 9) The fire stopping / compartmentation is subject to a 12-week check by the Fire Safety Rapid Response Team.

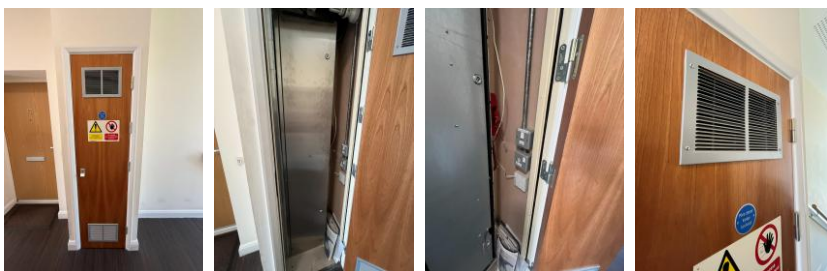
- 11) Any remedial works arising from the fire stopping / compartmentation check(s) will be actioned immediately by the Fire Safety Rapid Response Team.
- 12) Individual flat doors are nominal FD30s timber flush fire door sets with intumescent strips, cold smoke seals and self-closing devices.
-

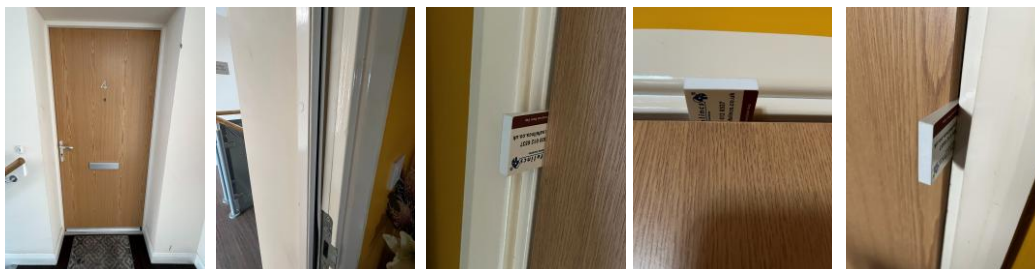
- 16) Flat 15 does not have a self closing device, smoke seal is away from frame, internal door leaf gaps exceed the 4mm threshold.**
