# Fire Risk Assessment

## Ashcroft

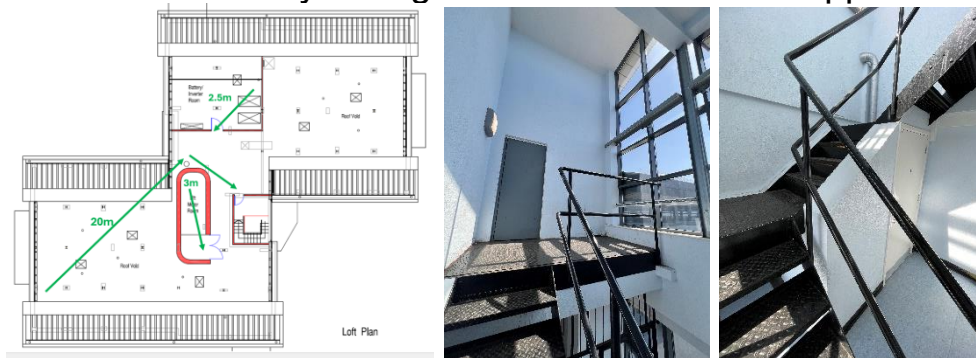
- 2) Individual flat entrance doors are predominantly nominal FD30s manufactured by Permadoor. A number of flats entrance doors have recently been replaced with certified FD30s manufactured by Shelforce.

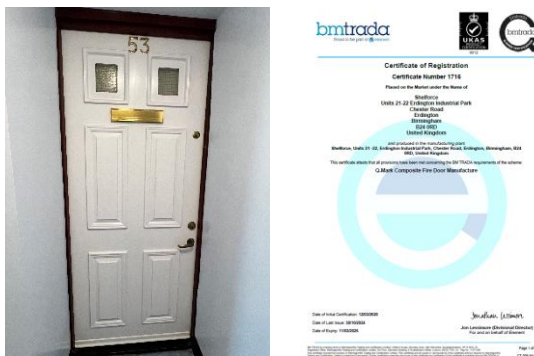
- 3) A number of flat entrance doors have door mats on the communal corridor side. The fire rating of the mats is unknown but deemed to be sufficiently low risk.
- 4) The means of escape are protected to prevent the spread of fire and smoke.

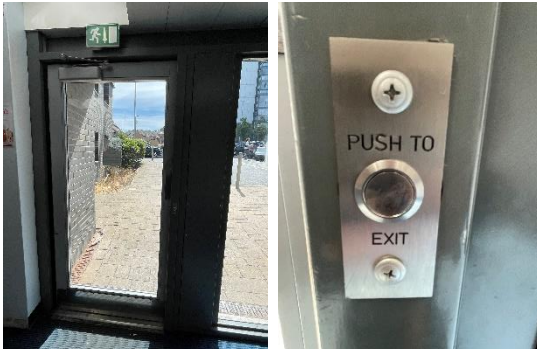
- 17) The final exit push button systems are designed to fail safe i.e., door unlocked in the event of a power failure. This prevents residents being locked in or out of the building.
- 18) Communal areas should be kept free of flammable items and obstructions. Several examples of personal belongings in communal areas were noted. Email requesting the Housing Officer to write to the following flats requesting all items are removed has been sent.

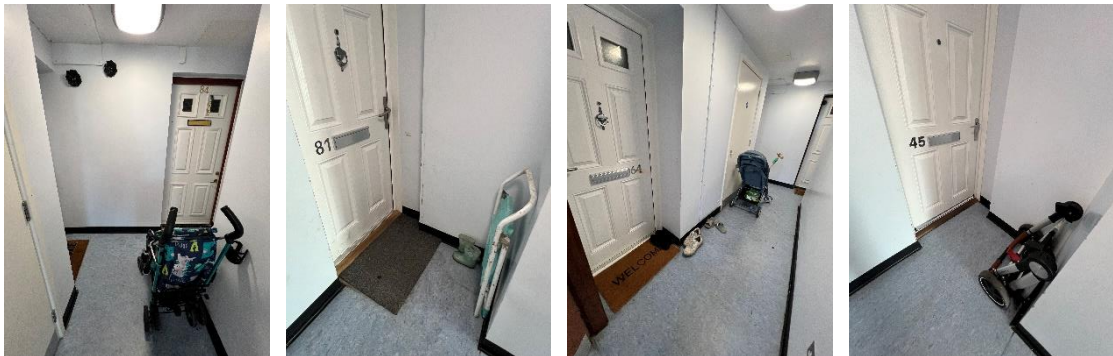
*Good housekeeping is fundamental to reducing risk in blocks of flats. Controlling the presence of combustibile materials and ignition sources not only reduces the potential for accidental fires to start and develop in the common parts, it also significantly reduces the scope for deliberate fires. It also ensures escape routes are free of obstructions that might hinder the evacuation of people from the building and access for fire-fighters.*

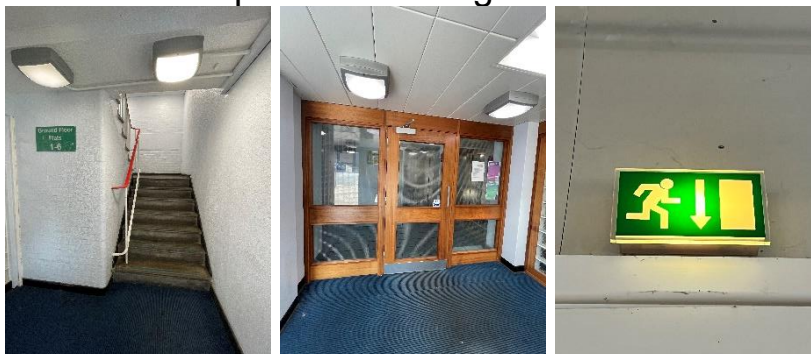
- 3) The emergency lights benefit from a central battery system which is located in the roof void plant room. The system automatically powers the emergency lights for 3 hours in the event of loss of power. Temperature in the room is controlled by air-conditioning units.

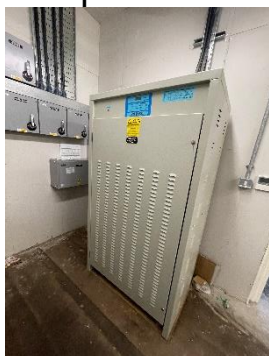
- 4) All installed equipment is checked and tested in accordance with BS 5266:2025 by Sandwell MBC in house electrical team or an approved contractor. The system was recently tested on 12<sup>th</sup> August 2026

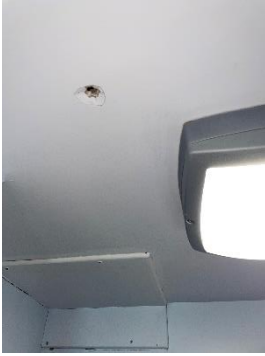
**9) Service panels adjacent flat 86 14<sup>th</sup> floor is MDF board therefore inadequate. These should be replaced with a non-combustible alternative “Promat Supalux” with a minimum 30 minutes fire resistance / intumescent seal.**

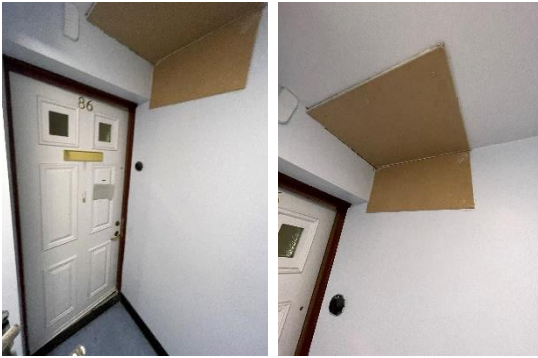
**10) Hole(s) / penetration in ground floor service cupboard within chute room requires fire stopping.**

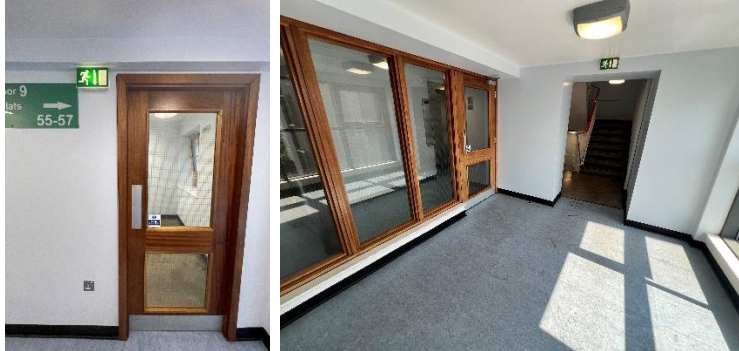
- 13) The transom to a number of communal FD30s doors on floors 12, 11 & 10 appears to be boarded with plywood and on one side only. It cannot be determined if this is equal to the fire resistance of the door set. The ply should be replaced with a hardwood material as per the remainder of communal fire doors within the building or a suitable alternative to maintain 30 minutes fire resistance.**

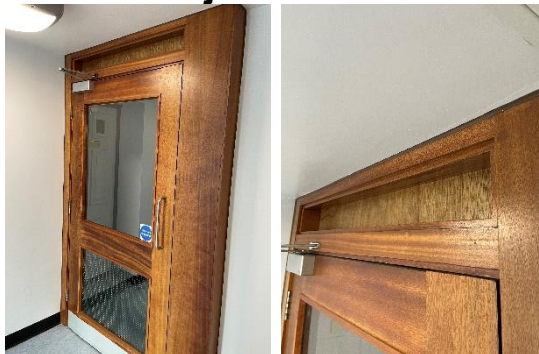
**b) Floor 11 adjacent flat 70.**

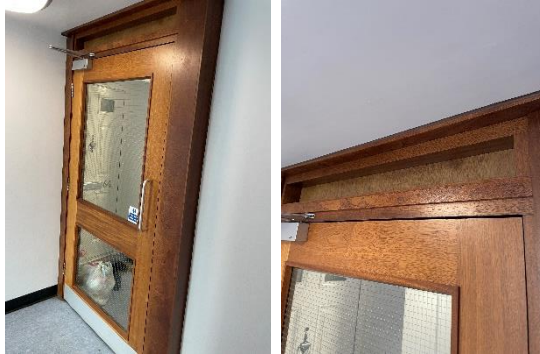
- 14) All communal doors are fitted with automatic closing devices that are checked on a regular basis by Caretaking Teams as part of their checks. Defective closing devices are replaced either by the Caretaking Team(s) or the in-house repairs team(s).
- 15) All communal fire doors are subject to a 12-week check by the Fire Safety Rapid Response Team.
- 16) Doors to service cupboards in lobbies are nominal FD60s.

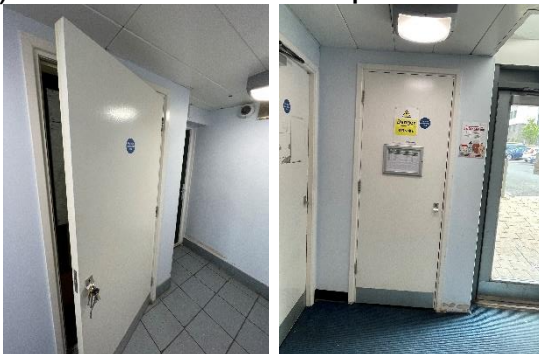
- 17) Doors to ground floor welfare room and cleaner's cupboard are nominal FD60s.

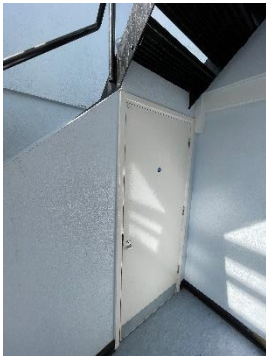
20) The door to the roof void is a steel door with a nominal FD60s timber door behind. Door requires a:

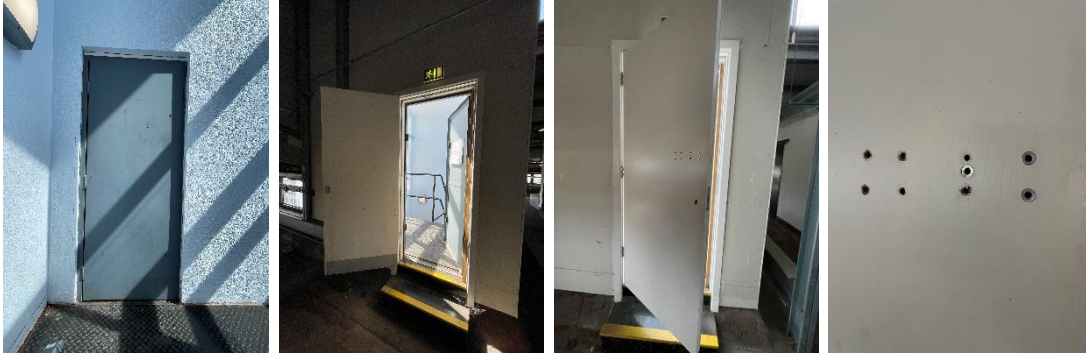
21) The battery store / plant room in the void has a nominal FD60s door. **The door was not lockable, bolt is not correctly aligned with bolt hole, door / lock requires adjustment.**

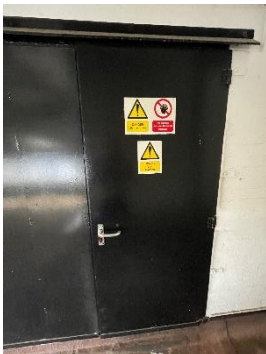
- 20) Flat entrance doors are predominantly nominal FD30s manufactured by Permadoor. A number of flat entrance doors have recently been replaced with certified FD30s manufactured by Shelforce.

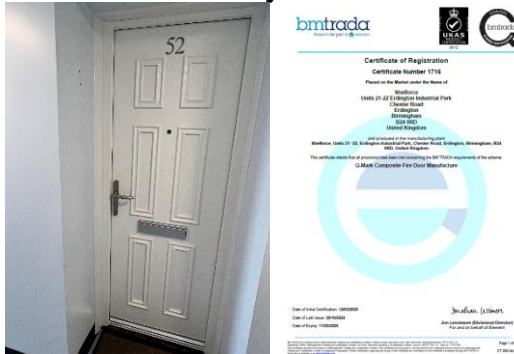
- 23) Flat entrance doors are scheduled for annual inspection August 2026 by SMBC's Fire Rapid Response team. Residents are notified in advance of the inspections. Any necessary repairs will be completed by the Fire Rapid Response team. An approved contractor will install any replacement FD30s doors that are required. Data from the inspections was not available at the time of this report.

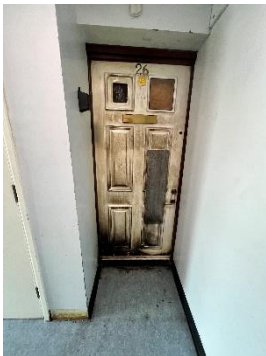
### Definitions Fire Doors.

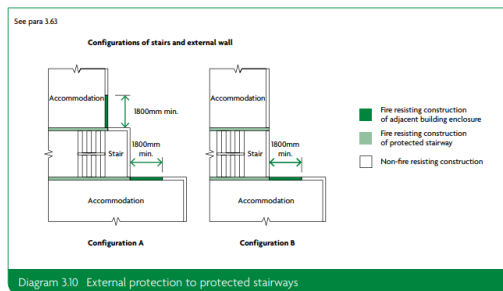
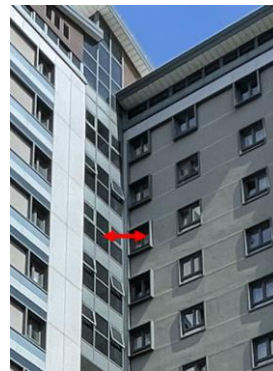
- 26) Glass block walling has been utilised at the foot of the staircase. This type of installation was installed during the 2014-16 refurbishment and typically achieves 60 to 120 minutes of fire resistance.

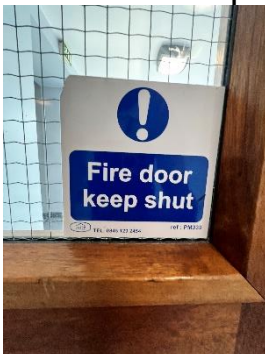
- 4) Missing signage to a number of fire doors in the roof void was replaced during this assessment.

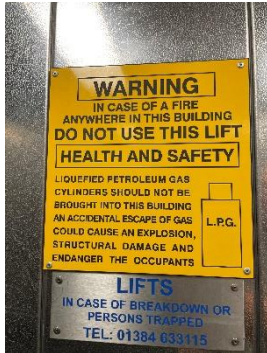
- 6) The fire escape routes use directional fire signage.

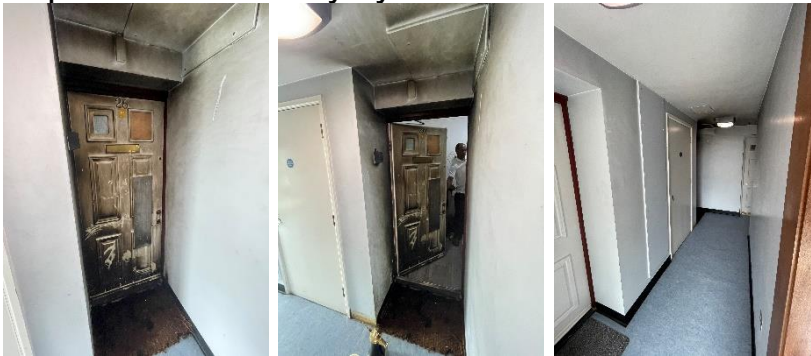
- 4) The perimeter of the building is well illuminated.

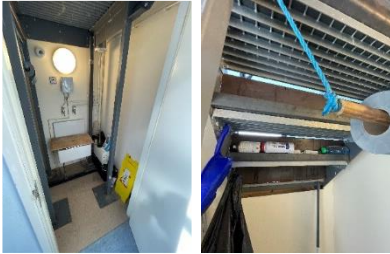
| 10/07 | 14 <sup>th</sup> floor cleaner's cupboard beneath steel staircase – Ceiling and steel staircase legs should be adequately covered and sealed with minimum 30 minutes fire resistant material. | | P3 | 3-6 Months<br>Fire Rapid<br>Response Team | |

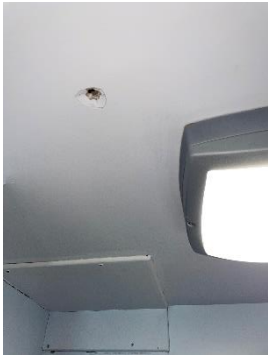
| 10/08 | 14 <sup>th</sup> floor small hole in ceiling adjacent flat 89 to be adequately fire stopped. | | P3 | 3-6 Months<br>Fire Rapid<br>Response Team | |

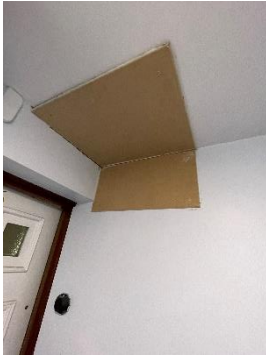
| 10/09 | 14 <sup>TH</sup> floor adjacent flat 86. Replace MDF service panels with 30 minutes fire resistant alternative and intumescent seal. | | P3 | 3-6 Months<br>Fire Rapid<br>Response Team | |

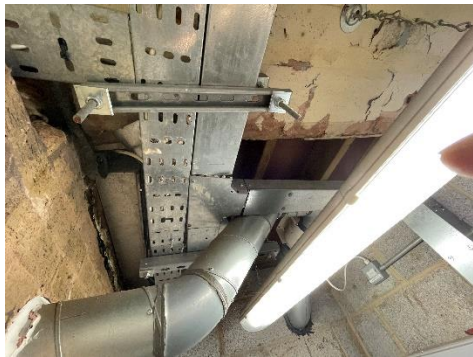
| 10/11 | Ground floor service cupboard adjacent welfare room – ceiling should be adequately covered and sealed with minimum 60 minutes fire resistant material. | | P3 | 3-6 Months<br>Fire Rapid<br>Response Team | |

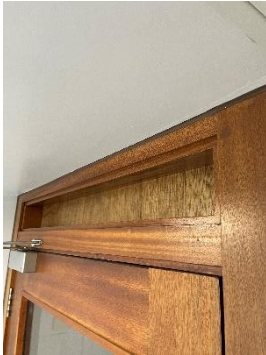
| 10/13a | 12 <sup>th</sup> floor lift lobby door / by flat 76 – replace plywood transom with hardwood material as per other fire doors sets in the building. (or suitable alternative to 30 minutes FR). | | P3 | 3-6 Months<br>Fire Rapid<br>Response Team | |

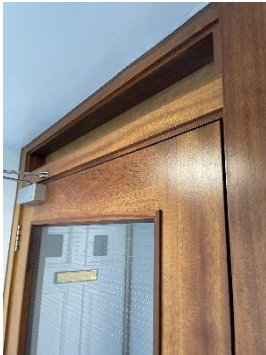
| 10/13b | 11 <sup>th</sup> floor lift lobby door / by flat 70 – replace plywood transom with hardwood material as per other fire doors sets in the building. (or suitable alternative to 30 minutes FR). | | P3 | 3-6 Months<br>Fire Rapid<br>Response Team | |

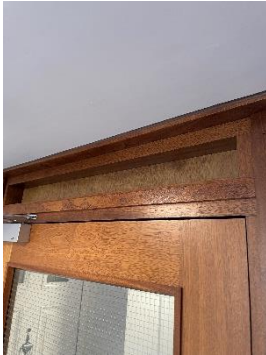
| 10/13c | 10 <sup>th</sup> floor lift lobby door / by flat 64 – replace plywood transom with hardwood material as per other fire doors sets in the building. (or suitable alternative to 30 minutes FR). | | P3 | 3-6 Months<br>Fire Rapid<br>Response Team | |

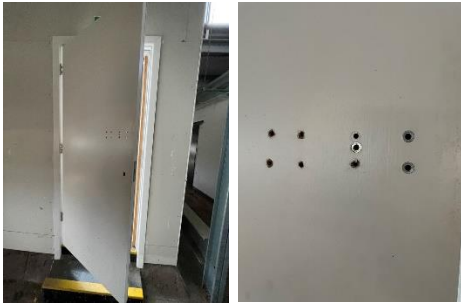
| 10/20 | <p>Roof void / stairwell FD60 timber door requires – Replacement cold smoke seal to the head</p> <p>Escutcheon plate with pull to void side</p> <p>Holes on void side to be filled with intumescent filler</p> | | P3 | 3-6 Months<br>Fire Rapid<br>Response Team | |
