Fire Risk Assessment

Greenford House

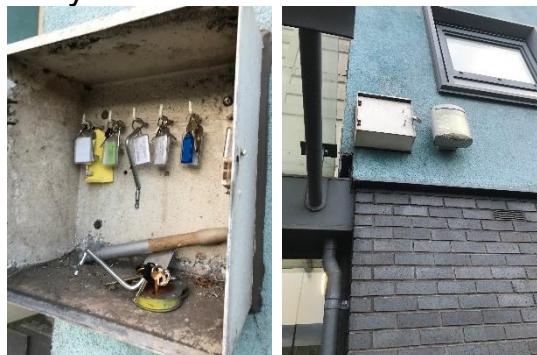
The block has a single protected staircase serving all floors of the building with floor identification numbers on the wall of each floor and the top step. The staircase is protected using nominal 44mm FD30s doors with combined intumecent and smoke seals. An additional timber constructed staircase can be found within the office area only granting access to the 1st floor office spaces.

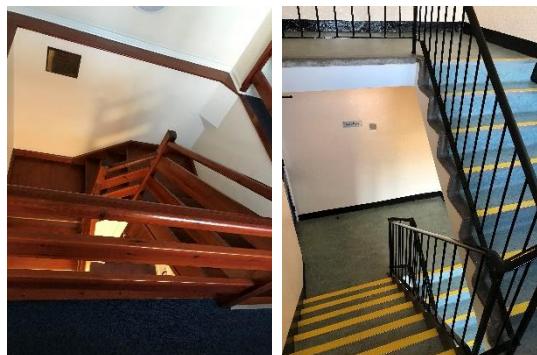
The block has a two skip stop lifts accessed on the ground floor that serve alternating floors of the block. Lift motor room accessed via a loft hatch with zip ladder on the 16th floor with keys stored within the fire fighters white box.

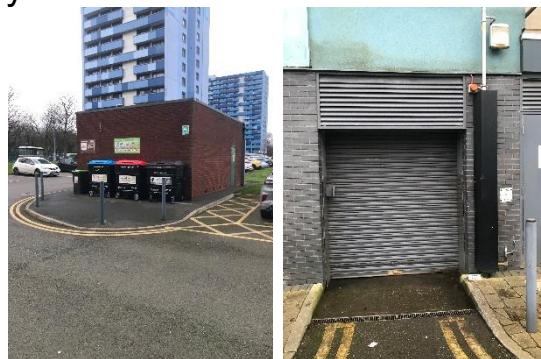
The fire hydrant can be located at the rear elevation of the block and can be found on the orientation plan located in the premise information box.

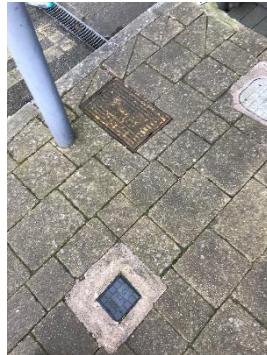
There is a dry riser that serves all floors of the block with a dry riser inlet cupboard located on the ground floor which is a steel door that is adequately signed and secured with a padlock, each floor of the block contains a dry riser protected via nominal 44mm FD30s doors with combined intumecent strip and smoke seals.

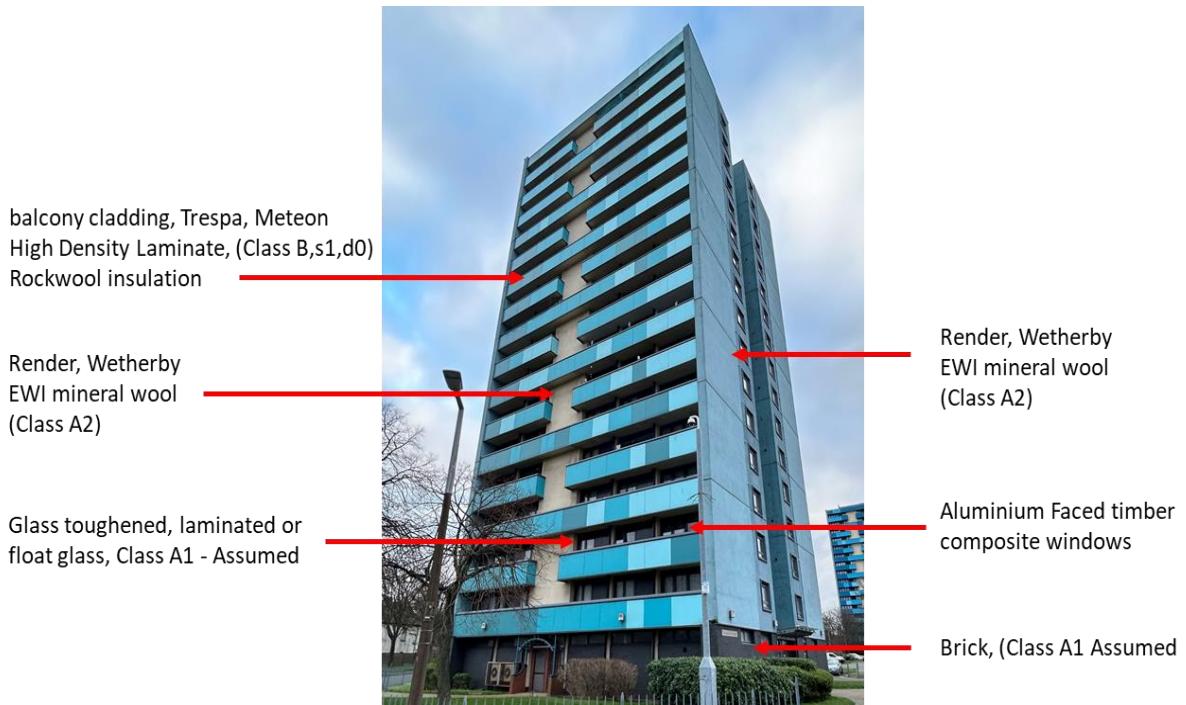
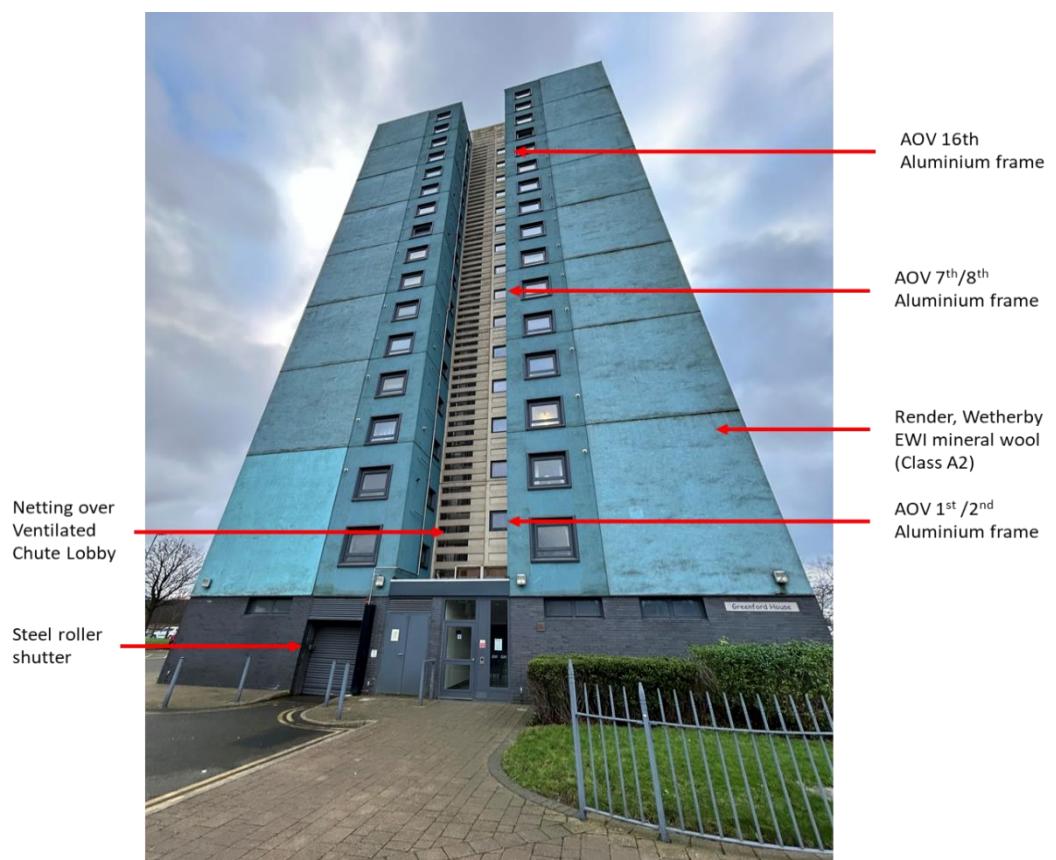
- 1) The block was constructed of a Insitu concrete frame with masonry infill (Wates) construction, last refurbished in 2010 with the addition of a external wall system. The external facade consists of high density laminate board (B,s1, d0), Rockwool insulated render (A2),

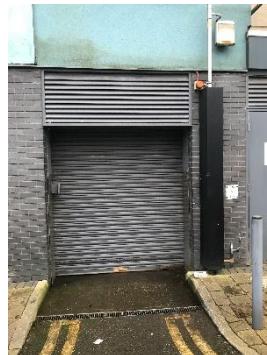
- 6) It was noted that some balconies may have had combustible materials in the form of hanging washing this is deemed acceptable risk due to the likelihood of a fire starting in this area being low and combined with the temporary nature of the activity.
- 7) Aluminium faced timber composite windows to resident's flat windows/balcony doors and communal windows.

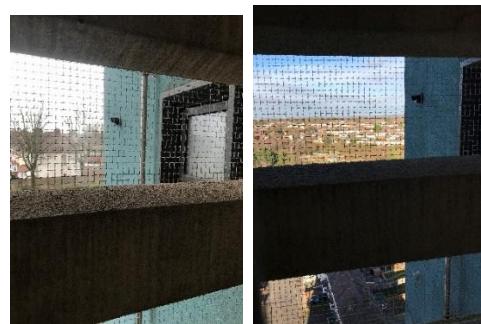
9) Gas was noted to be external running along the rear elevation.
Gas isolation points located on the orientation plan.

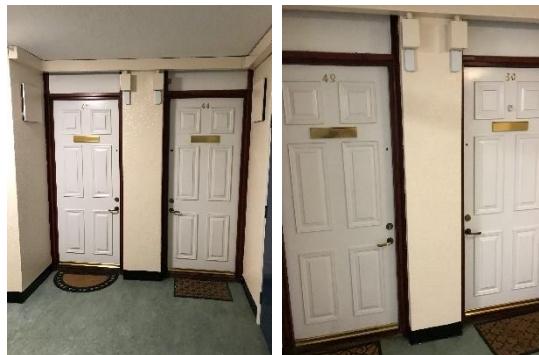
- 2) Access was not gained to a sample of properties as part of the fire risk assessment due to the Fire Rapid Response team scheduled to conduct a full non-invasive fire door inspection, however condition of the external leaf of each door was assessed to ensure no damage or faults, the fire risk assessment draws on information taken from the previous fire risk assessment, information kept on file (JM) and previous fire door inspections conducted by Firntec on 15/12/2025. All actions created from the fire door inspections will be dealt without outside of this fire risk assessment.

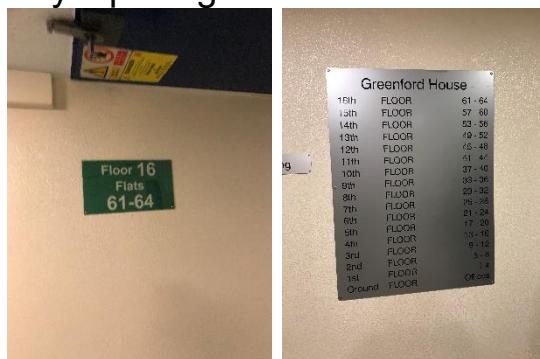
12)All communal doors are fitted with automatic closing devices that are checked on a regular basis by Caretaking Teams as part of their checks. Defective closing devices are replaced either by the Caretaking Team(s) or the in-house repairs team(s).

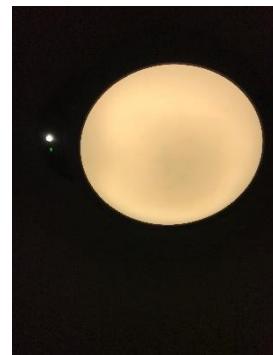
17) Communal areas should be kept free of flammable items. The communal areas are checked on a regular basis by Caretaking / Cleaning teams 365 days per year, and all items of rubbish are immediately removed. There is also an out of hour's service that allows combustible items of furniture / rubbish to be removed. This was found satisfactory however it was noted that a plant had been left outside a resident flat although was not deemed to compromise the escape route and is deemed a trivial risk and to be dealt with outside of this assessment.

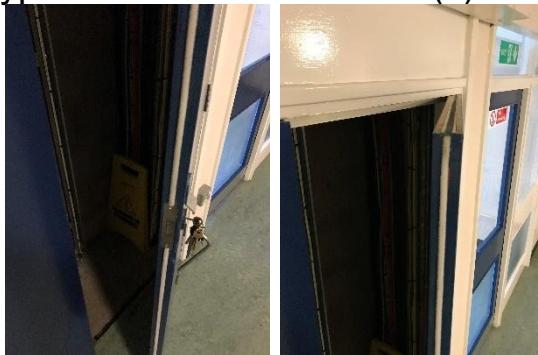
21) The refuse chute hoppers are fitted with intumescent strips and are secured behind nominal 44mm, 30-minute fire doors with combined intumescent strips & cold smoke seals along the means of escape.

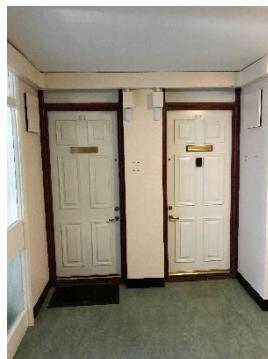
It is accepted that, in older blocks, fire doors, particularly flat entrance doors, do not meet current test standards for FD30S doors. However, these doors may still be acceptable if the doors remain in good condition, and they met the relevant standards at the time of construction of the block.

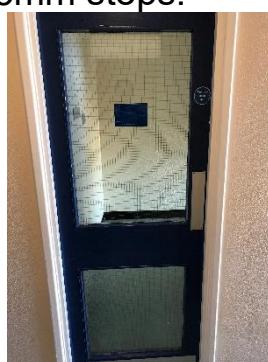
- 11) SMBC have commissioned a survey of all fire doors to flat entrances, communal corridor doors, landing doors and service cupboard doors. Firntec Building Compliance have been commissioned to complete the surveys via their subsidiary Ventro Fire Compliance.

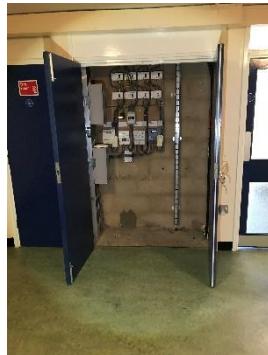
16) The use of expanding foam was present within the communal cupboards around cabling in the previous risk assessment stopping knowing that intumecent pads and a concrete slab is present, This has since been enhanced as programmed works by the FRR team.

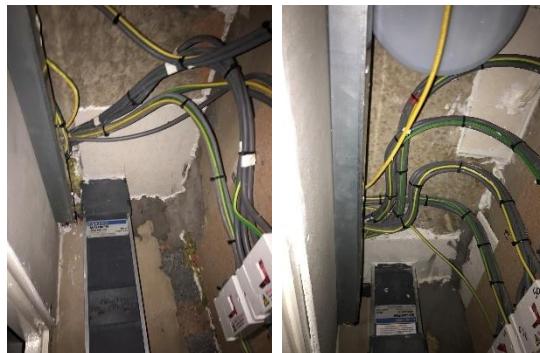
17) Some wear and tear was beginning to show on some cold smoke seals on communal doors and communal cupboards however will still serve their purpose in the event of a fire.

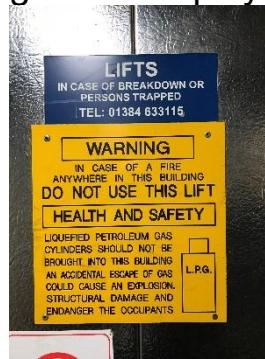
- 4) Signage depicting the floor location of each flat is fitted to the ground floor lobby wall it was noted that the sign displays the office space on the first floor as flats 1-4 the location of the flats is correct however these flats have been converted into office spaces.

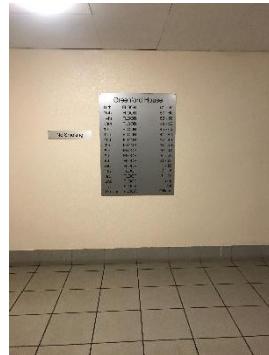
- 5) Wayfinding Signage to the block depicting floor level and flat numbers has been installed to the wall adjacent to lift and within the staircase. This meets the requirements set out in the Fire Safety (England) Regulations 2022.
- 6) Currently there is signage on each floor of the block as well as on the wall of each floor from the staircase including the new photoluminescent signage installed with the introduction Fire Safety (England) Regulations 2022.
- 7) Premise information box is signed appropriately and located at the main entrance to the block. Plans are in place to re located keys currently residing in the white box into the PIB.

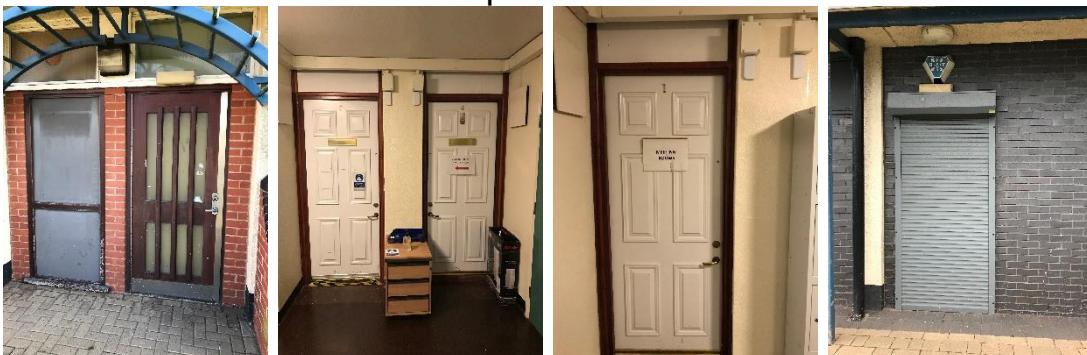
Ground floor contains mostly empty office space used as storage and welfare rooms with the exception of a protected server room on the ground floor.

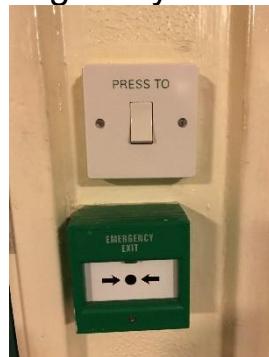
11) Emergency escape signage is used within the office spaces along the means of escape. Some signage on the ground and 1st floor directs occupants to a now redundant escape route and has since been removed.

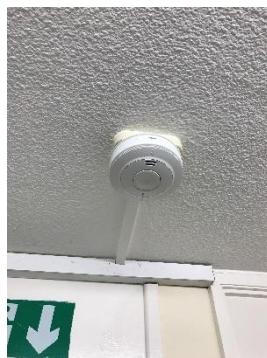
- 18) Emergency exit door Located on the ground floor is no longer in use and therefore redundant SMBC employees who access the site are aware and adequate signage is in place.

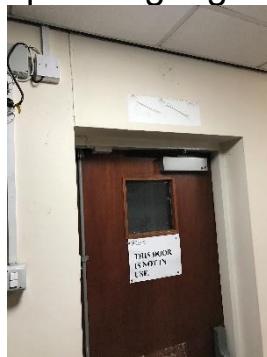
- 19) Inner rooms are used within the office; this risk is reduced due to a managed approach including robust signing in procedures combined with clear vision panels/ windows for full visibility when room is in use due to the occupancy type and familiarisation with the space this is deemed an acceptable risk.
- 20) Steel filing cabinets were observed in use within the lift lobby area. This space could be considered an extension of the adjoining offices, which in turn creates inner rooms as occupants would need to pass through the lobby to escape. It is therefore recommended that future upgrades to the premises incorporate additional early warning measures, particularly if storage in this area is maintained, albeit at a minimal level. Current mitigating factors include restricted

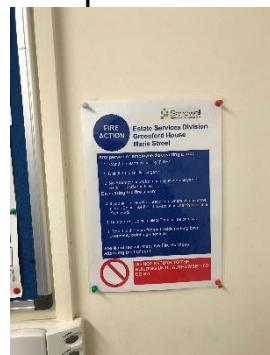
39) Signage detailing the escape route from offices placed strategically around the premise. All employees who use the site being aware of the procedures.

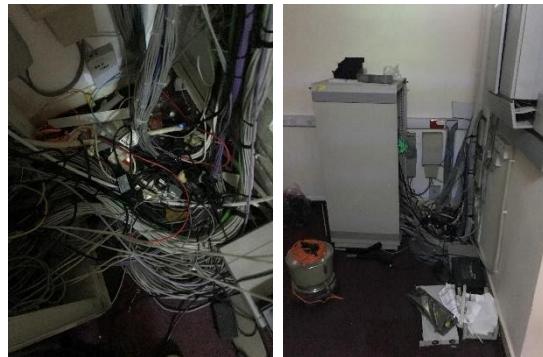
Control and supervision of contractors.
