1-9 Keswick House Lovett Avenue, Oldbury, B69 1BP

Date Completed: 08/07/2025 Review Period: 3 years.

Current Risk Rating = Tolerable

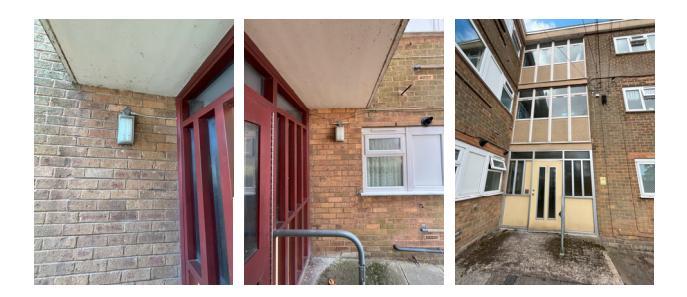
5) There is lighting installed to the front door for safety and security, however the rear elevation would also benefit from having lighting installed on a future programme.

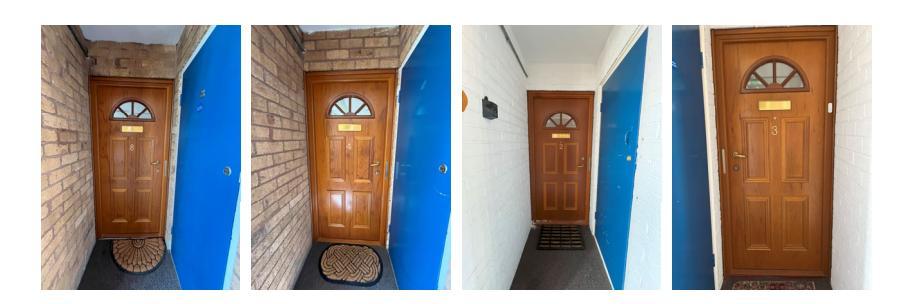
6) All floors have S.M.B.C fitted carpet. Due to the fact S.M.B.C specified and managed the installation of the carpets it has been presumed that it is class 0 fire rated.

A number of flat entrances have door mats; the fire rating is not known on these door mats.

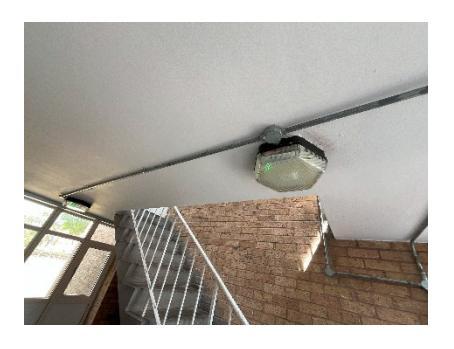
9) Emergency lighting is provided to communal landings and stairs. Checks are done on a monthly basis by Sandwell MBC in house electrical team or approved contractor. (Refer to section 9)

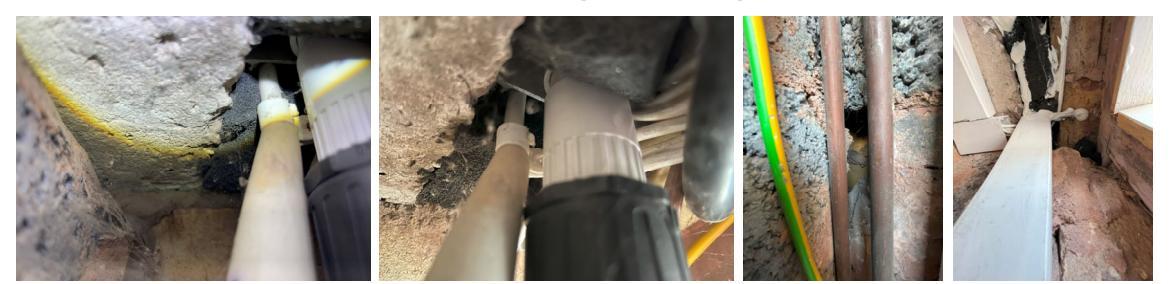
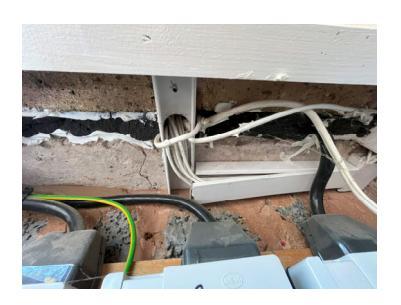
5) The electrical service cupboards on the ground floor and second floor are in need of fire stopping due to gaps in the structure

10/5	The electrical service cupboards on the ground floor and second floor are in need of fire stopping due to gaps in the structure. Due to no access to 1 st floor cupboard can this be checked at time of works?		P2	1-3 Months Fire Rapid Response
10/8	Self-closer removed from flat 7 front door		P2	1-3 Months Fire Rapid Response
12/4	NO SMOKING signs need replacing at the front and rear doors due to fading and damage.	It is against the law to smoke in any communal area of these premises	P2	1-3 Months Fire Rapid Response

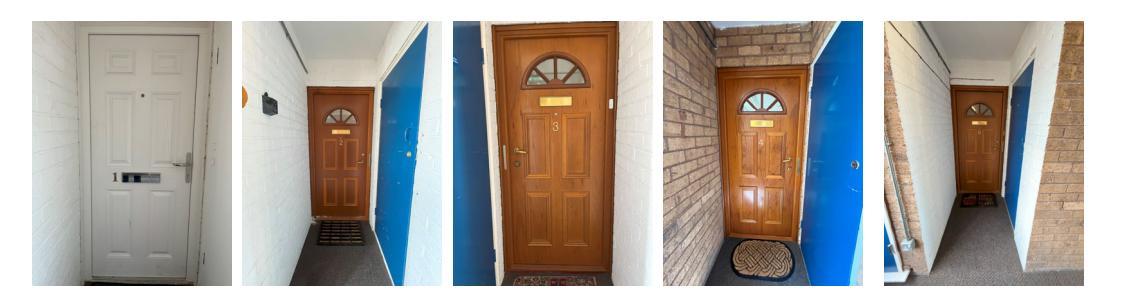
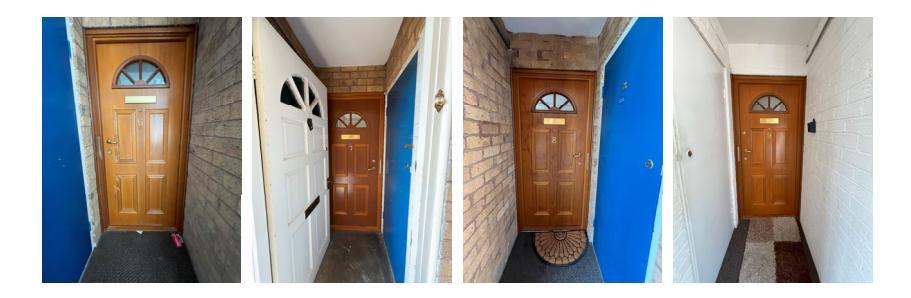
7) Individual flat doors are FD30s rated composite fire door construction. Flat 7 has an additional door fitted to the alcove in front of the rated door. 1-9 pictured

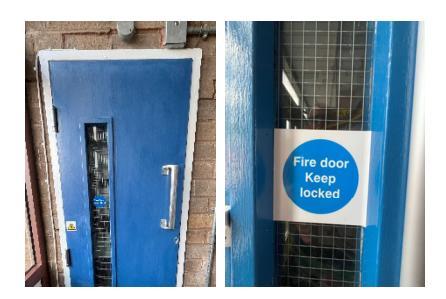
- Fire Action Notices are not displayed throughout the building. The signs are not necessarily due to the building not having a complex layout.
- 3) Yellow LPG warning signs are not displayed within the block. <u>refer</u> to section 18
- 4) Smoking is prohibited within any communal parts of the building in line with Smoke Free England legislation. **Signage at the front and rear of premise require changing due to fading and damage**.

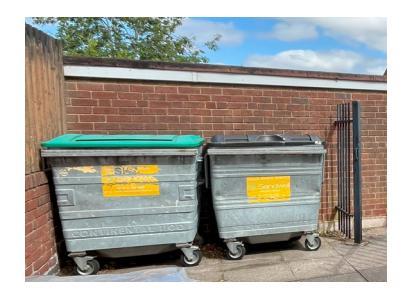
- 1) There is a regular Cleaning Service to the premises. In need of a cabinet fitting to show cleaning documents as this is not in place.
- 2) Refuse bins are stored to the rear of the building. Bins Are regularly emptied by site services.

3) Regular checks by Caretakers minimise risk of waste accumulation. Cleaning rota not on display due to missing cabinet, team notified.

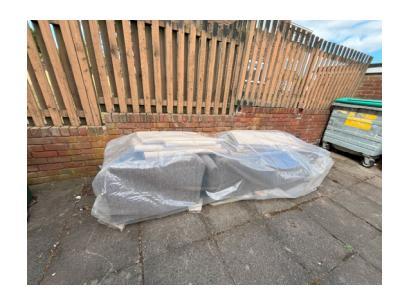
- 4) 'Out of Hours' service is in place to remove bulk items.
- 5) Out by the bins at the rear of the premises there is a settee being stored. These need removing.

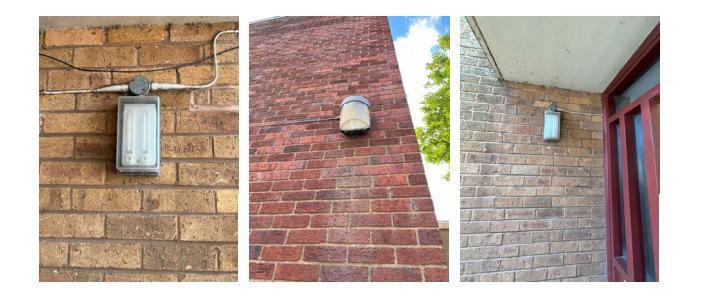
- 3) There is no current evidence of arson.
- 4) The perimeter of the premises is well illuminated. Lights required outside the rear exit door.
