# Fire Risk Assessment

**Wheeler House,  
Oldbury,  
B69 4JH**

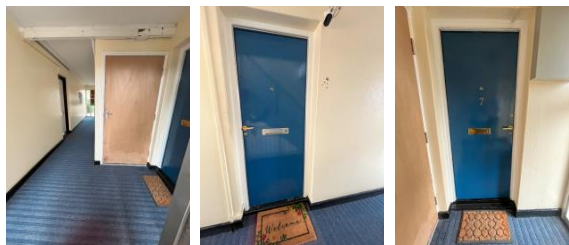
Standard lighting is installed within escape routes, supplemented by windows allowing in natural light. However, there is no emergency lighting, which is a requirement for a three-storey building. It is recommended that emergency lighting be installed during future refurbishment works.

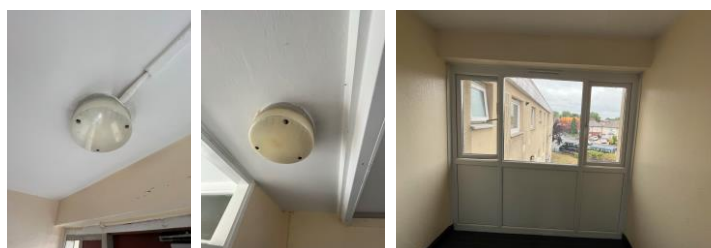
The building's compartmentation is sufficient to limit the spread of smoke and flame, supporting a stay-put policy. Individual flat doors are predominantly notional timber FD30, with some being FD30s composite fire doors. Electrical service cupboards have lockable FD30s timber doors with 138 mortice locks.

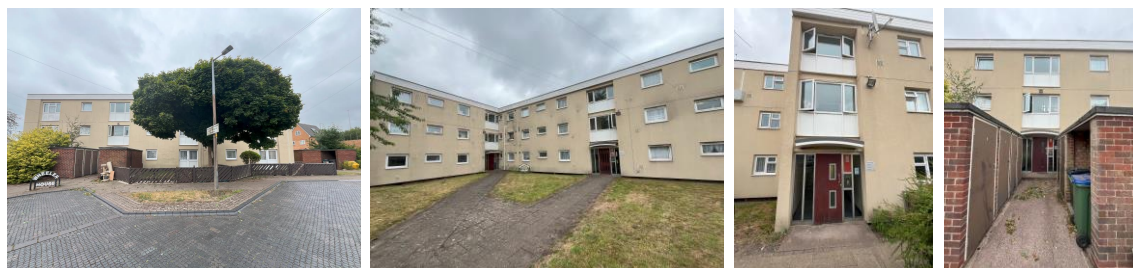
- 2) **The building currently has several areas of damaged render that require repair to maintain fire safety standards. Recommend a joint visit with the repairs team and Fire Risk Assessor to identify areas. Also, to carryout a review of the fire risk assessment every 12 months.**
- 3) UPVC double glazed units have been installed to each flat and communal stairway. There is a canopy situated over the front and rear entrance to the block. Entrance & rear door are timber with steel framework.

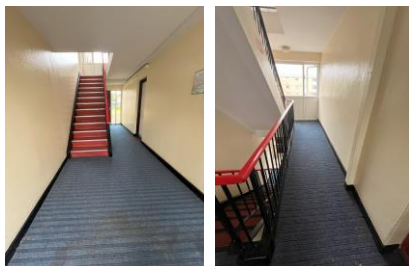
- 4) The means of escape are protected to prevent the spread of fire and smoke. All service cupboards to communal landings are updated timber notional doors with added smoke seal and intumescent strip, they are lockable with budget locks and include a fire door Keep locked signage.
-

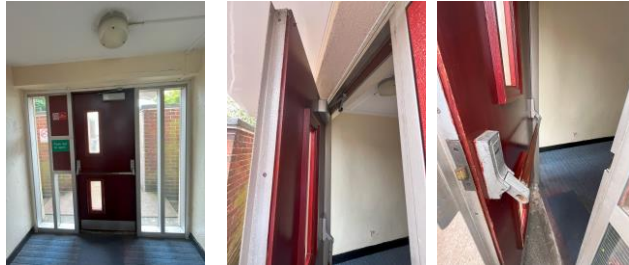
- 6) Individual flats are fitted with a minimum FD30 rated door. Access was gained to a sample of properties as part of the fire risk assessment to ensure the doors have not been tampered with.

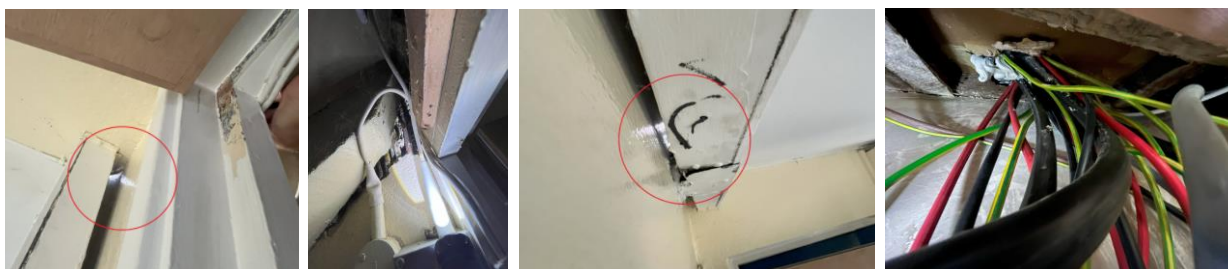
6) The front and rear final exit doors are push-bar operated from inside the building, they are also fitted with automatic closing devices. These are checked on a regular basis by Caretaking Teams as part of their checks. Defective closing devices are replaced either by the Caretaking Team(s) or the in-house repairs team(s).

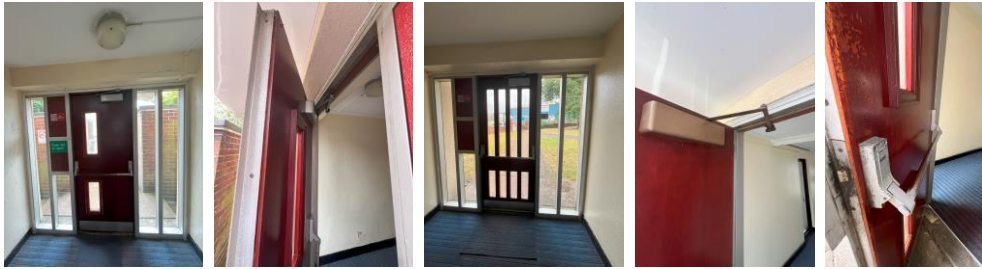
7) All service cupboards to communal landings are upgraded notional doors with fire/smoke seals and are lockable with a 138 key and include a "Fire door Keep locked" signage. Service cupboard in block 7-12 requires "Fire door Keep Locked" signage, also block 1-6 service cupboard requires replacing existing "Fire Door Keep Shut" signage" See section 12/1

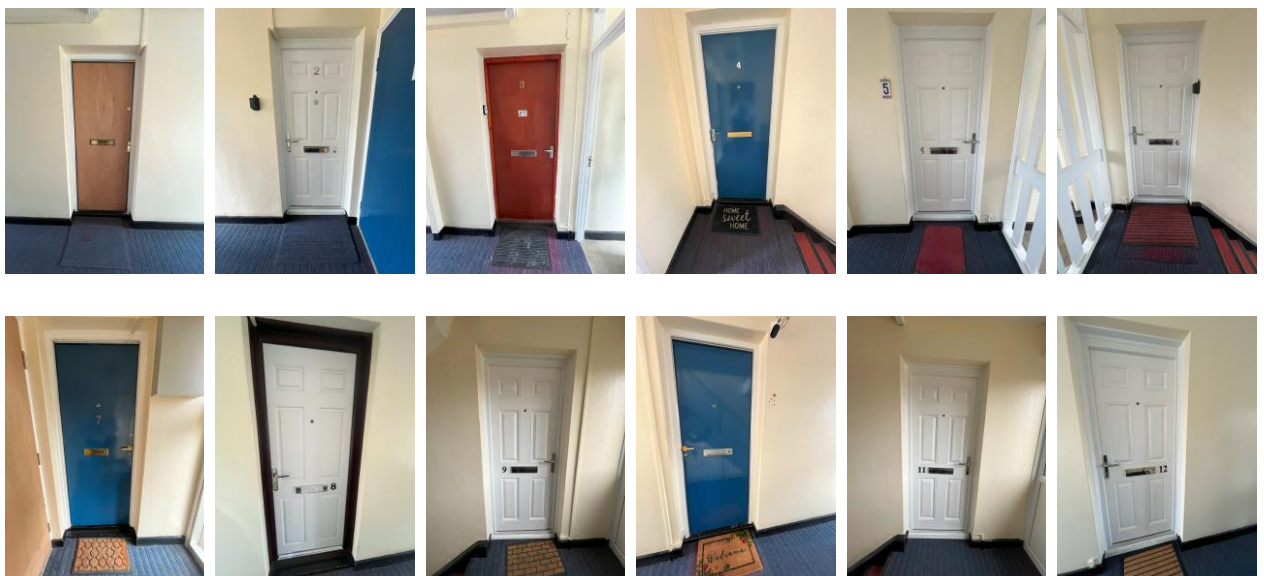
9) During the fire risk assessment, the following doors were assessed.

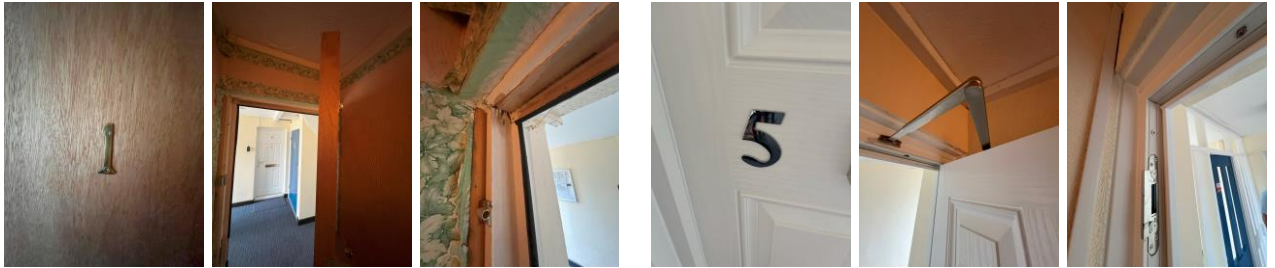
b) Flat 5 composite door: All door fire safety kit in place and working.

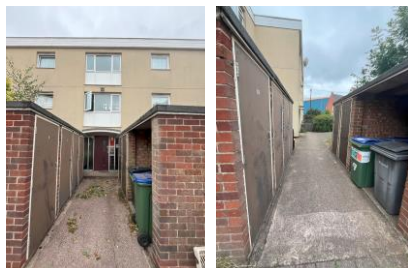
- 1) Residents instructed not to bring L.P.G cylinders into block.
- 2) The tenancy conditions, Section 7 – Condition 5.6 stipulates “If you live in a flat or maisonette, you, people living with you and any visitors to your property must not keep or use paraffin oil, petrol, bottled gas appliances or any other explosive, FLAMMABLE or dangerous material in the property. This restriction also applies to any storage facility situated in or attached to the block, which has been provided for your use.”
- 3) No Flammable liquids stored on site by Caretakers / cleaners.
- 4) There are no flammable liquids or gas cylinders stored on site.
- 5) Residents have individual storage cupboards externally which they keep secured by means of their own keys.
