Fire Risk Assessment

1-12 Jeffries House

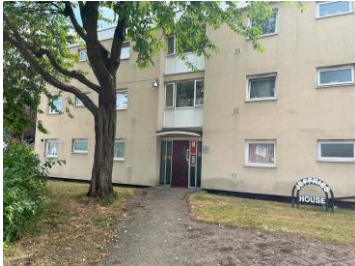
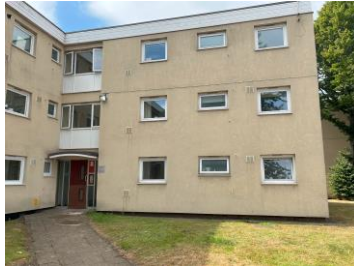
- 3) UPVC double glazed units have been installed to each flat.

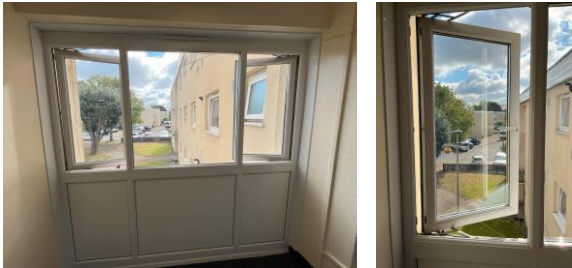
- 14) The premises have a sufficient emergency / escape lighting system in accordance with BS 5266.
- 15) The final exit doors have door push bar exit systems installed. These doors are checked on regular bases by the Caretaking Teams as part of their checks. Defective closing devices are replaced either by the Caretaking Team(s) or the in-house repairs team(s). The final exit doors have a push bar system fitted to exit the building.
