Fire Risk Assessment

**7 -12 Elm Tree Way
Cradley Heath,
B64 6EN**

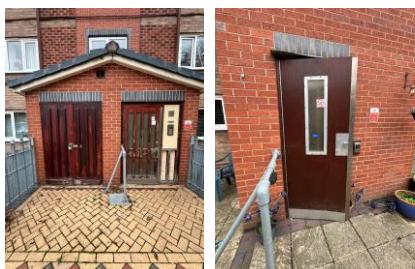
3) UPVC double-glazed window units have been installed in each flat and in the communal areas within the block. Additionally, UPVC cladding is present on the front and rear elevation of the building, extending from the ground to the second floor. Upgrading this cladding has been previously recommended as part of any future works program.

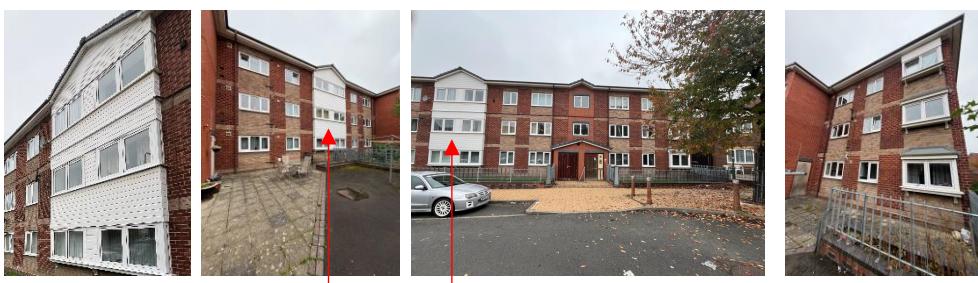
UPVC Shiplap cladding to the front and rear and UPVC window units

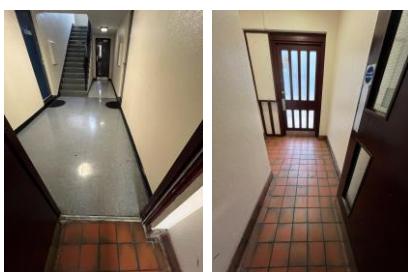
- 3) Front entrance doors to residents' flats have floor mats placed in communal area, they are of a suitable size and in acceptable condition, the fire rating for these mats is not known, but deemed to be sufficiently low risk.

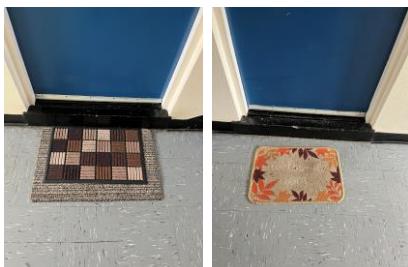
- 4) Resident electrical cupboards are located next to residents flats. The cupboards installed into the block work within secured units. It is recommended that on any future refurbishment of the block that the electrical cupboards are to be relocated within the residents flat at housed within the required compartmentation.

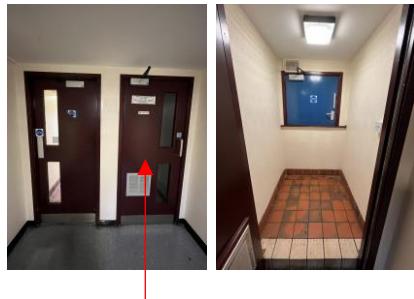
9) On the ground floor communal hallway there is access to a bin refuse room which is located behind a FD30s fire door.

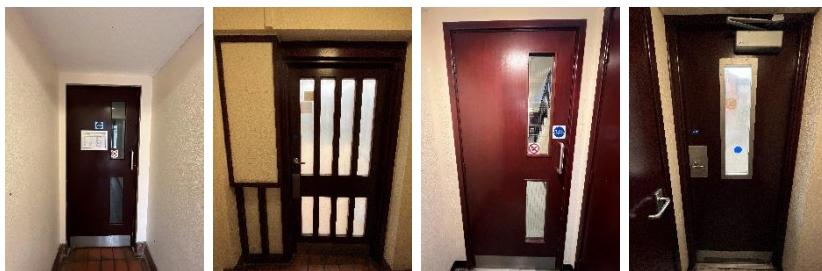
Communal doors with front and rear final exits doors.

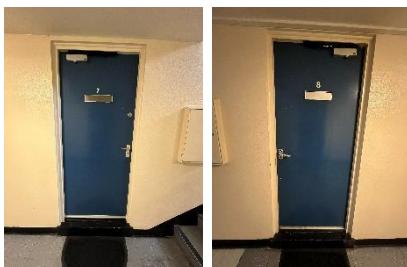
Ground floor flats, 7,8

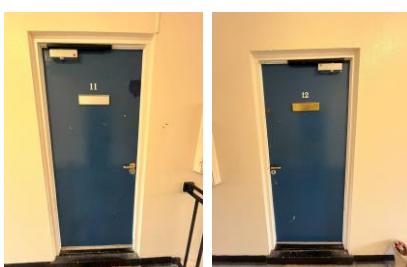
2nd floor flats 11,12

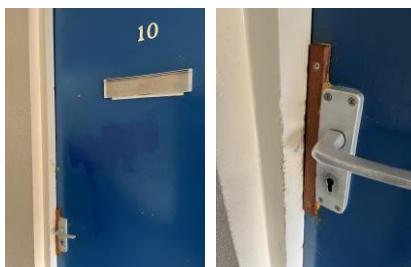
7) The building has adequate compartmentation between the refuse bin room and the communal hallway. This is achieved through an FD30s timber fire door equipped with a self-closing device. The refuse bin hatch is also fitted with a timber fire door that includes smoke seals. These condition of these seals were inspected, and no issues were identified.

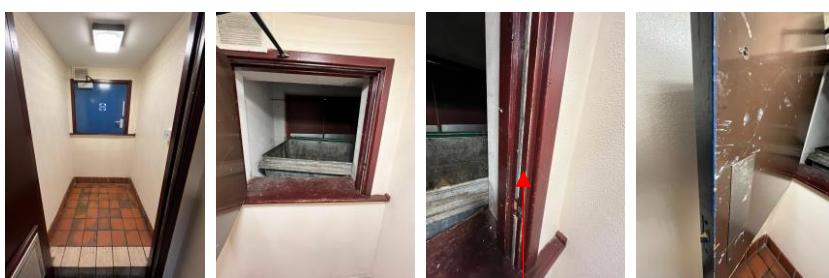
Bin store enclosure and smoke seals

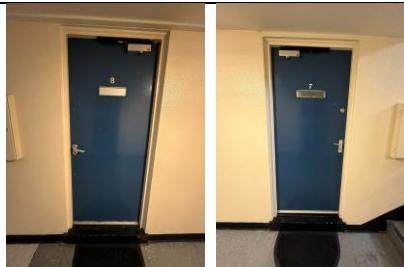
It is recommended that the UPVC cladding be considered for removal on any future renovation to the building.
