# Fire Risk Assessment

17-23  
Portway Hill,  
Rowley Regis,  
B65 8BG.

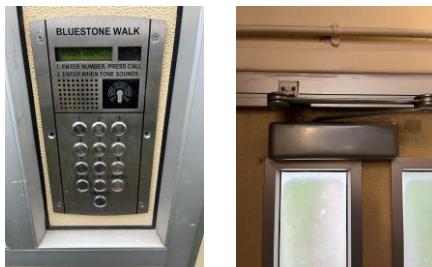
16) The final exit door at the rear of the building has a thumb turn lock on the internal side.

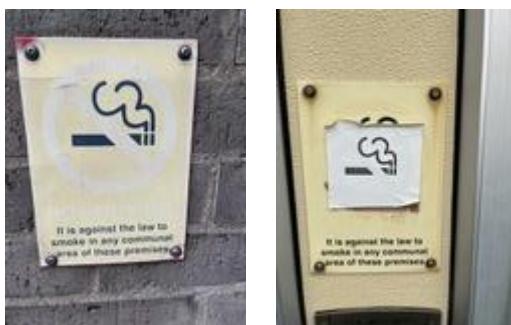
- 5) Smoke free signage requires replacement by front and rear exit due to being faded. See action 12/5**

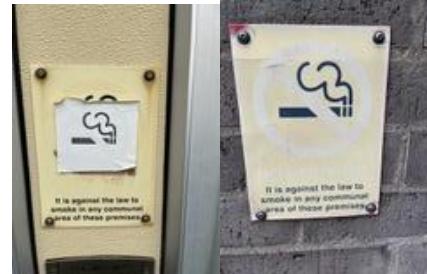
P2	1-3 Months Fire Rapid Response
