Fire Risk Assessment

**104-104a
Tower Road,
Oldbury,
B69 1NF**

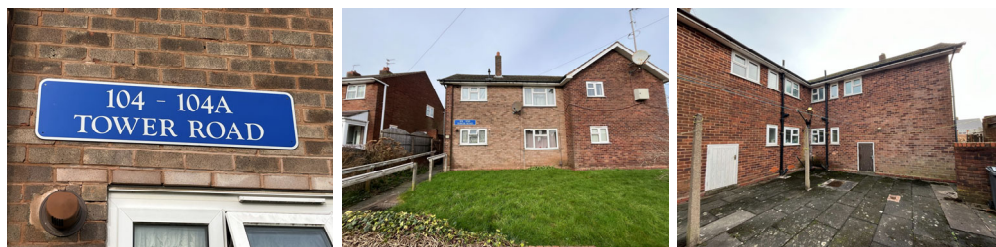
A Type 1 Fire Risk Assessment of the premises at 104-104a Tower Road has been carried out. The assessment included a thorough inspection of the site's layout, identification of potential fire hazards, and evaluation of existing fire safety measures. The findings and recommendations have been documented.

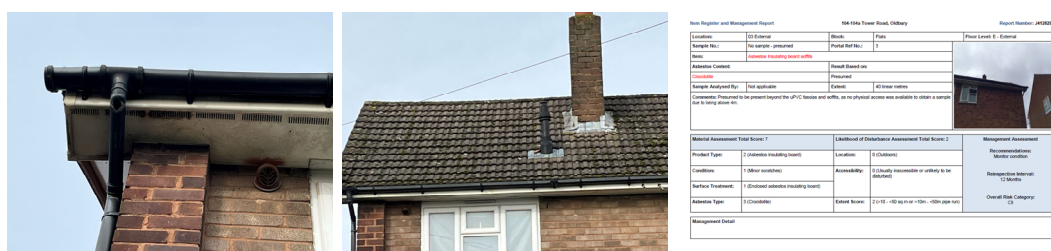
The building is a semi-detached block adjoining 48-50 Hawfield Road. Access is gained via a secured side entrance. The entrance/exit door is timber construction with glass panelled inset. Access is gained with fob, flat call button and fire service drop key. Beyond the entrance, there is a ground-floor flat (No. 104) and a concrete staircase providing access to Flat 104A.

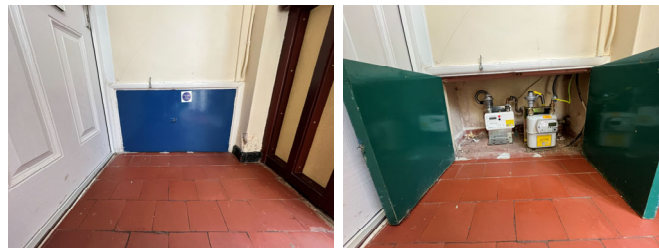
14) The final exit doors are fitted with a push button to egress the building and are also fitted with automatic closing devices that are checked on a regular basis by caretaking teams as part of their checks. Defective closing devices are replaced either by the Caretaking Team(s) or the in-house repairs team(s). The final exit doors have door entry systems installed. These systems are designed to fail safe i.e. door unlocked in the event of a power failure. This prevents residents being locked in or out of the building.

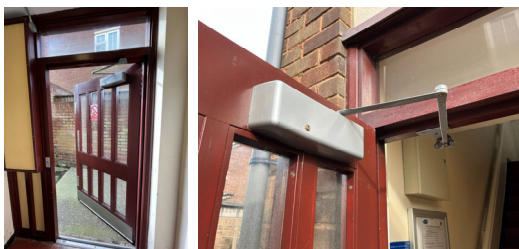
15) Communal areas are kept free of flammable items. The communal areas are checked on a regular basis by Caretaking / Cleaning teams 365 days per year and all items of rubbish are immediately removed. There is also an out of hour's service that allows combustible items of furniture / rubbish to be removed.

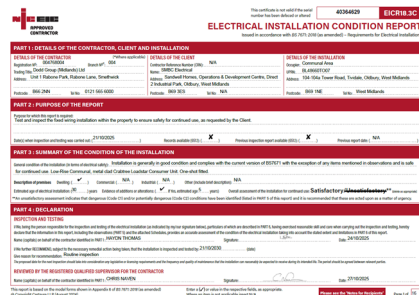
- 5) Portable heaters are not allowed in any common parts of the premises.
- 6) Gas appliances and pipework (where installed) are subject to annual testing and certification. This cyclical contract is managed by the in-house Gas Team.

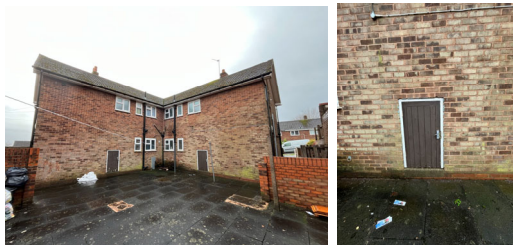
- 1) Residents instructed not to bring L.P.G cylinders into block.
- 2) The tenancy conditions, Section 7 – Condition 5.6 stipulates “If you live in a flat or maisonette, you, people living with you and any visitors to your property must not keep or use paraffin oil, petrol, bottled gas appliances or any other explosive, FLAMMABLE or dangerous material in the property. This restriction also applies to any storage facility situated in or attached to the block, which has been provided for your use.”
- 3) Residents should not store flammable liquids or gas cylinders on site.
- 4) No Flammable liquids stored on site by Caretakers / Cleaners.
- 5) There is one storage cupboard in the rear courtyard, which is built within the building and is locked by a tenant only key.

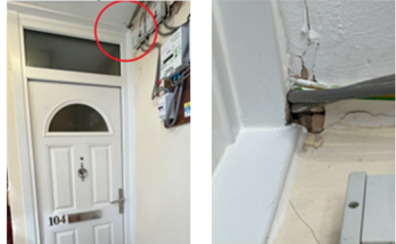
<p>P2</p>	<p>Within 1-3 months Fire Rapid Response</p>

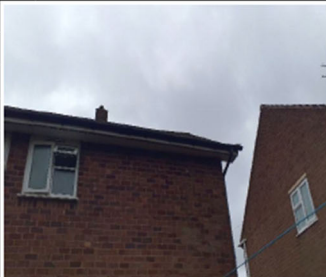
Item:	Asbestos Insulating board soffits			
Asbestos Content:	Result Based on:			
Crocidolite	Presumed			
Sample Analysed By:	Not applicable	Extent:	40 linear metres	
Comments: Presumed to be present beyond the uPVC fascias and soffits, as no physical access was available to obtain a sample due to being above 4m.
