# **Fire Risk Assessment**

## **Applewood Grove**

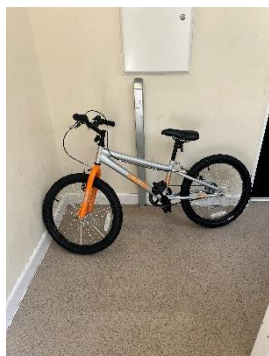
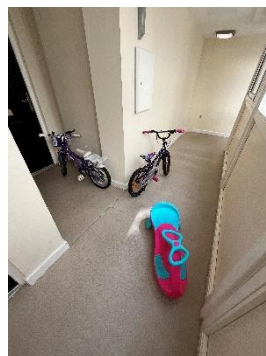
- 6) The communal landings and protected staircases are protected by use of nominal self-closing FD30s timber fire doors with vision panels. The landing side of the door leaf is fitted with a single operation levered handle, opening in the direction of escape. The main entrance door and each floor level lobby door have door entry systems installed. These systems are designed to fail safe i.e. door unlocked in the event of a power failure. This prevents residents being locked in or out of the building and or area.

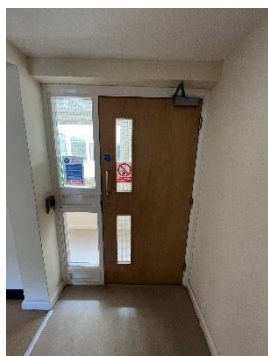
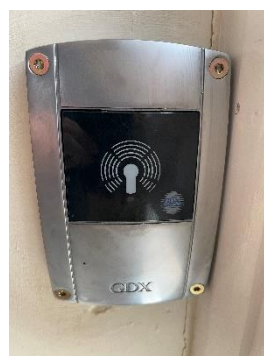
- 7) All communal doors are fitted with automatic closing devices that are checked on a regular basis by the on-site teams / Premises Supervisors / Caretaking Teams as part of their daily checks. Defective closing devices are replaced either by the Caretaking Team(s) or the in-house repairs team(s).

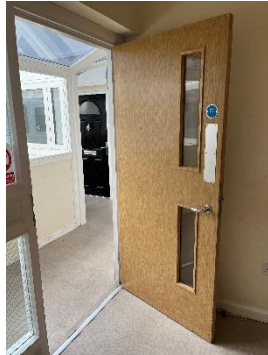
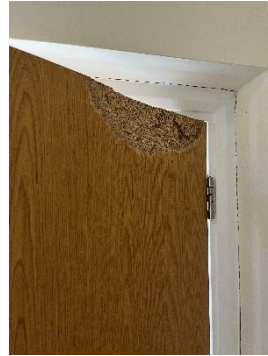
- 9) The 1<sup>st</sup> floor landing fire door closes too quickly and requires adjustment. See action 7/9.

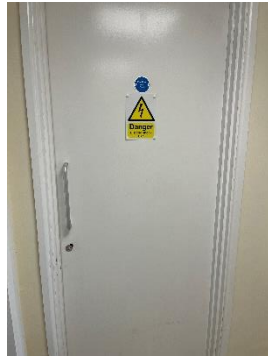
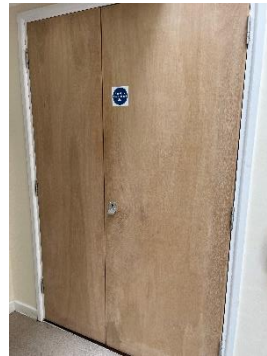
- 5) Communal doors are fitted with automatic closing devices that are checked on a regular basis by the on-site teams / Premises Supervisors / Caretaking Teams as part of their daily checks. Defective closing devices are replaced either by the Caretaking Team(s) or the in-house repairs team(s).
- 6) Individual flat doors are FD30s rated. The design is 'Neuma' an FD30s composite door set manufactured and installed by Nationwide Windows and Doors. A BM Trada Q-mark registered company.

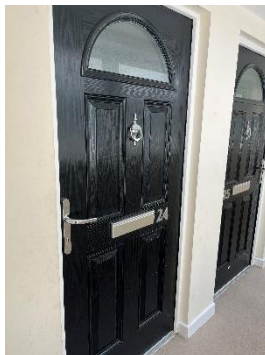
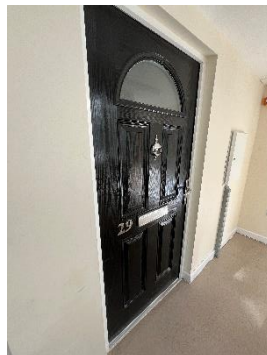
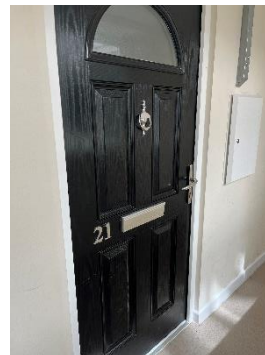
- 7) The communal corridors, landings and protected staircases are protected by use of nominal self-closing FD30s timber fire doors with vision panels. These cross-corridor doors are fitted with hold-open devices, the majority of which are magnetic locks attached to the AFA system.

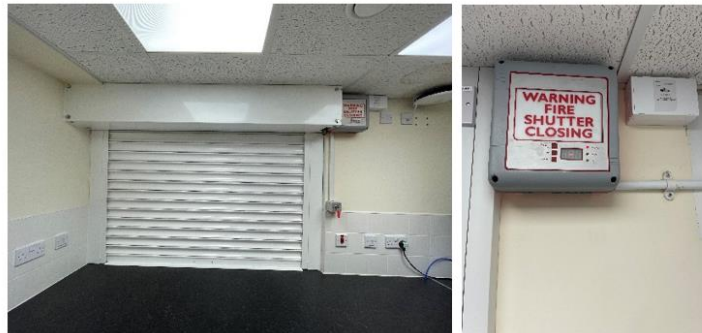
- 12) **Flats on floors 1 to 3 are in pairs, with an interconnecting door so that two 1 bed flats can become one 3 bed flat. This is facilitated using a FD60s fire door. Although out of the scope of this type 1 fire risk assessment, it is recommended that the FD60s doors separating the two flats are subject to a periodic test regime. See action 10/12.**

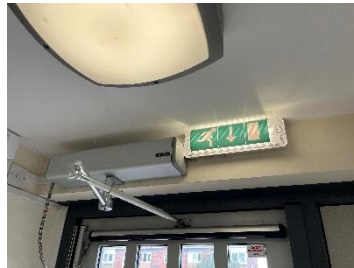
- 4) The fire escape routes use directional fire signage.
