# Fire Risk Assessment

## New Hope Road 91 -95

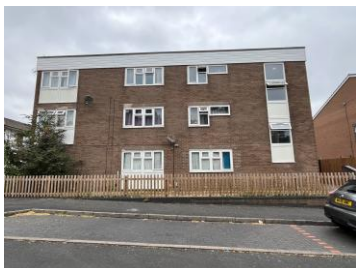
- 1) The exterior of the building is predominately traditional brick construction with a flat roof design with UPVC cladding boards under the roof line and a bitumen and felt roof. Front entrance is through timber doors with glazing in the inserts of the doors. Further along the front entrance is the refuse bin store secured by a steel door, this can be found in the secured courtyard,

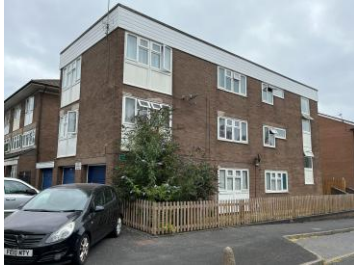
- 3) Three residential garages are integrated beneath the residential flats on the side elevation. Noted that vehicles are parked too close to the envelope of the building and directly under resident flat windows. This will need to be considered on any future refurbishment of the building.

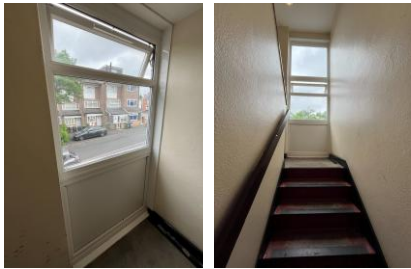
1st and 2<sup>nd</sup> floor landing

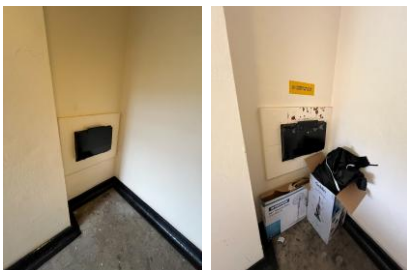
- 10) The residential electricity meters are installed within durable metal enclosures situated in the communal corridors adjacent to the flat entrance doors. Access control to these service boxes is maintained via standard budget lock mechanisms.

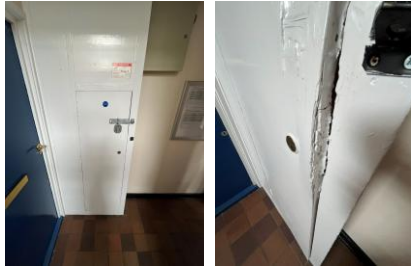
- 7) No access was gained to assess the cleaners storage cupboard in the means of escape. Ventilation apertures were noted directly above the door framework.

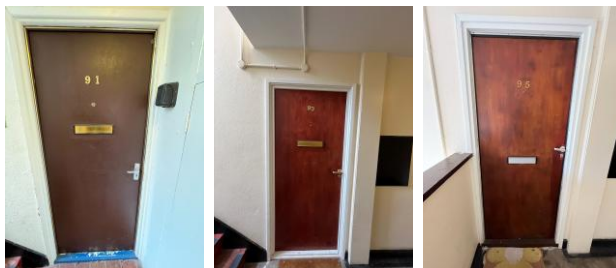
- 8) All individual flats are installed with timber FD30s doors. *Recommendation on any future refurbishment of the block the doors be upgraded to certified FD30s rated fire doors.*

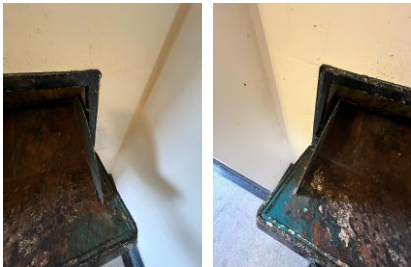
- 11) Resident electrical cupboards installed next to flat entrances in the communal corridors were sampled for fire stopping, no issues found within the enclosure.

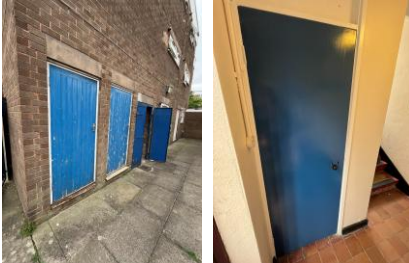
- 5) There are two storage cupboards located externally to the rear in the secured courtyard, these are kept locked. There is also one internal storage cupboard in the communal hallway by the front entrance.

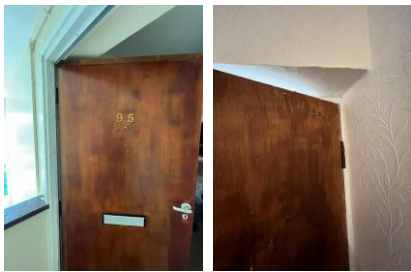
| 10/9 | Flat 95 has had self-closing device removed. Refit and make correct. | | | 1-3 Months<br>Fire Rapid<br>Response | |
