# PAS 9980 STEP 1

## ADDENBROOKE COURT

Addenbrooke Court  
Southbank Road  
Old Hill  
West Midlands  
B64 6LL

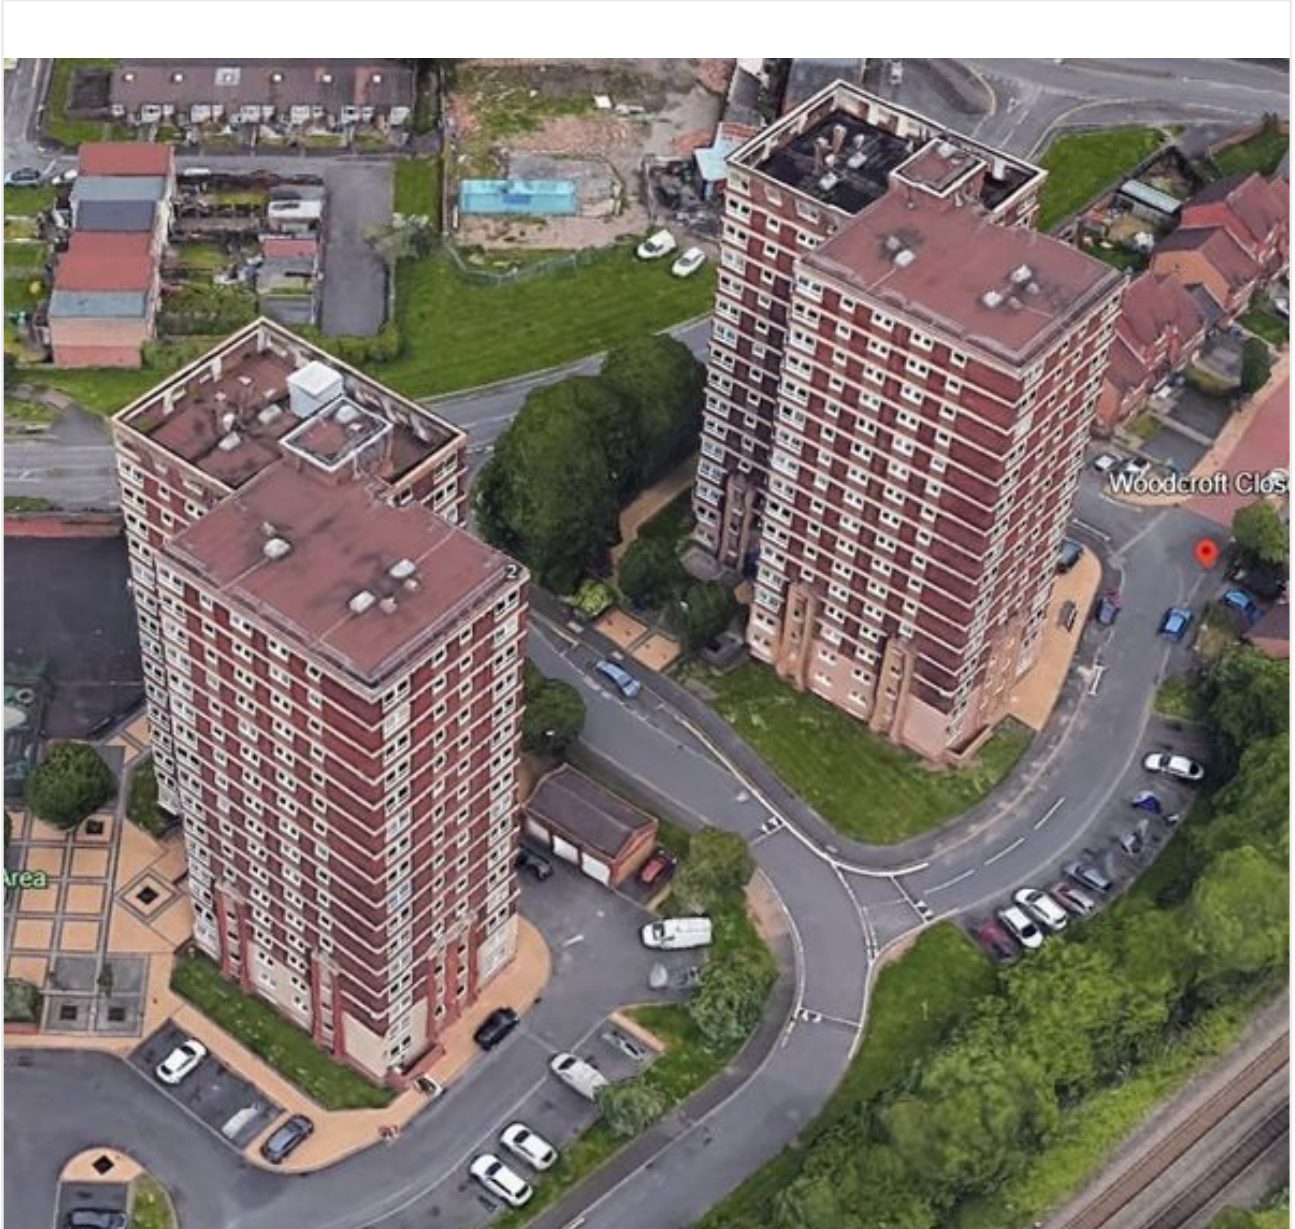
# Aerial Perspective: Aerial Perspective: Addenbrooke Court Center Left

Showing Wesley Court and Addenbrook Court and the surrounding area
