Document Version 10  
Survey Date 23/11/2024  
Suggested Review Date 23/11/2029

# FIRE RISK APPRAISAL EXTERNAL WALLS

## BIRCHCROFT

Birchcroft  
Windmill Lane  
Smethwick  
West Midlands  
B66 3LW

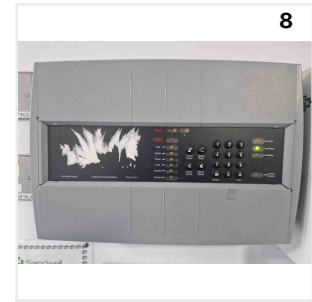
Photos

Automatic Smoke Ventilation:

Installed at the stairwell on the 14th floor.

System includes automatic opening windows.

Control and repeater panels are located in the ground floor lobby and 14th floor staircase.
