# EXTERNAL WALL SURVEY

## MOORLAND

Moorlands Court  
Reservoir Road  
Rowley Regis  
West Midlands  
B65 9PB

## External Wall Survey

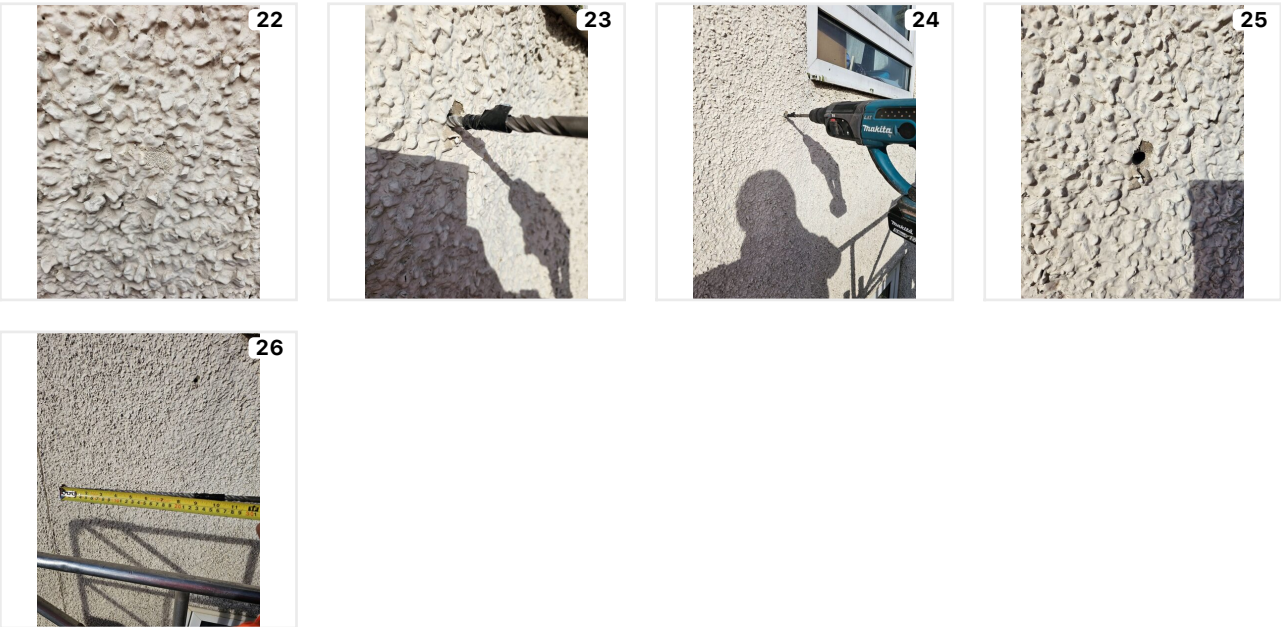
# Inspection: RYB7LZ

Wall Type 2 - Solid concrete with granular finish

| 1 Element | Thickness/Depth | Material | Photo Ref. | Rating (BS EN13501) |
|---|---|---|---|---|
| Surface Finish | 250mm | Granular stone finish which forms part of the concrete wall system | | A1 - Non-Combustible |

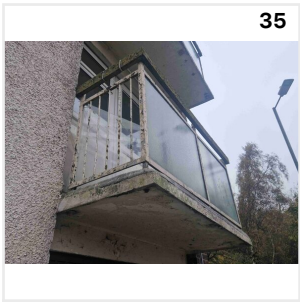
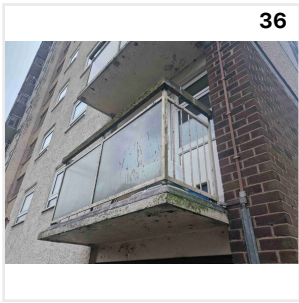
Attachment Reference  
LFNQ21

Stacked

Private balcony spanning only a single compartment

Reinforced concrete framework extension of the floor slab

Concrete

Timber

Steel and Glass
