Survey Date 04/11/2024

# EXTERNAL WALL SURVEY

## ST GILES

St Giles Court  
Reservoir Road  
Rowley Regis  
West Midlands  
B65 9PE

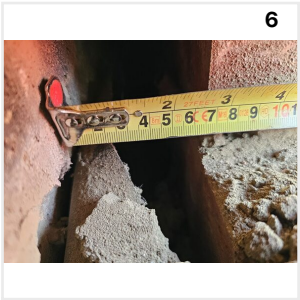
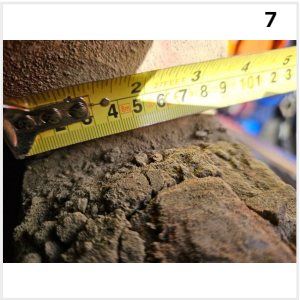
# Inspection: V9UCRZ

Wall Type 1 - Twin wall masonry - brickwork/concrete

| 3 Elements | Thickness/Depth | Photo Ref. | Rating (BS EN13501) |

| Outer leaf | 102mm | | A1 - Non-Combustible |

| Cavity | 60mm | | |

| Inner Leaf | 100mm | | A1 - Non-Combustible |

Cast in situ concrete

None

Backing Wall Sits On The Floor Slab

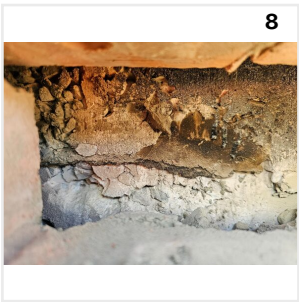
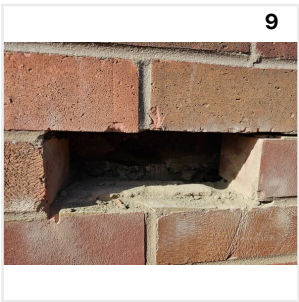
# Inspection: 2JEFLJ

Wall Type 1 - Twin wall masonry - brickwork/concrete

| 3 Elements | Thickness/Depth | Photo Ref. | Rating (BS EN13501) |

| Outer leaf | 102mm | | A1 - Non-Combustible |

| Cavity | 60mm | | |

| Inner Leaf | 100mm | | A1 - Non-Combustible |

Cast in situ concrete

None

Backing Wall Sits On The Floor Slab

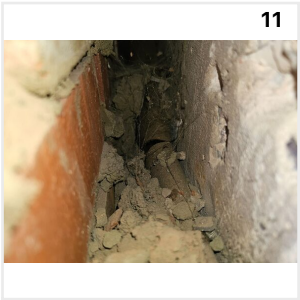
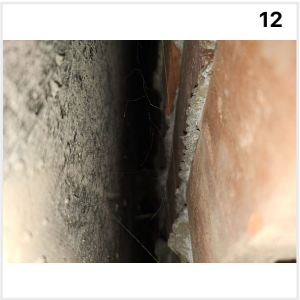
# Inspection: JW4L4R

Wall Type 1 - Twin wall masonry - brickwork/concrete

| 3 Elements | Thickness/Depth | Photo Ref. | Rating (BS EN13501) |
| Outer leaf | 102mm | | A1 - Non-Combustible |
| Cavity | 60mm | | |
| Inner Leaf | 100mm | | A1 - Non-Combustible |

Cast in situ concrete

None

Backing Wall Sits On The Floor Slab

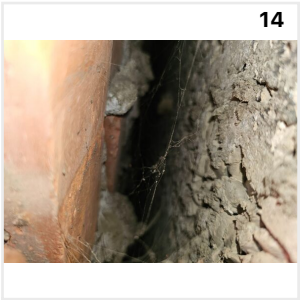
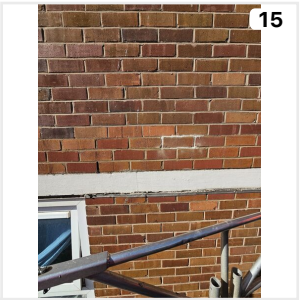
# Inspection: PLIVW4

Wall Type 1 - Twin wall masonry - brickwork/concrete

| 3 Elements | Thickness/Depth | Photo Ref. | Rating (BS EN13501) |
| Outer leaf | 102mm | | A1 - Non-Combustible |
| Cavity | 60mm | | |
| Inner Leaf | 100mm | | A1 - Non-Combustible |

Cast in situ concrete

None

Backing Wall Sits On The Floor Slab

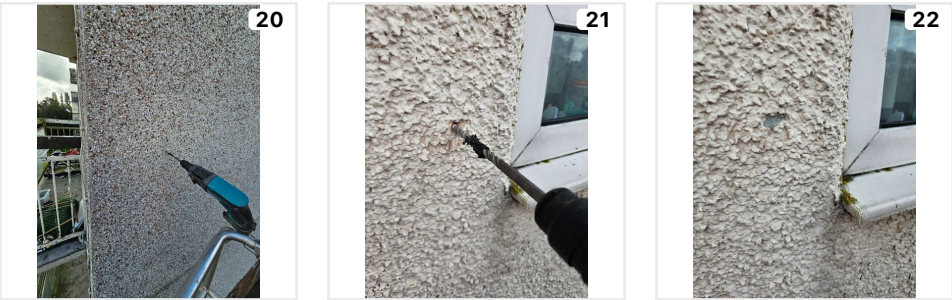
# Inspection: YS5QKP

Wall Type 2 - Solid concrete with granular finish

| 1 Element | Thickness/Depth | Material | Photo Ref. | Rating (BS EN13501) |
| Surface Finish | 250mm | Granular stone finish which forms part of the concrete wall system | | A1 - Non-Combustible |

There is no external wall cavity

Backing Wall Sits On The Floor Slab

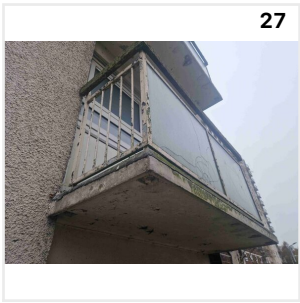
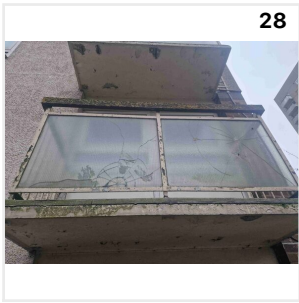
# Attachment: Cantilever Balcony

Timber

Concrete
