Document Version 3  
Survey Date 09/11/2024  
Suggested Review Date 09/11/2029

# FIRE RISK APPRAISAL EXTERNAL WALLS

## ST GILES

St Giles Court  
Reservoir Road  
Rowley Regis  
West Midlands  
B65 9PE

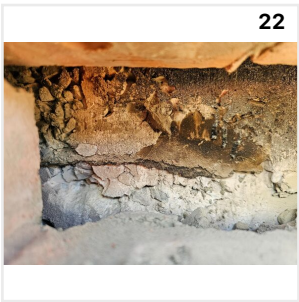
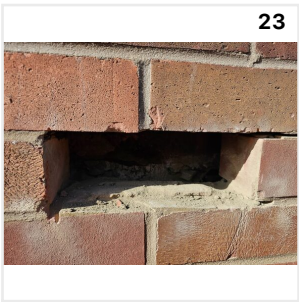
# Inspection Photos

Backing Wall Sits On The Floor Slab

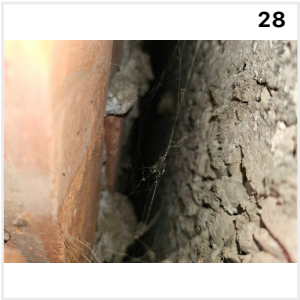
# Inspection Photos

Backing Wall Sits On The Floor Slab

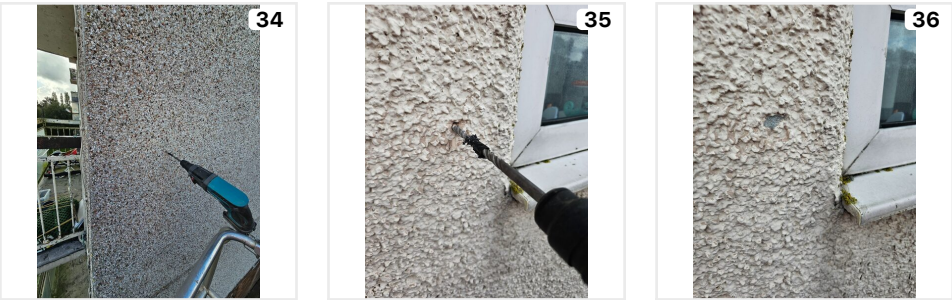
## Inspection Photos

Elevation • Location  
Wall Type 2 - Solid concrete with granular finish • Accessible wall

Backing Wall Sits On The Floor Slab
