Fire Risk Assessment

Wesley Court

Southbank Rd,
Cradley Heath, B64 6LQ

Date of Inspection: 13th July 2026

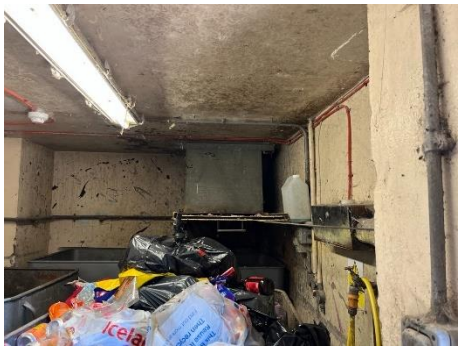
The dry riser inlet is located on the side elevation adjacent the bin store. Facing the front of the main entrance this is to the right-hand side of the block / Woodcroft Close.

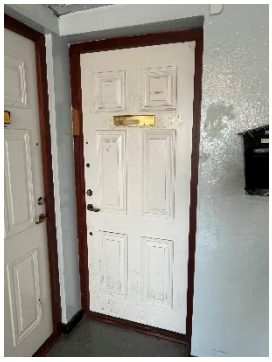
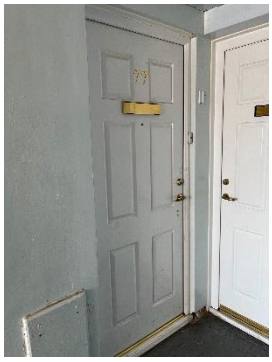
1) Individual flat entrance doors are a mixture of, nominal FD30S timber fire door sets and Certified FD30s fire door sets.

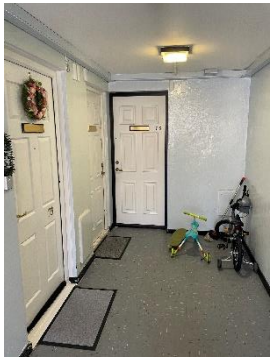
Question/ Ref No	Required Action	Supporting photograph	Priority	Timescale and Person Responsible	Date Completed
7/14	Ensure combustible items are removed from communal areas outside flat 88 and issue correspondence to residents reminding them of the requirement to maintain sterile		P2	1-3 Months Housing Management
