Fire Risk Assessment

41 - 56
Wellington Road
Smethwick, B67 6EU.

Date of Inspection: 10th September 2026

Sandwell
Metropolitan Borough Council

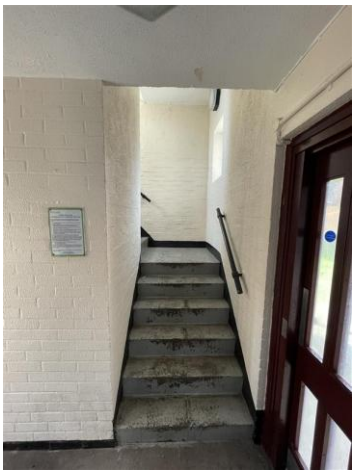
The 3 access doors to the communal areas and staircase are of timber construction with glazed panel insets. Access is controlled by a fob system, property number call button, and fire-service drop key.

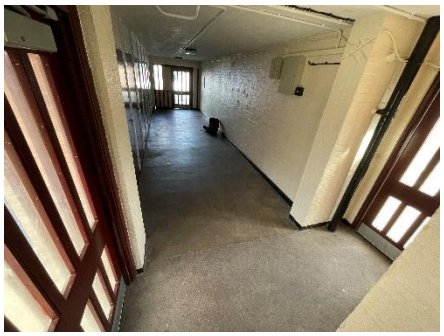
9) All electrical cabling within the ground-floor enclosed communal corridors is run through metal electrical trunking and conduits. Some cabling on the open deck is also run through metal trunking. Cabling not contained within trunking was observed to be securely fixed and showed no visible signs of damage.

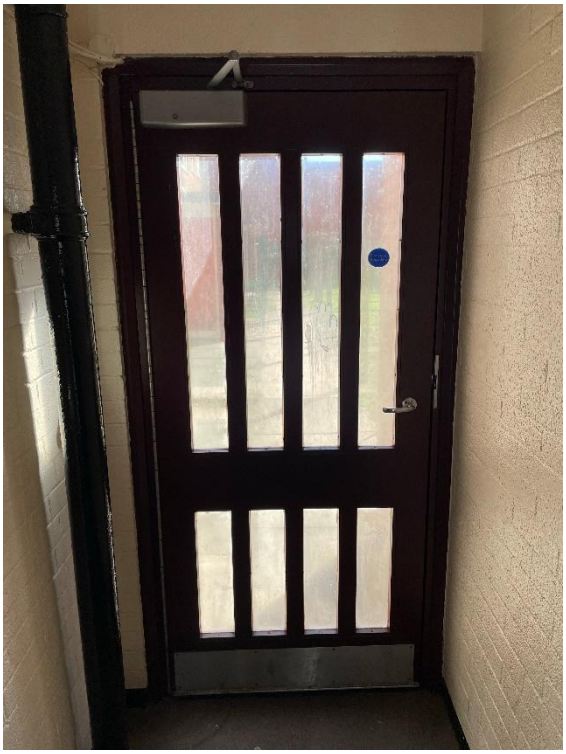
10a) The exit door leading to the rear garden was found unable to secure in the closed position due to damage to the lock keep/strike plate assembly within the door frame. Whilst the defect does not affect means of escape, it compromises the security of the building and may facilitate unauthorised access to the common parts.
Email sent to CCTV & Concierge on 14/09/2026 for repair / replacement of the strike plate located within the door frame. Email received 14:57 14/09/2026 confirming a job has been raised for the repair.

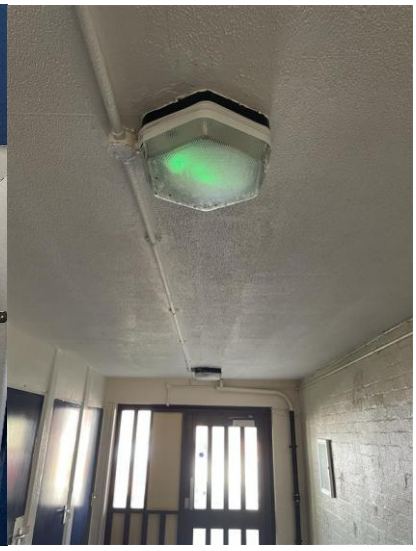
1) Emergency lighting is provided throughout the common escape routes and is subject to routine testing and maintenance in accordance with BS 5266-1:2025.

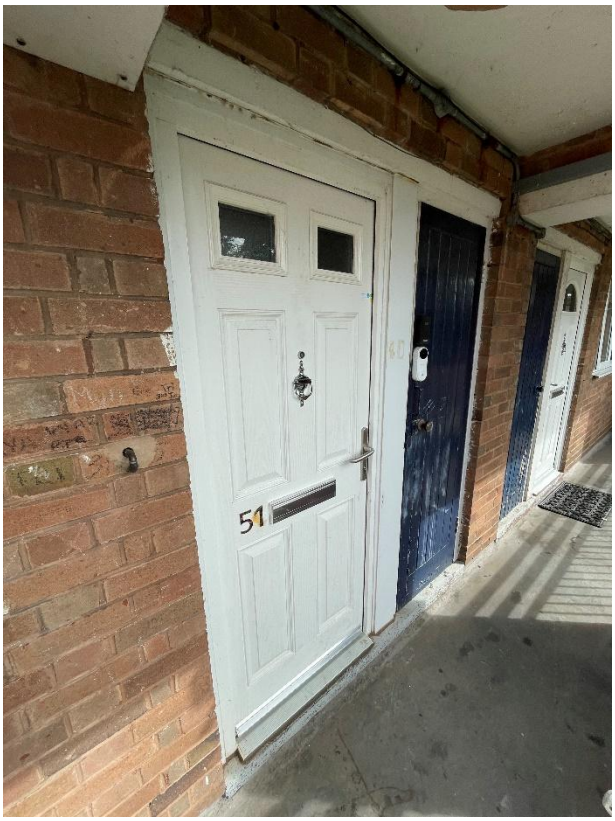
7) Ground floor maisonettes are provided with storage cupboards located immediately adjacent to the flat entrance doors. All cupboards were secured with resident-controlled locks and were therefore outside the scope of this assessment. As access was not available, the nature and quantity of combustible materials stored within the cupboards could not be determined.
