Fire Risk Assessment

90 - 104
Thompson Gardens
Smethwick, B67 6RZ.

Date of Inspection: 5th October 2026

Sandwell
Metropolitan Borough Council

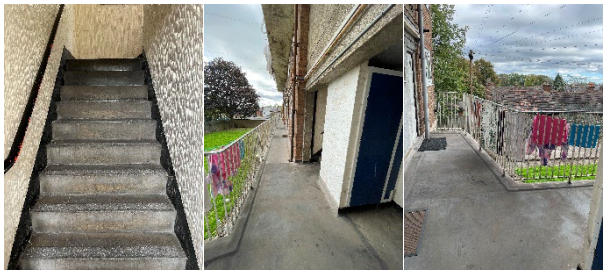
The property was built in 1961 and is of traditional brick construction. The property has 5 storeys inclusive of the ground floor.

The block consists of 3 ground floor flats, 6 deck accessed maisonettes on the 1st floor and 6 deck access maisonettes on the 3rd floor. 15 properties in total.

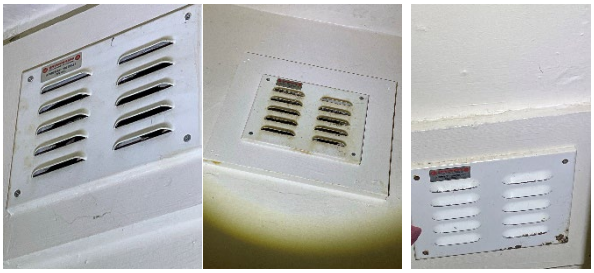
7) An electrical cupboard is located within the ground floor communal area. Fire-stopping measures are present around cable penetrations within the cupboard and where cables pass through the cupboard enclosure; however, sections of the sealant have detached from the surrounding surfaces, leaving gaps around some penetrations. **Suitable fire-stopping is required to reinstate an effective seal.**

8) Air transfer vents were observed within the electrical cupboard, which connect to vents located within the kitchen of Flat 90. The vents showed evidence of previous fire-stopping works; however, the materials used appear to have deteriorated and may no longer provide an effective seal. **Suitable fire-stopping should be provided around the vents to reduce the potential for fire and smoke spread, or alternatively the vents should be replaced with a suitable fire-resisting product similar to that installed within the flat.**

10/8	Suitable fire-stopping should be provided install intumescent vent within the electrical cupboard on the ground floor.		P2	1-3 months Fire Rapid Response.	
14/4	Electrical Team to provide an update on the status of the remedial works identified within the report and confirm whether all defects have been rectified.	 Dodd Group ELECTRICAL INSTALLATION CONDITION REPORT	P2	1-3 months Electrical Team

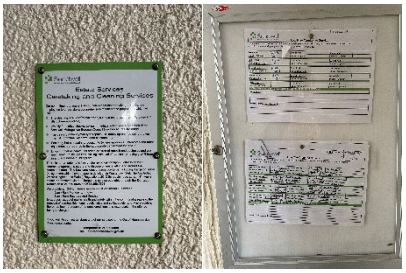
1) 3 refuse hopper doors are installed on the ground, 1st & 3rd floor, allowing residents to dispose of household waste. A bin chute dispenses of the household rubbish into containers located in the bin store at the front elevation. The bin store doors are metal in construction and secured with a lever lock. The chute, rubbish containers and bin store provide a dedicated means of waste collection and storage separate from the residential accommodation.
