Fire Risk Assessment

1-8
South Dene,
Smethwick,
B67 7DB.

Date of Inspection: 06 November 2026

Sandwell
Metropolitan Borough Council

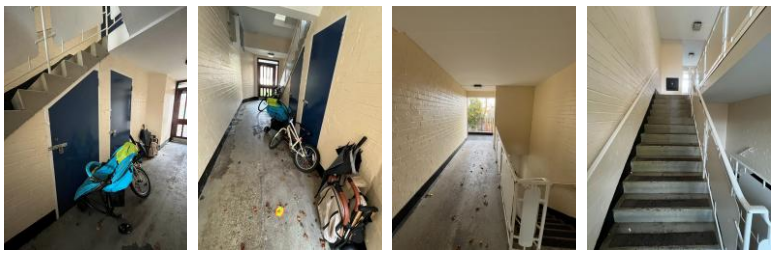
6) The upper floor is served by a concrete staircase, which provides the means of escape for occupants of the flats located on the upper floor. The staircase has a clear width of approximately 1 metre measured between the handrail and wall.

7) The communal staircases and landings within the block are of reinforced concrete construction

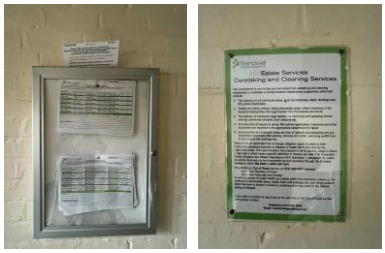
1) There is a regular Cleaning Service to the premises.

2) Refuse bins serving South Dene 1-8 are located within a dedicated bin store at the rear of the premises. This room also incorporates the refuse chute discharge point, where waste deposited via the bin hoppers from the upper floors is collected. At the time of the survey, the bin store appeared suitably managed, and refuse is removed as part of the routine waste collection service.
