Fire Risk Assessment

65-67
Hawfield Road,
Tividale,
B69 1LD

Date Completed: 03/02/2026

Sandwell Metropolitan Borough Council

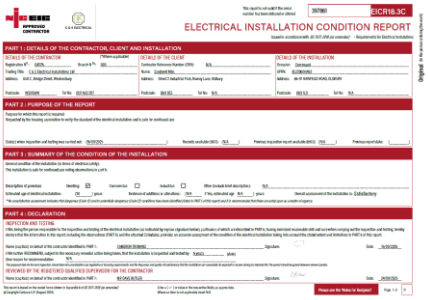
ELECTRICAL INSTALLATION CONDITION REPORT

4) The fixed electrical installation shall be tested every 5 years. The date of the last EICR was 15/09/2025.
