Fire Risk Assessment

Church Gardens 53 - 72

Smethwick,

Date of Inspection: 1ST September 2026

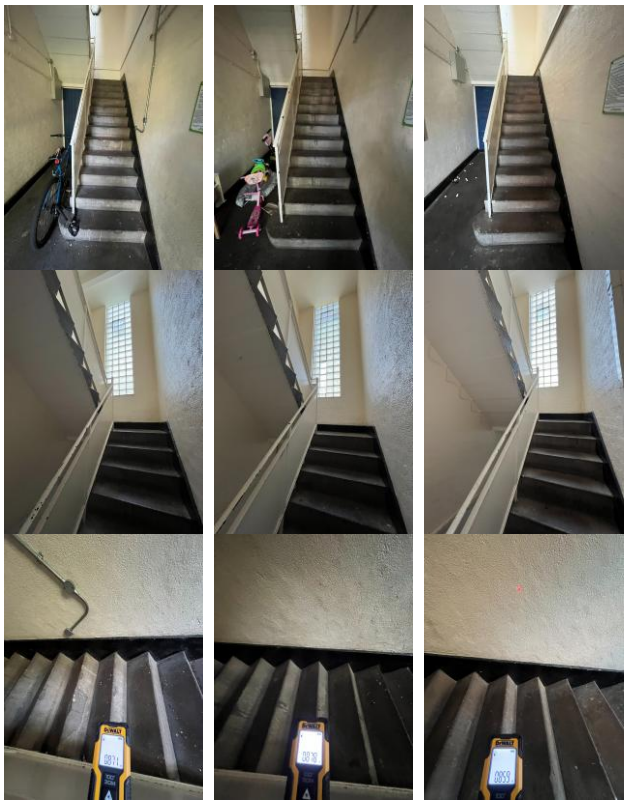
Sample of stairs and measurements

8) Church Gardens 53 - 72 consists of a single staircase that provides sufficient means of escape to all flats on the 1st and 2nd floor, this is located as you enter each block. The width of the staircases has been measured from concrete handrail to wall at a measurement of between 871& 878mm, each block differs in measurement slightly. These stairs and landings are kept clear to maintain safe means of escape, however on blocks 54-55,58-59,62-63, had items stored in the communal area.

10) An inspection of Block 54–55 revealed a substantial volume of combustible items stored adjacent to the staircase within the communal entrance. This accumulation obstructs the primary egress route and directly impacts the integrity of the means of escape, presenting a critical risk to safe emergency evacuation.
Email has been sent to housing on 09/09/2026

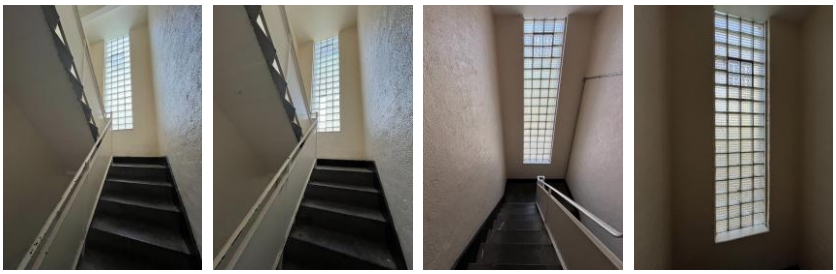
11) While there are no openable communal windows, natural ventilation is provided via dedicated vents integrated into the glass panes at the head of the communal staircase. This will reduce any smoke logging in the communal stairwell in an event of a fire.

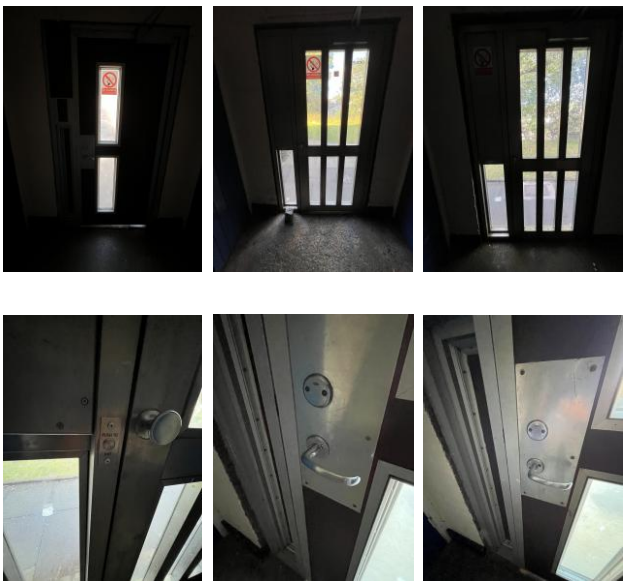
16)There is a clear and safe exit out of the building via the ground floor exits. The final front exit doors are accessed using a mixture of levered handles door release push buttons.

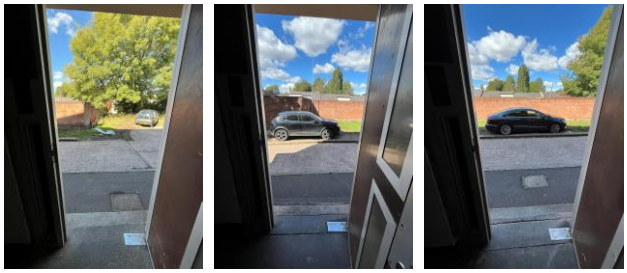
17) The route out the block to ultimate safety is clear from single final exit door.

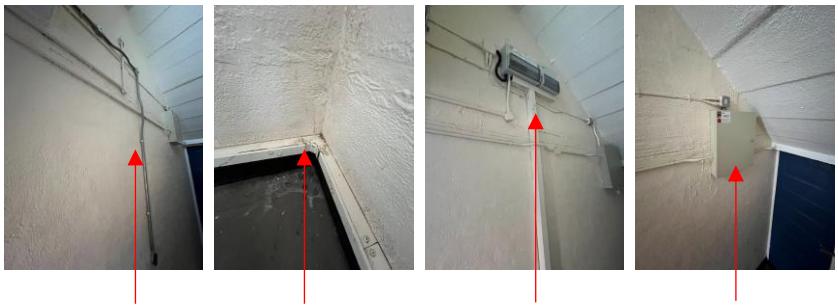
7) All electrical cabling within the communal corridors and protected escape routes is securely enclosed within metal trunking and metal conduits to prevent premature collapse in a fire. Additionally, the surface-mounted electrical distribution board on block serving flats 62 -63 is within a metal enclosure. All door access control units in the ground floor communal area are within a secure metal enclosure.

Metal conduit and trunking, metal enclosed D.B, Door access power supply.
