Fire Risk Assessment

9-17
South Dene,
Smethwick,
B67 7DB.

Date of Inspection: 10th November 2026

Sandwell
Metropolitan Borough Council

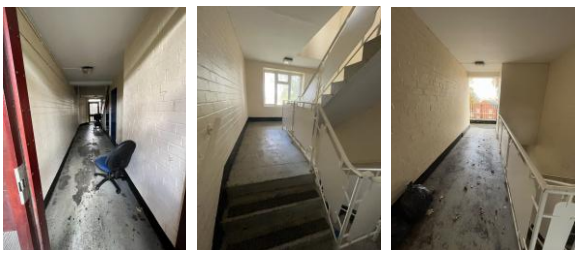
7) The communal staircases and landings within the block are of reinforced concrete construction

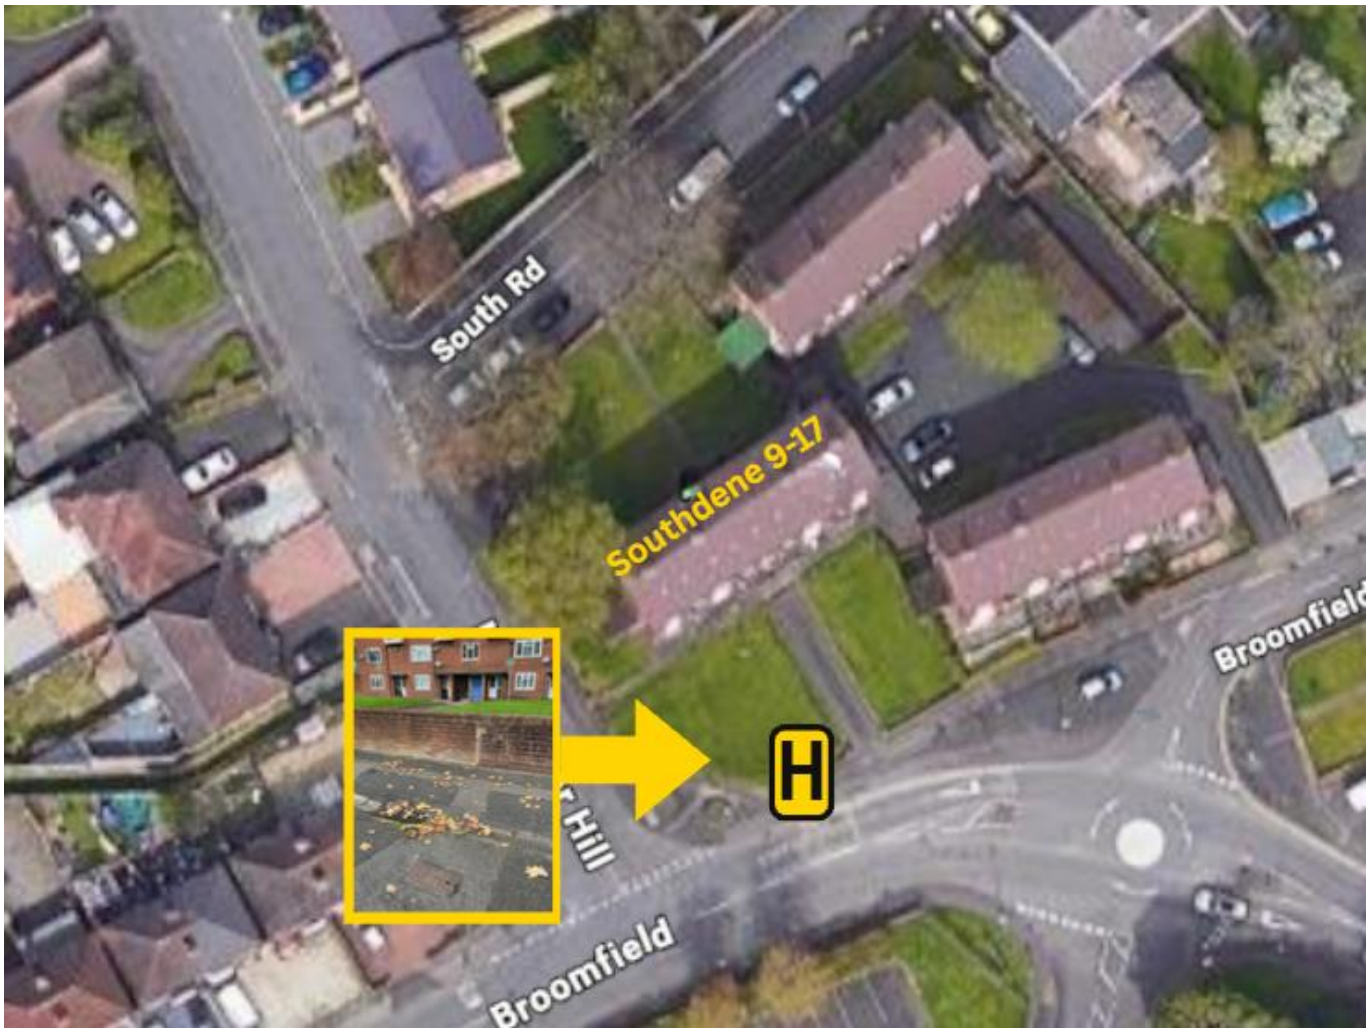
1) There is no firefighting equipment on this premises.

2) Nearest fire hydrant is indicated within the attached plan.
