Fire Risk Assessment

77 - 82
Aston Street
Tipton, DY4 0JD.

Date of Inspection: 2nd November 2026

Sandwell Metropolitan Borough Council

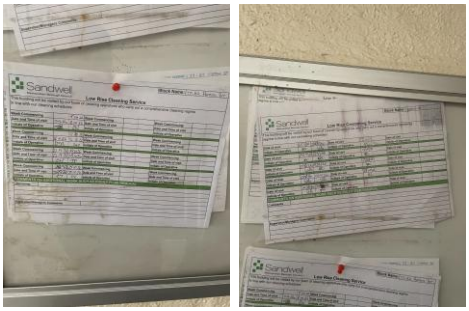
3) Communal areas are kept free of flammable items. The communal areas are checked on a regular basis by Caretaking / Cleaning teams 365 days per year, and all items of rubbish are immediately removed. There is also an out of hour's service that allows combustible items of furniture / rubbish to be removed.
