Fire Risk Assessment

95 - 100
Aston Street
Tipton, DY4 0JD.

Date of Inspection: 11th November 2026

Sandwell
Metropolitan Borough Council

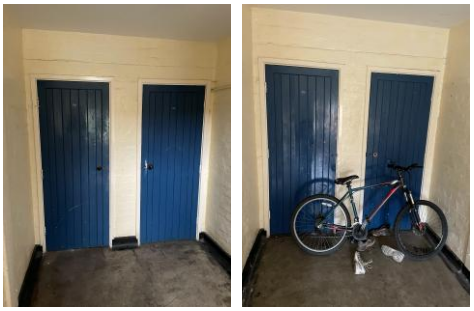
Electrical service cupboard containing intake cables and resident's meters are provided within the communal corridor.

Residents have storage cupboards provided within the landings on the 1st and 2nd floor.

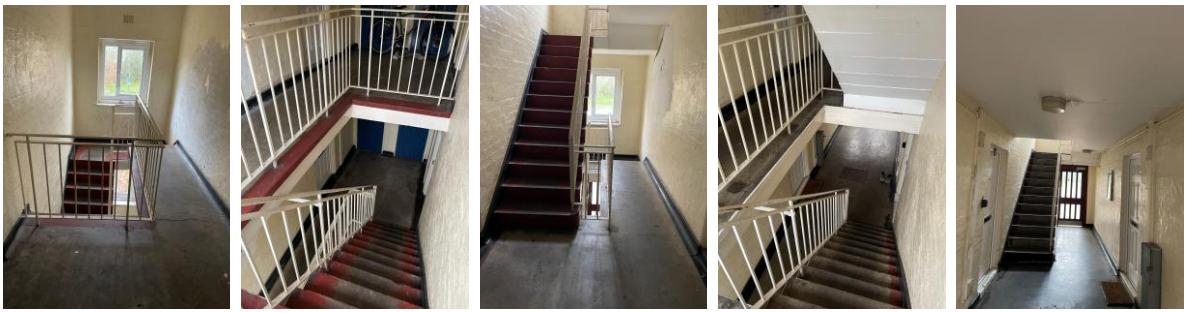
1) The means of escape is provided via a shared landing on each floor served by a single staircase.

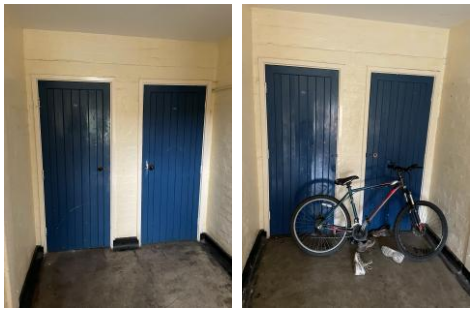
9) The storage cupboard door sets display "Fire Door Keep Shut" signage; however, the fire-resisting performance of the doors could not be confirmed during the assessment. The cupboard doors appear to be timber ledge and brace. *As part of any future refurbishment or replacement programme, replaced with appropriate FD30s fire-rated door sets.*

10/9 - As part of any future refurbishment or replacement programme, the fire rating of the resident's cupboards door sets should be confirmed and, where they are not of a suitable fire-resisting standard, replaced with appropriate fire-rated door sets.
