Fire Risk Assessment

Newbury House

**Arley Close,
Oldbury,
B69 1EB**

Date Completed: 4th Aug 2025

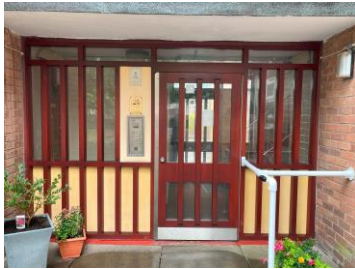
Front entrance and fob

Both front and rear door entrances are accessed through a fob reader, the front entrance is equipped with a firefighters override switch.

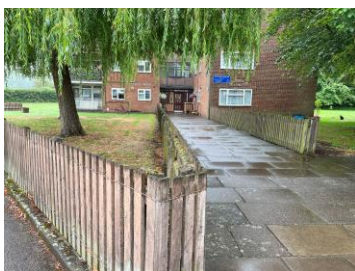
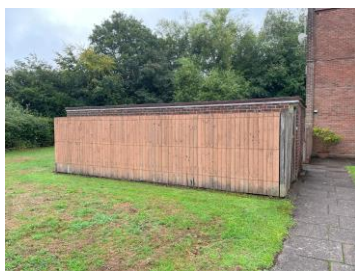
Residents' storage and refuse bins storage

Externally the building has a timber fenced perimeter with a courtyard to the rear that accommodates the refuse bins and residents' storage.

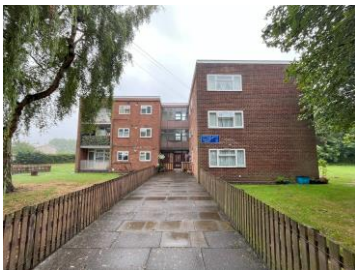
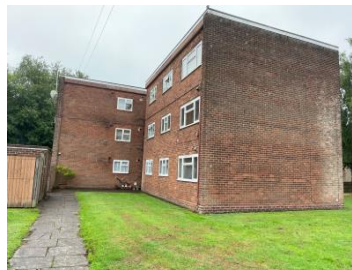
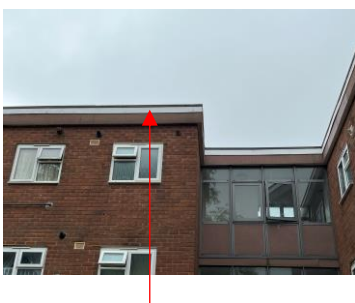
UPVC and felt roofing

- 1) The external construction of the building is predominantly brick with UPVC and felt fascia to the roof line.

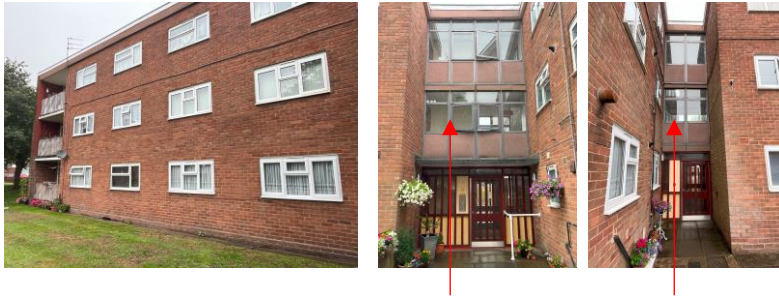
UPVC Units Front and rear Aluminium Framing

- 2) UPVC double glazed units have been installed to each flat. Aluminium framed units to the communal stairwell.

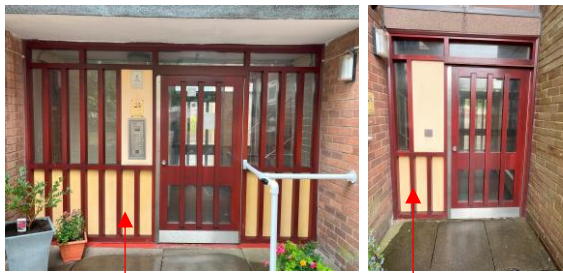
Front and rear Spandrel panelling within the inserts.

- 4) There are also Spandrel panelling on the inserts to the front and rear entrance doorways.

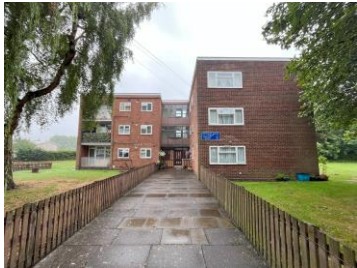
Front Elevation

- 4) There are individual balconies to each flat on the block, there are 3 on frontal elevation to the building and a further 6 to the side elevation of the building, all balconies have metal railings as a means of a safety barrier.

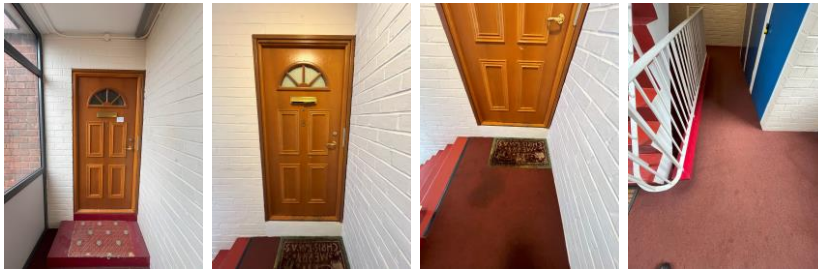
- 1) Each flat is equipped with, as a minimum LD3 fire detection to facilitate means of escape and provide sufficient response time.
- 2) All communal hallway floors are carpeted, the flat entrances have raised step to the door, some have door mats placed over the step, the fire rating is not known for the door mats.

All floors have S.M.B.C. fitted carpet. Due to the fact SMBC specified and managed the installation of the carpets, they are in accordance with BS EN 13501-1.

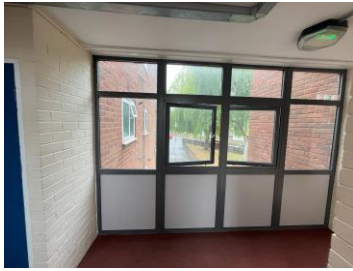
1st floor

- 6) On the 1st and 2nd floor communal landings, there are a set of aluminium windows with Georgian wired glass, these windows can be opened without the use of a key in the case of escape from the 1st floor, which is to a canopy over the front entrance, these also allow sufficient airflow. There is no automatic smoke ventilation system installed in this premises.

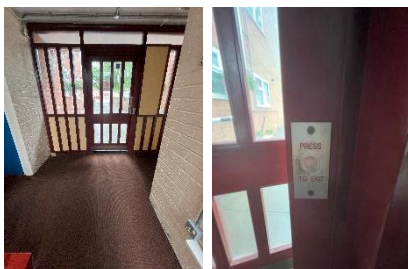
Front door entry/exit

- 12) The final exit doors have door entry systems installed. These systems are designed to fail safe i.e. door unlocked in the event of a power failure. This prevents residents being locked in or out of the building. These doors are checked on regular bases by the Caretaking Teams as part of their checks. Defective closing devices are replaced either by the Caretaking Team(s) or the in-house repairs team(s).

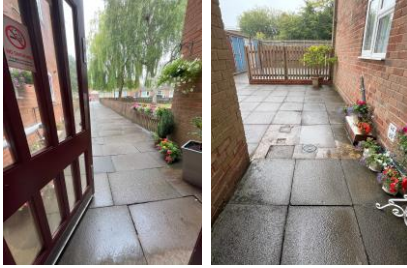
Front final & Rear final exit

- 13) There is a clear and safe exit out of the building via the two-ground floor exits.

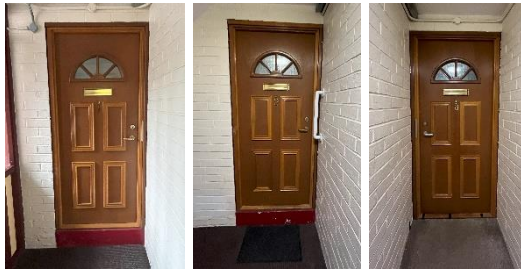
Ground floor flats 1,2,3

- 4) A variety of methods and materials have been used to achieve fire-stopping including Rockwool and intumescent pillows where needed.
- 6) All individual flats are installed with FD30s rated composite doors.

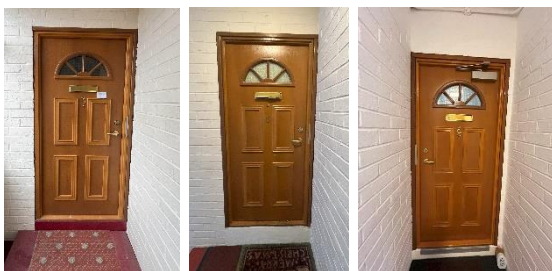
2nd floor flats 7,8,9

Flat 3,4,6 have combustible screening attached to the balcony railings and Flat 9 door closure does not self-close into the door frame from the recommended 15 degree opening of door test.

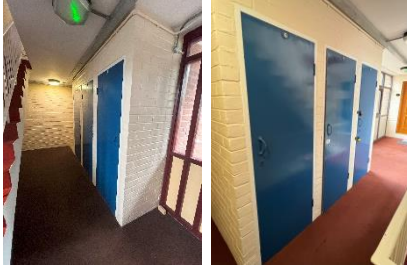
- 7) All residents' storage cupboards on each floor are secured notional fire doors and with residents own key.

Residents storage cupboards.

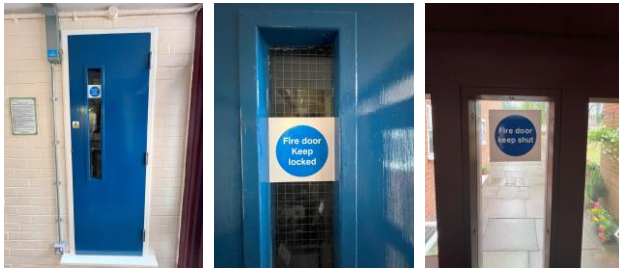
Electrical cupboards and final exit doors.

- 1) Fire door keep shut signs are displayed where appropriate. All resident meter cupboards display "Fire Door Keep Shut/" sign.

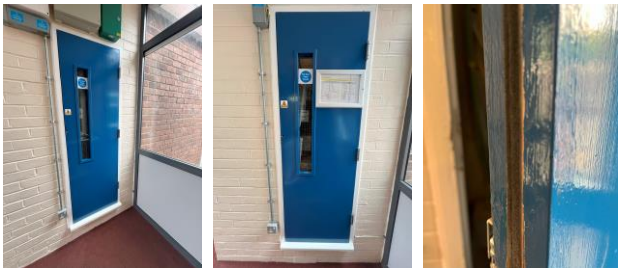
- 8) All Residents service cupboards on each floor are housed behind a FD30s fire rated doors. All cupboards are free from any combustibles.

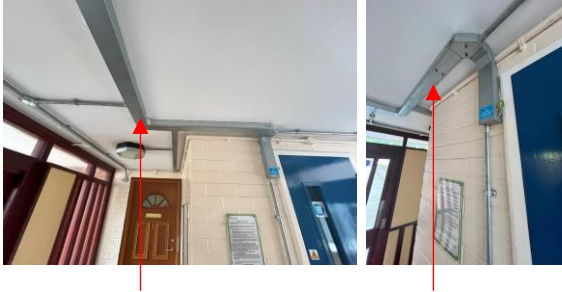
Metal Electrical Trunking

- 11) All electrical cabling feeding supply from electrical risers to residents' flats and other units within the communal areas are channelled through
-

secure metal box trunking that is securely install across the upper walls and ceilings.

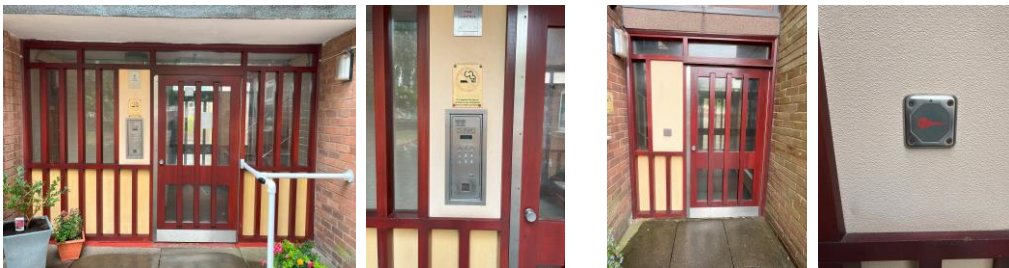
Front and rear entrance and access control

- 1) Regular checks are undertaken by Caretakers / Cleaning Team(s) 365 days per year which helps reduce the risk of arson.
- 2) Restricted access to the premises by means of a door entry system to the front and the rear.

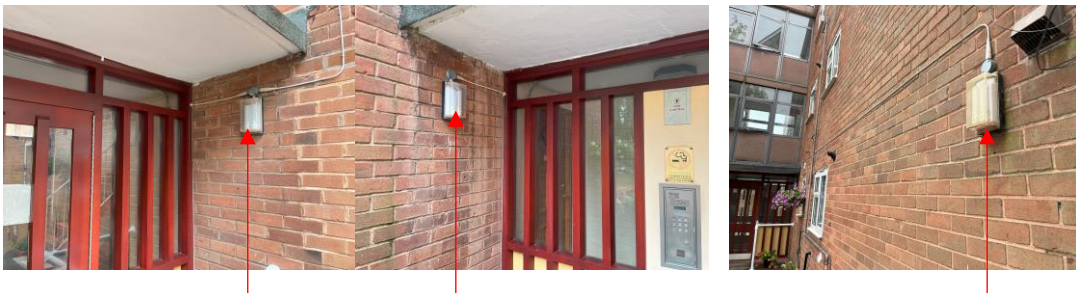
- 3) There is no current evidence of arson.
- 4) The perimeter of the premises is well illuminated.

Front External lighting

Rear External lighting
