# **Fire Risk Assessment**

## **1-6 Richards House**

**Kempsey close, Oldbury,  
B69 1BN**

**Date Completed: 10/06/2025**

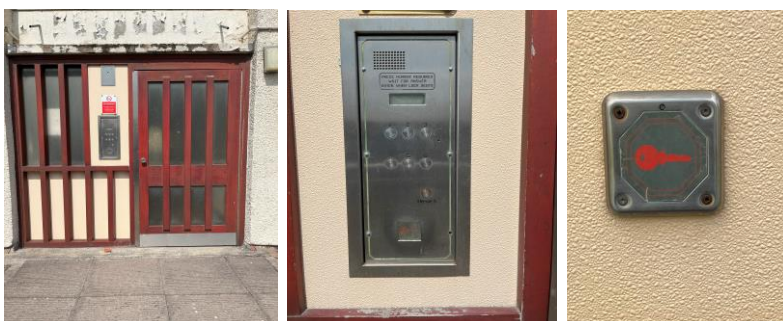
There is a main entrance / exit to the front elevation. The door is equipped with a door entry system and firefighter's override switch.

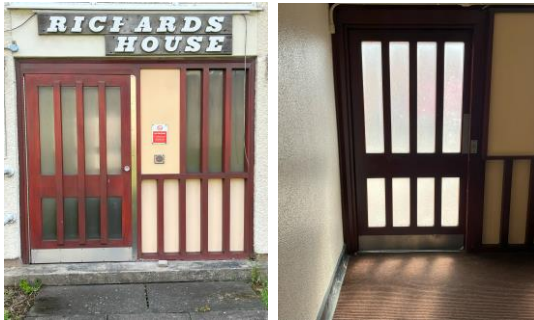
There's a further entrance / exit door to the rear which leads to an enclosed courtyard.

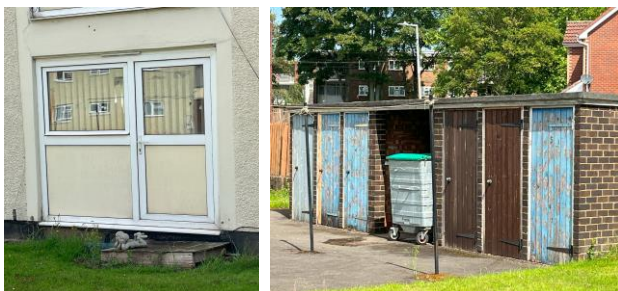
Ground floor flats numbers 1 & 2 have a rear door access to the communal garden. The communal garden also houses a brick-built compound with wooden doors to the front and flat roof. The compound currently accommodates a single bin.

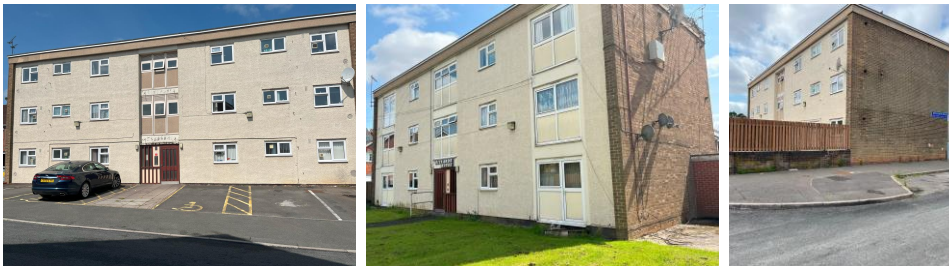
- 1) The external surface of the building is a traditional masonry & concrete construction with a flat roof. The front and rear elevations have a rendered finish

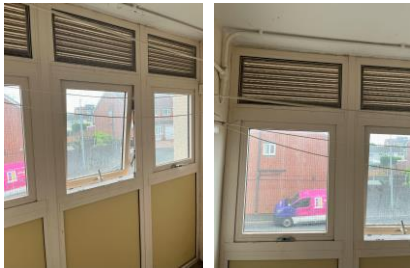
- 3) Louvered vents above the front communal windows provide natural ventilation to the means of escape.

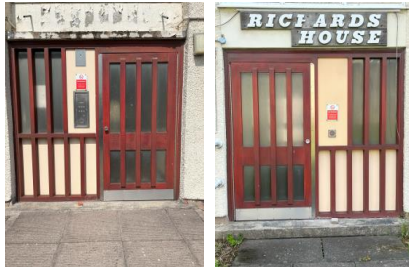
- 4) Front and rear entrance doors & combination frames are timber.

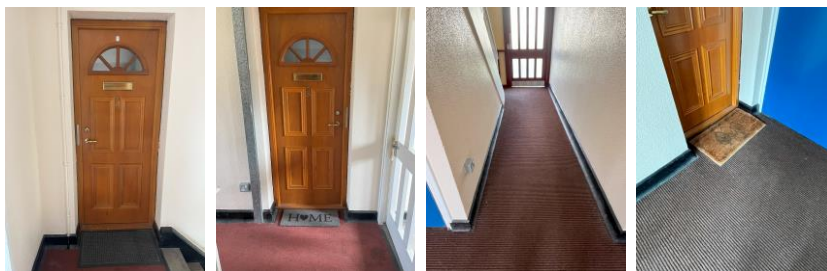
Also, all floors have S.M.B.C. fitted carpet. It is understood that carpets have been procured in accordance with BS 5287: 1988 specification for assessment and labelling of textile floor coverings and & BS 4790 Fire Test to Textile Floor Coverings.

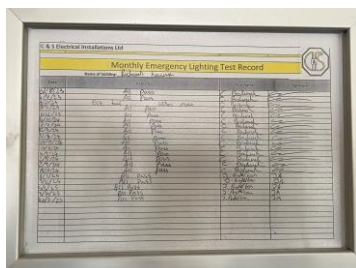
- 3) All installed equipment is checked and tested on a monthly basis by Sandwell MBC in house electrical team or approved contractor, in accordance with current standards. The equipment was last tested 05/06/2025.

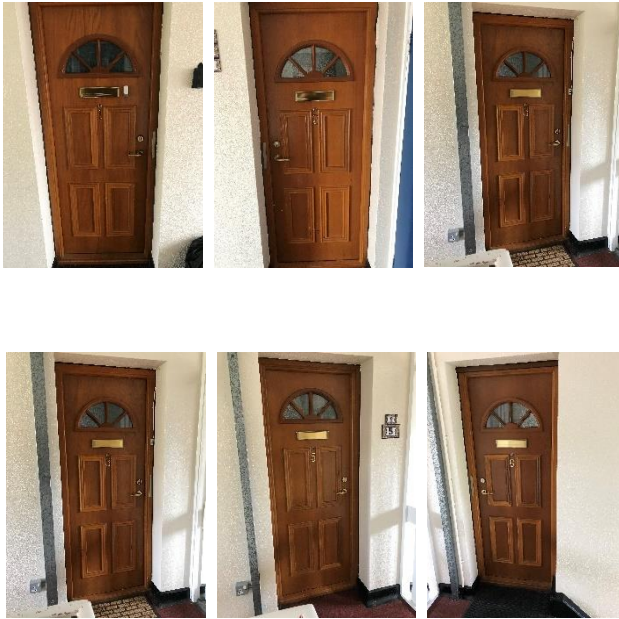
- 3) The means of escape is predominantly protected from flats with the use of FD30s rated composite doors.
- 4) All flats have FD30s rated composite doors.

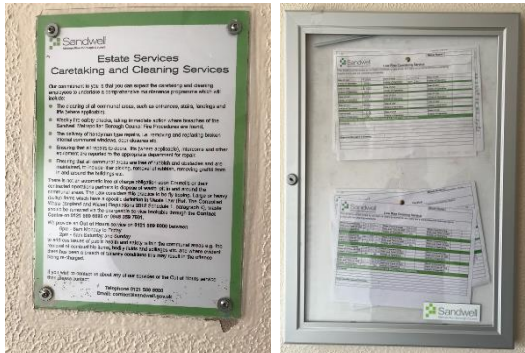
- 1) There is a weekly Cleaning Service to the premises.

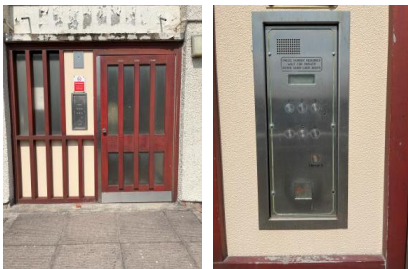
- 2) Access to the flats is restricted by a door entry system.
