Fire Risk Assessment

Smestow House (1-9)

**Queensway, Oldbury
B68 0HQ.**

Date Completed: 30.04.25

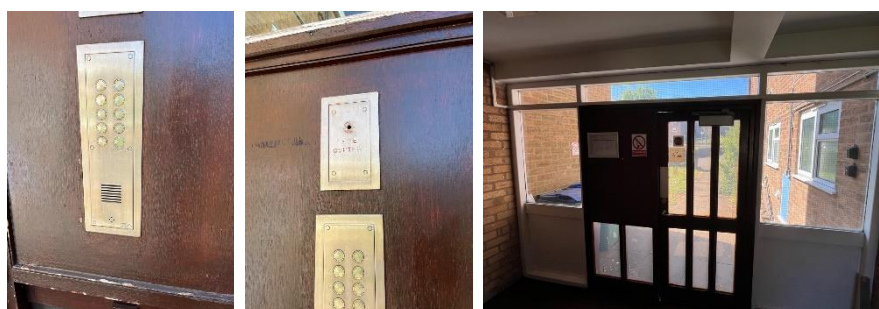
The block has a front entrance, that has a door entry system, and a fob reader installed. There is a rear access door, leading to a rear garden and courtyard area containing ancillary storage sheds. Local authority employees and the fire & rescue service can use a drop latch key to gain access.

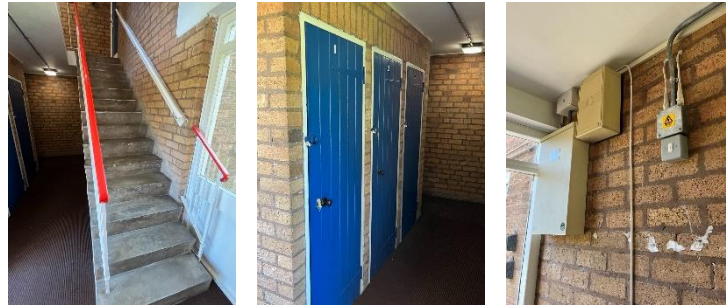
The common area consists of a single concrete stairwell with residents' storage cupboards on all floors. There are small electrical cabinets at high level on the ground floor containing door entry control equipment.
