# Fire Risk Assessment

## Shelley House

Tudor road,  
Oldbury,  
B68 9RE

**Date Completed: 12<sup>th</sup> July 2022**

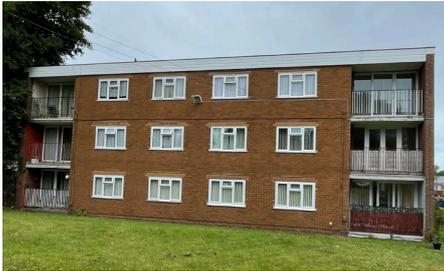
- 1) The external surface of the building is predominantly brick structure with UPVC fascia boards to the roof line.
