# Fire Risk Assessment

**Showell House,  
Oldbury,  
B69 4JJ**

**Date Completed:** 11/09/2025

**Current Risk Rating = Tolerable**

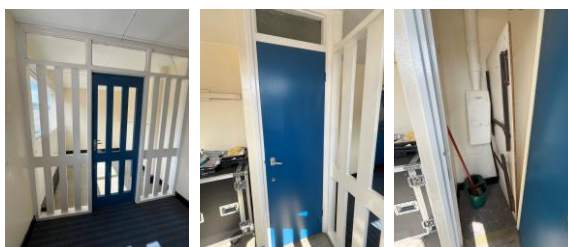
Each landing features a secured drying room, accessible only with a key, intended for drying clothes; some of these areas are also being used for storage. Within the drying room is a cupboard that should be locked at all times and only accessible by SMBC staff.

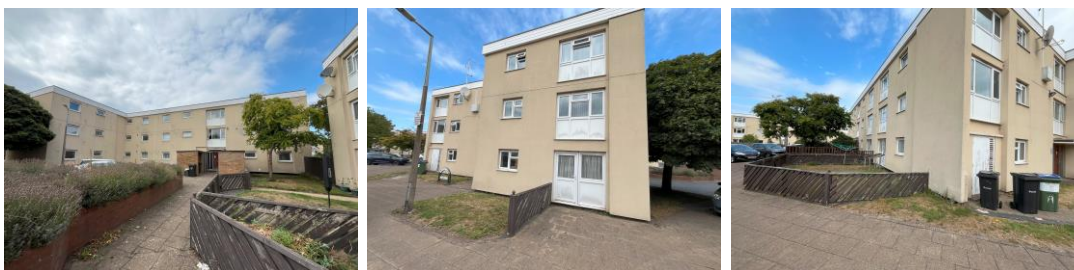
- 1) The external surface of the building is External Wall Insulation (EWI) systems with a silicone render. The roof is flat roof with UPVC fascia boards.

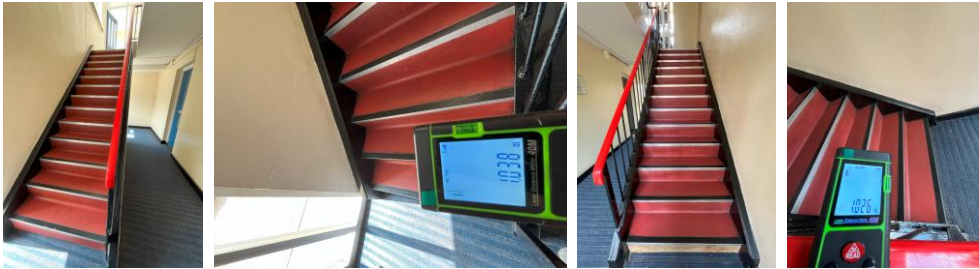
- 1) Each floor is accessed via a single staircase that provides a means of escape and has a width of 1 metre.

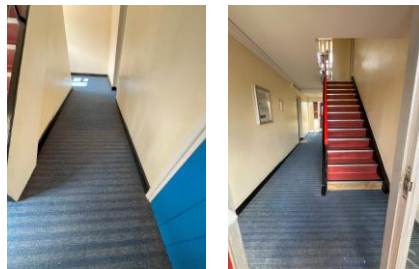
- 2) Corridors are at least 1050mm in width and are kept clear.

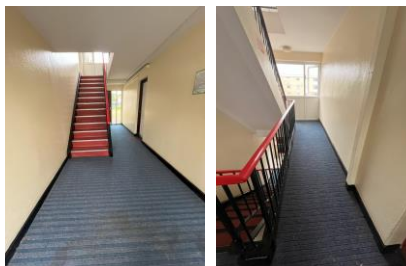
- 3) All communal hallway floors are carpeted. All floors have S.M.B.C fitted carpet. Due to the fact S.M.B.C specified and managed the installation of the carpets it has been presumed that they are BS 5287,1988 specification for assessment and labelling of textile floor coverings and BS 4790 Fire Test Method to textile Floor Coverings.

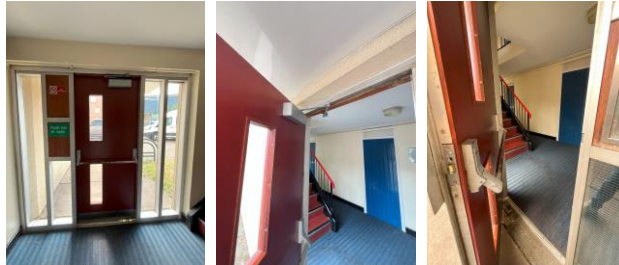
- 7) The final exit doors are push bar operated and fitted with automatic closing devices that are checked on a regular basis by caretaking teams as part of their checks. Defective closing devices are replaced either by the Caretaking Team(s) or the in-house repairs team(s).

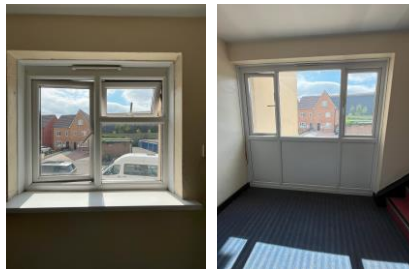
- 8) Windows within the communal area on each floor are UPVC and fitted with openers to assist with ventilation

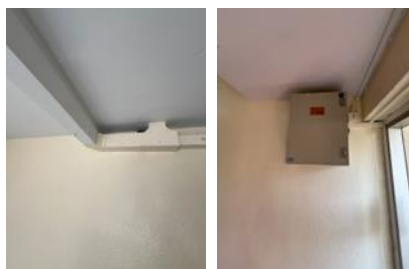
- 9) All cabling that runs through the communal area is encased within metal trunking. Door entry control system is also within a metal box on the ground floor.

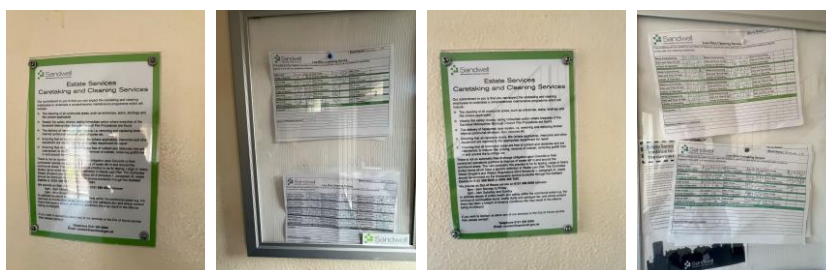
11) Communal areas are kept free of flammable items. The communal areas are checked on a regular basis by Caretaking / Cleaning teams 365 days per year and all items of rubbish are immediately removed. There is also an out of hour's service that allows combustible items of furniture / rubbish to be removed.

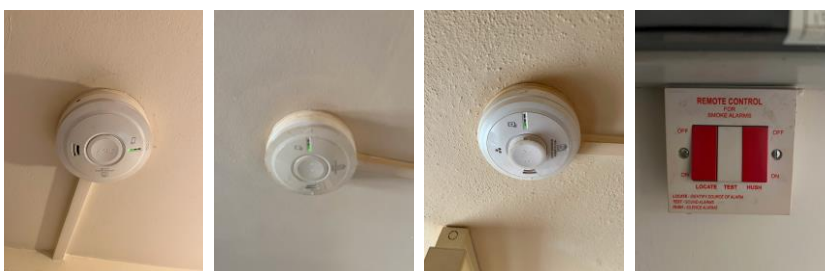
Types of detection in flats

- Flat 11 was checked at the time of the fire risk assessment: Battery powered alarms were fitted in the hallway, living room and bedroom. 26/08/2025 email sent to look in to an upgrade, reply 26/08/2025 was that the flat is down for a rewire and will cover the smoke detection also, been chased with the contractors.

- Flat 12 was checked at the time of the fire risk assessment: Smoke detection within the hallway and living room, with heat detection in the kitchen. (LD2)

- 3) Recommend flats are upgraded to LD1 in future improvement programs.

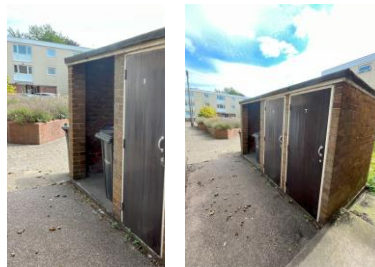
Block 7-12 Waste bins are stored within a purpose-built brick structure detached from the main building. These are emptied by SMBC on a regular basis.

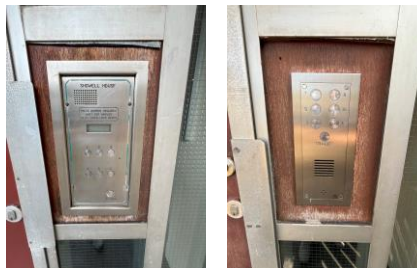
- 1) Regular checks are undertaken by Caretakers / Cleaning Team(s) 365 days per year which helps reduce the risk of arson.
- 2) Restricted access to the premises by means of a door entry system to the front and the rear.
