Fire Risk Assessment

1-9 Tennyson House

**Tudor Road, Oldbury,
B68 9RD**

Date Completed: 03/06/2025.

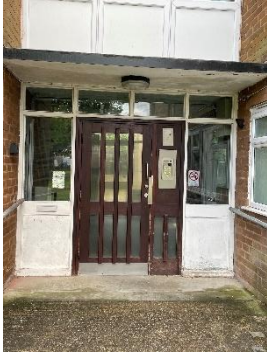
- 6) The front final exit door has a door entry system installed. These systems are designed to fail safe i.e., door unlocked in the event of a power failure. This prevents residents being locked in or out of the building.

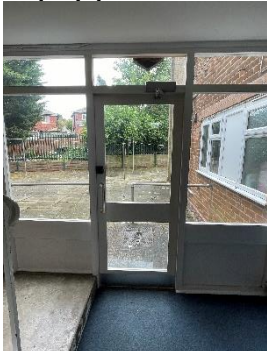
- 8) The rear courtyard is enclosed with perimeter fencing and a gate. The rear courtyard is suitable as a place of reasonable safety because residents can stand at a safe distance greater than the height of the building. The gate was locked at the time of the survey however residents are provided with a key. Access through the gate leads to ultimate safety.

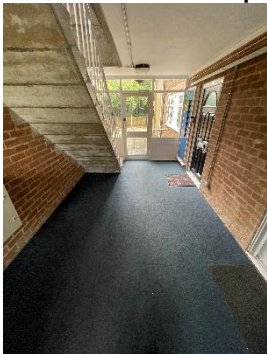
1. The building is designed to provide as a minimum 1-hour vertical fire resistance and 1-hour horizontal fire resistance around flats. All flat entrance doors are 30-minute nominal doors, including those in 1-hour rated walls.
- 2) The premise does not have sufficient compartmentation to limit the travel and effect of smoke and flame in event of a fire in communal areas due to open plan staircase.

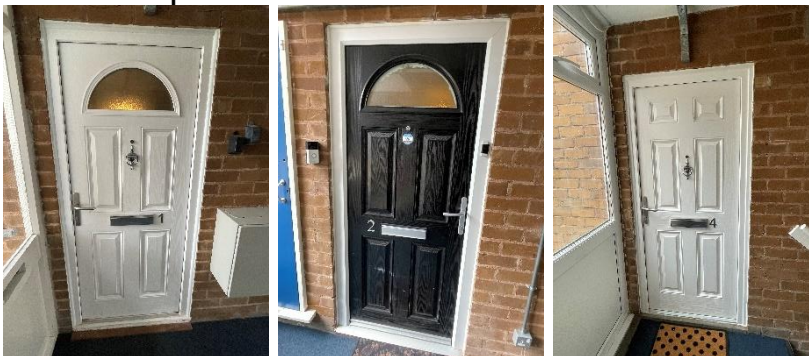
- 3) The means of escape is protected from flats with the use of FD30s rated composite doors.

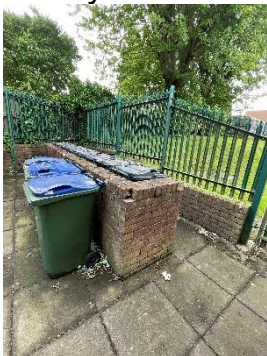
- 2) Refuse containers are stored on hard standing within the rear courtyard at a safe horizontal distance from the building.

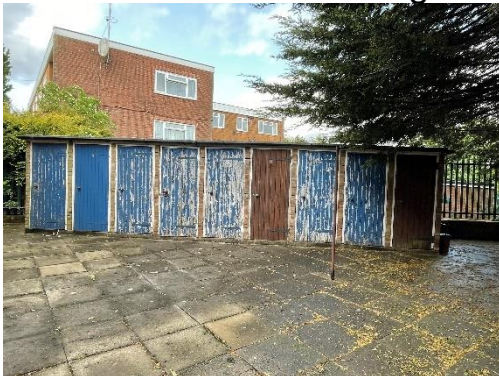
- 1) Residents are instructed not to bring L.P.G cylinders into block. This information is contained within the tenants' handbook.
- 2) The tenancy conditions, Section 7 – Condition 5.6 stipulates “If you live in a flat or maisonette, you, people living with you and any visitors to your property must not keep or use paraffin oil, petrol, bottled gas appliances or any other explosive, FLAMMABLE, or dangerous material in the property. This restriction also applies to any storage facility situated in or attached to the block, which has been provided for your use.”
- 3) No Flammable liquids stored on site by Caretakers / Cleaners.
- 4) Residents have access to individual brick built storage sheds at the rear of the building. The sheds are secured and at a safe horizontal distance from the building.
