Fire Risk Assessment

1-11 Shelsley Avenue

**Shelsley Avenue, Oldbury,
B69 1BP**

Date Completed: 12.06.25.

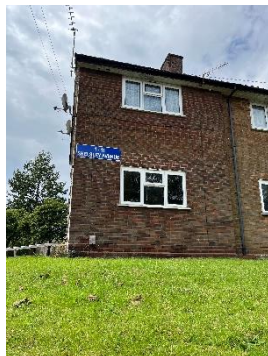
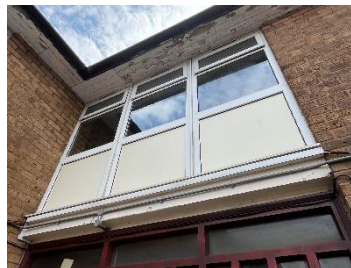
- 1) The external surface of the building is traditional brick construction with a small amount of spandrel panels below the first-floor common area windows.

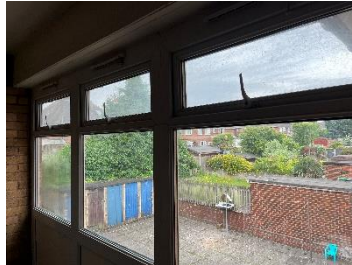
- 2) Individual flat windows are UPVC double glazed window frames. The windows in the communal staircases are UPVC window frames with openable vents. The communal staircase window frames are fitted with spandrel panels.

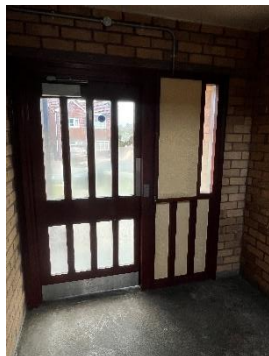
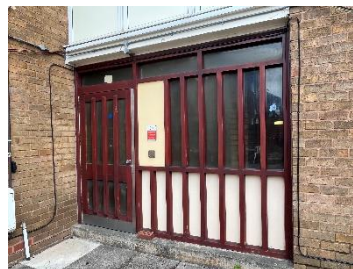
- 3) Access is gained to all flats from the ground floor using the main access door leading to the staircase area, further egress is available via the rear access door. Both access doors are solid timber.

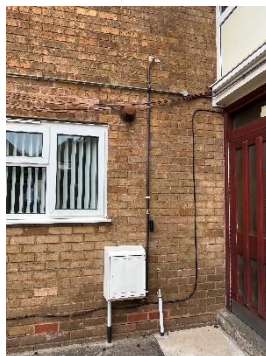
- 4) Gas risers are on external elevations.

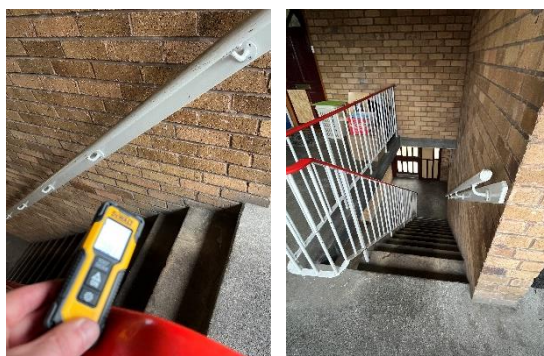
- 1) The block has a single staircase that provides a means of escape and is 880mm in width.

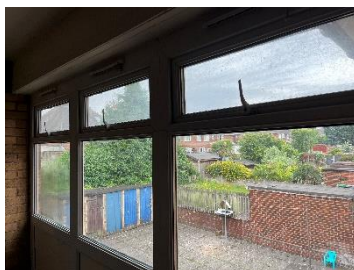
- 7) Ventilation of the common area is facilitated by openable windows in the stairwell.

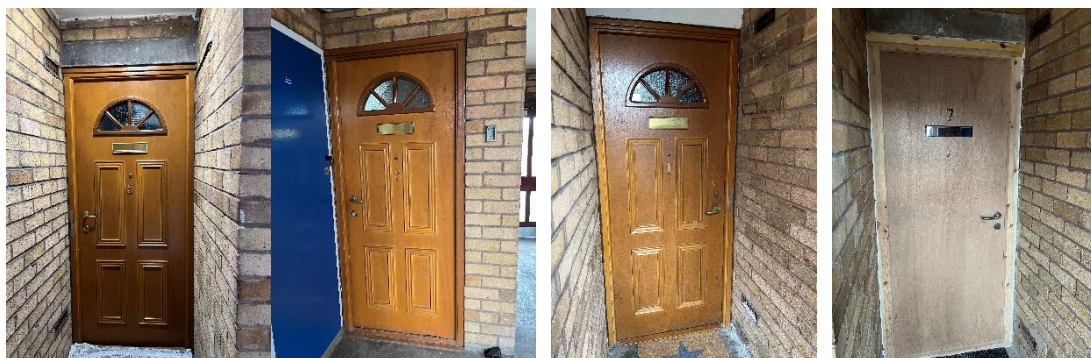
- 8) Surface coatings to the walls in the staircases appear to be Class 0 rated.
- 9) The building has sufficient passive controls that provide effective compartmentation to support a Stay Put Policy. Therefore, residents are advised to remain in their flat unless the fire directly affects them.
- 10) Most flat entrance doors appear to be nominal FD30s timber doors.

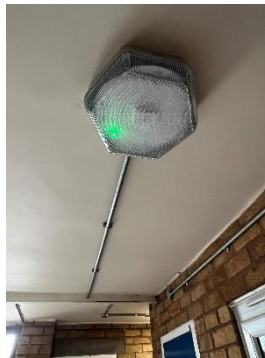
- 12) The premises has emergency lighting installed.

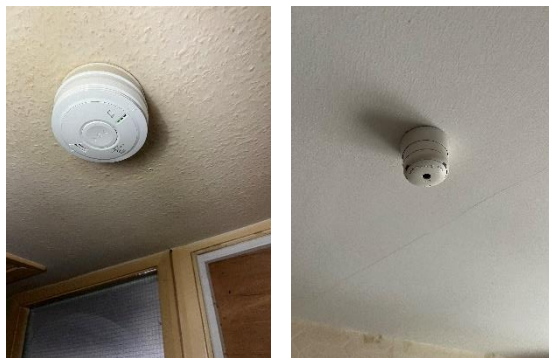
- 1) Early warning is limited to hard wired or battery smoke alarms within each of the resident's flats. The equipment is subjected to a cyclical test.
- 2) Based on the sample of properties accessed during the fire risk assessment the smoke alarms within resident's flats are installed to an LD2 Standard. Flat 9 was accessed and has detection in the hallway and kitchen.

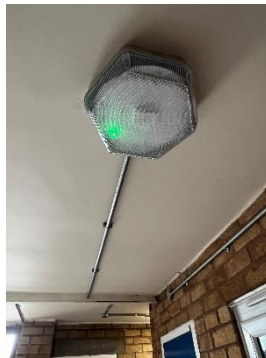
- 1) The premises has a sufficient emergency / escape lighting system in accordance with BS 5266 and has test points strategically located.

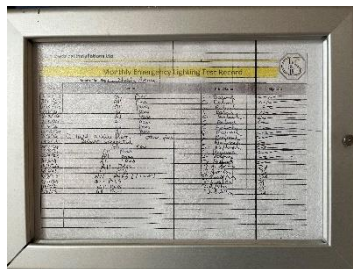
- 2) The self-contained units are provided to the communal landings, stairs.
- 3) All installed equipment is checked and tested on a monthly basis by Sandwell MBC in house electrical team or approved contractor, in accordance with current standards. The emergency lighting was subject to an in-house test on 02.06.25.

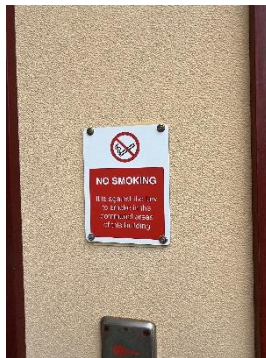
- 1) All fire doors display “Fire Door Keep Shut” where appropriate.
- 2) No smoking (Smoke Free England) signage is displayed at the front entrance to the premises.

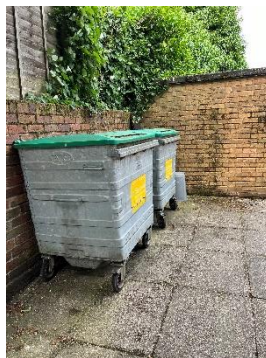
- 1) Refuse containers are emptied at regular intervals.
- 2) There is an 'Out of Hours' service in place to remove bulk items.
- 3) Refuse containers are emptied at regular intervals.
- 4) There is a dedicated refuse bin area for the block.

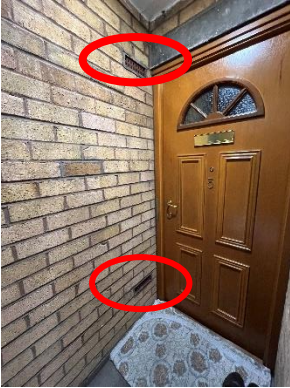
10/11	<p>Airbricks are fitted in the flat walls that separate the flats 1, 5, 7, and 11 from the common area. Intumescent grills are to be fitted over the air bricks in the above flats, where the airbricks vent into the common area.</p>
