Fire Risk Assessment

9-12 Salop Drive

**Salop Drive, Oldbury,
B68 9AG**

Date Completed: 27.05.25.

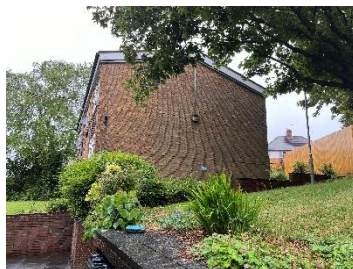
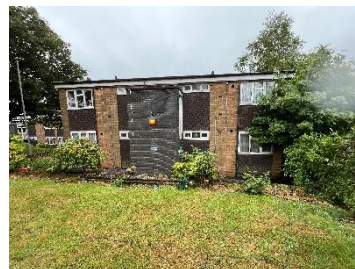
- 1) The external envelope of the premises is predominantly traditional brick construction, with an amount of hung tile cladding, surmounted pitched roof.

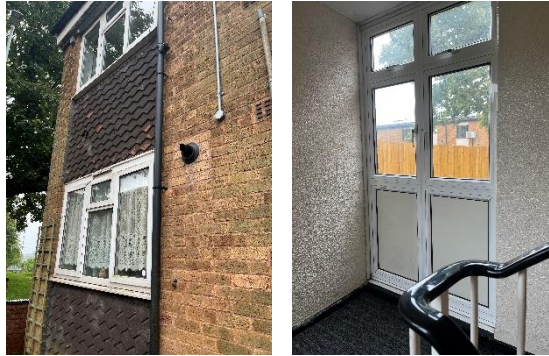
- 2) Individual flat windows are UPVC double glazed window frames. The windows in the communal staircase are UPVC window frames with openable vents. The communal staircase window frames are fitted with spandrel panels.

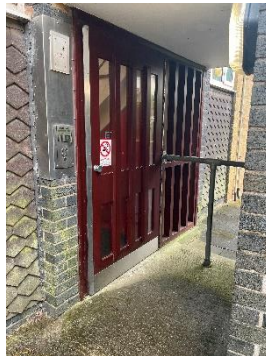
- 3) Access is gained to all flats from the ground floor using the main access door leading to the staircase area, the front access door is solid timber.

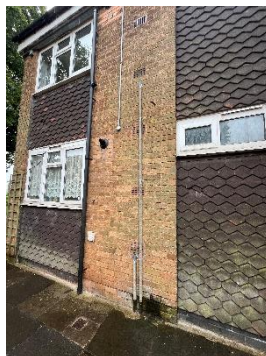
- 4) Gas risers are to the external front elevation of the block.

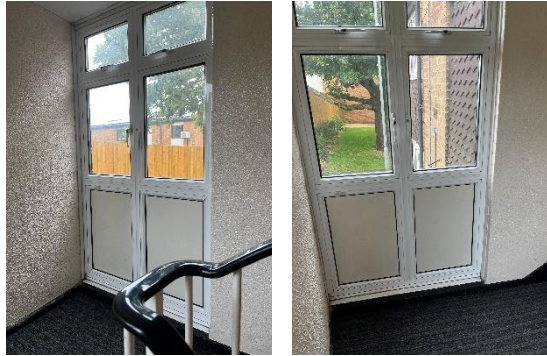
- 7) Ventilation of the common area is facilitated by openable windows in the stairwell.

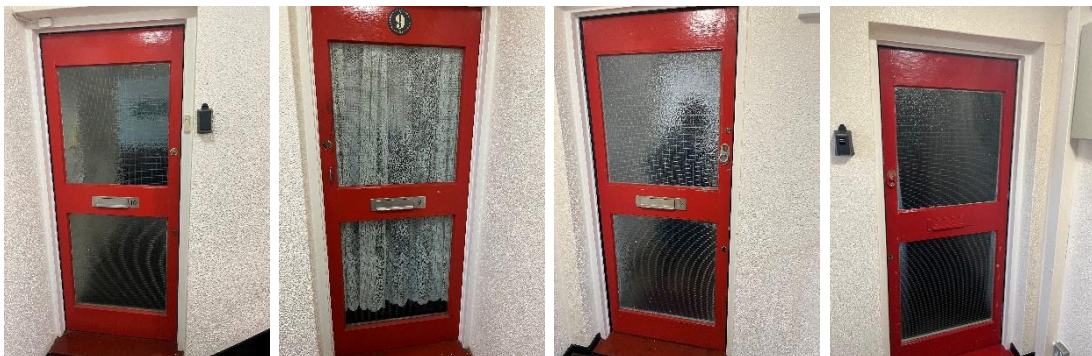
- 8) Surface coatings to the walls in the staircases appear to be Class 0 rated.
- 9) The building has sufficient passive controls that provide effective compartmentation to support a Stay Put Policy. Therefore, residents are advised to remain in their flat unless the fire directly affects them.
- 10) Flat entrance doors are notional timber with GWG doors. These should be upgraded to certified FD30s door sets as part of any future refurbishments. A refurbishment program was confirmed by email on 16.06.22.

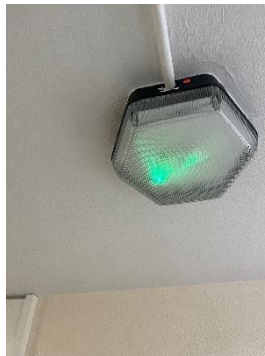
- 12) The premises has emergency lighting installed.**

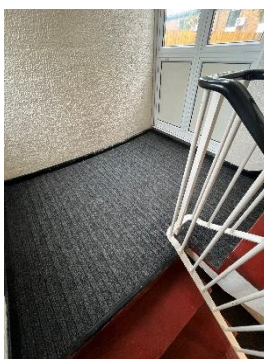
- 16) At the time of the assessment, it was noted that landing floors were fitted with carpet. It is understood that carpets have been procured in accordance with BS 5287: 1988 specification for assessment and labelling of textile floor coverings and & BS 4790 Fire Test to Textile Floor Coverings.

These carpets have been procured by SMBC utilising third party approved contractors. Therefore, it is understood that carpets fitted meet the approved standard.

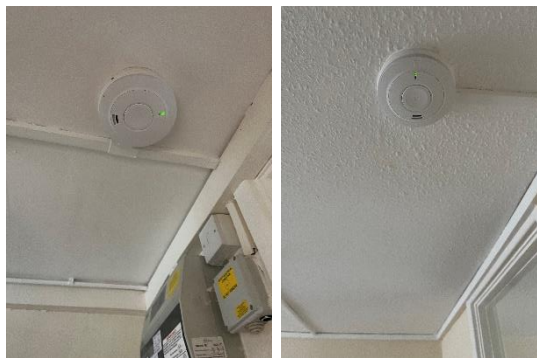
- 1) Early warning is limited to hard wired or battery smoke alarms within each of the resident's flats. The equipment is subjected to a cyclical test.
- 2) Based on the sample of properties accessed during the fire risk assessment the smoke alarms within resident's flats are installed to an LD3 Standard. Flat 12 was accessed and has smoke detection in the hallway and living room only.

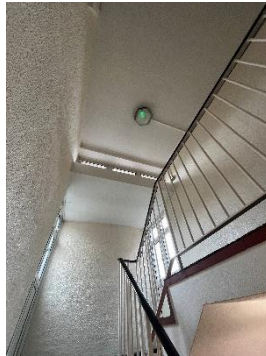
- 1) The premises has a sufficient emergency / escape lighting system in accordance with BS 5266 and has test points strategically located.

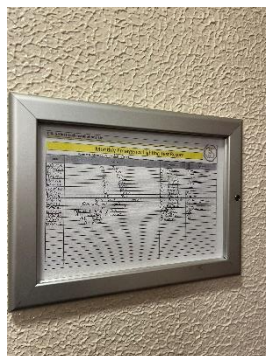
- 2) The self-contained units are provided to the communal landings, stairs.
- 3) All installed equipment is checked and tested on a monthly basis by Sandwell MBC in house electrical team or approved contractor, in accordance with current standards. The emergency lighting was subject to an in-house test on 21.05.25.

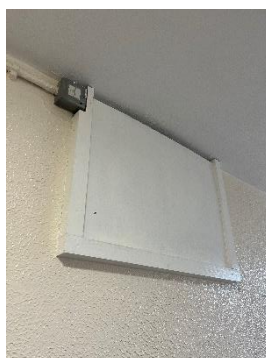
- 8) Any remedial works arising from the fire stopping / compartmentation check(s) will be actioned immediately by the Fire Safety Rapid Response Team.
- 9) The building has sufficient passive controls that provide effective compartmentation to support a Stay Put -Unless policy. Therefore, residents are advised to remain in their flat unless the fire directly affects them or if they are advised to evacuate by the emergency services.
- 10) The block is fitted with a pitched roof, not accessible from the common area.
- 11) There is wood panelling at high level on the 1st floor landing area. This panelling should be replaced with suitably fire resisting materials when the block undergoes refurbishment in the future.

There is wood panelling at high level on the 1st floor landing area. This panelling should be replaced with suitably fire resisting materials when the block undergoes refurbishment in the future.	
When any refurbishment of the building takes place consideration should be given to upgrading resident's front doors to certified FD30s door sets. A refurbishment program was confirmed by email on 16.06.22.

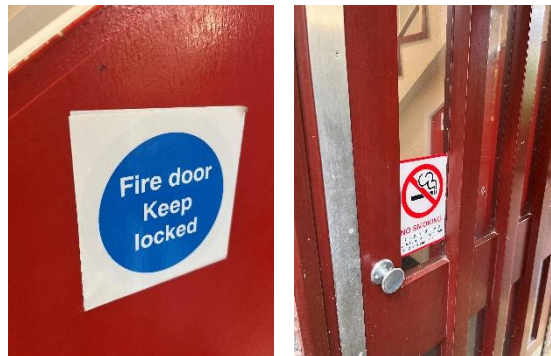
- 1) All fire doors display “Fire Door Keep Shut” where appropriate.
- 2) No smoking (Smoke Free England) signage is displayed at the front entrance to the premises.

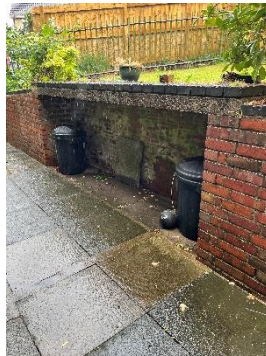
- 1) Refuse containers are emptied at regular intervals.
- 2) There is an 'Out of Hours' service in place to remove bulk items.
- 3) Refuse containers are emptied at regular intervals.
- 4) There is a dedicated refuse bin area for the block.
