Fire Risk Assessment

Chandler House

**Shelsley Avenue, Oldbury,
B69 1BW**

Date Completed: 1st July 2025

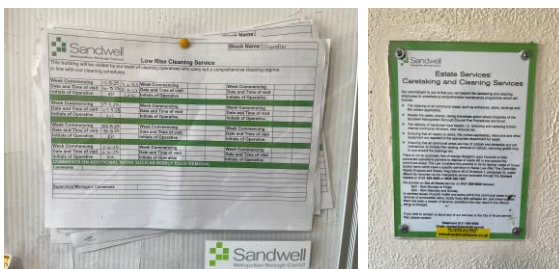
- 5) Communal areas are kept free of flammable items. The communal areas are checked on a regular basis by Caretaking / Cleaning teams 365 days per year and all items of rubbish are immediately removed. There is also an out of hour's service that allows combustible items of furniture / rubbish to be removed.

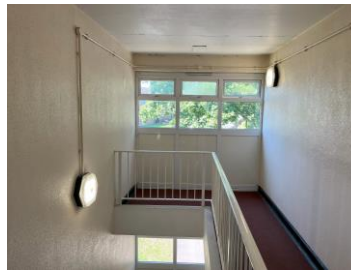
Second

- 8) There is dead end corridor on the 2nd floor, but this is acceptable due to the length and being equipped with emergency lighting and natural ventilation, it is therefore acceptable.

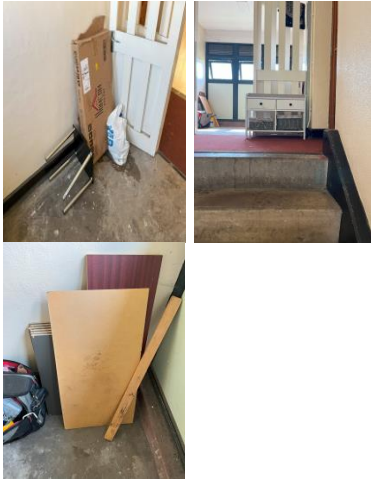
7, 14	2 nd floor former drying area has several items of combustion that need removing

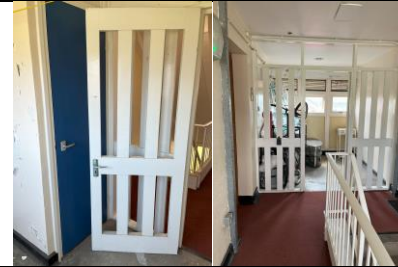
It is recommended that the former drying area that are on the 1st and 2nd floor landing be removed of the timber partition as this is creates a impression that this is a separate area from the communal landing and encourages residents to use this as a area to store items.
