Fire Risk Assessment

1 – 6 Cleton Street

**Cleton St, Tipton,
DY4 7TR**

Date Completed: 15/11/22

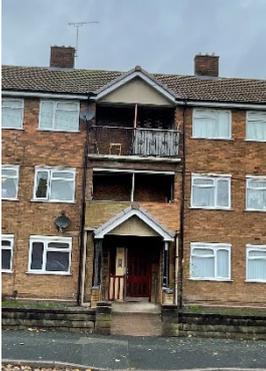
- 4) Flats to the 1st and 2nd floors have access to a balcony.

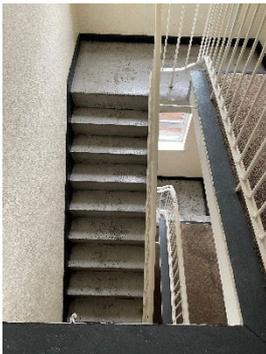
- 1) The site has a single staircase that provides a means of escape and is 825mm.

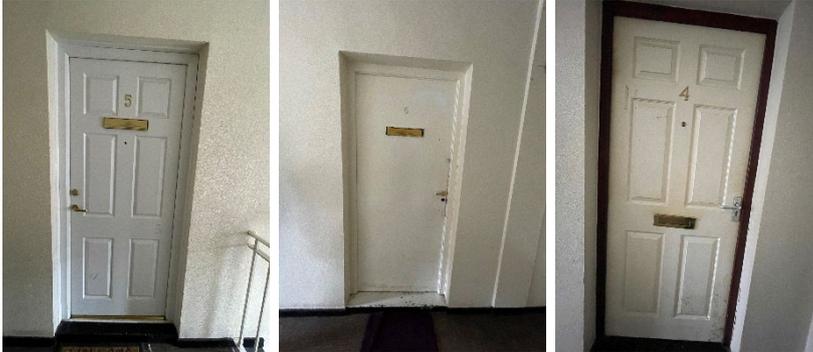
- 14) Individual flat doors are a combination of FD30s rated composite doors sets manufactured by Permadoor and timber FD30s fire doors.

At the time of the visit access could only be gained to flat 6. This door is a timber flush FD30s with no evidence of tampering, **however the door did fail to reliably self-close fully into frame, and screw was missing from the centre hinge.** A combined intumescent strip & cold smoke seal was installed to the frame **with a section missing from above the upper hinge**, in addition there was a second intumescent strip installed to the door edge.

P2	Within 1 - 3 months of action plan date. Housing Manager	20/07/2023
07/15	Flat 6 entrance door - doesn't reliably self-close into frame. - requires smoke seal above top hinge. - replace missing screw to centre hinge.

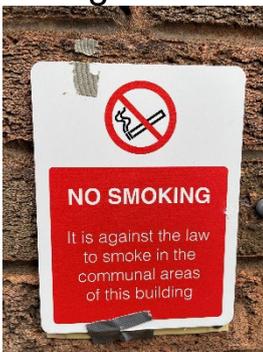
- 1) Fire Action Notices are not displayed throughout the building. The signs are not necessary due to the building not having a complex layout.
- 2) Yellow LPG warning signs are not displayed ([refer to section 18](#)).
- 3) Smoking is prohibited within any communal parts of the building in line with Smoke Free England Legislation. Signs are displayed throughout the building.

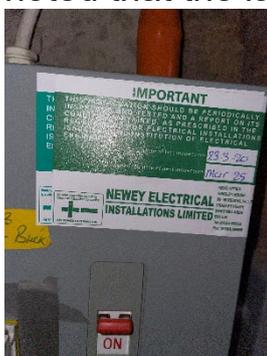
- 1) Smoking is prohibited within any communal parts of the building in line with Smoke Free England legislation.
- 2) Hot working is not normally carried out. If essential maintenance requires the use of hot work processes, then corporate policies and procedures are to be followed.
- 3) Portable electrical equipment used as part of the Caretaking / Cleaning regime is subject to annual PAT Testing. This information is held by the Estate Services Manager Bryan Low.
- 4) The fixed electrical installation shall be tested every 5 years. It was noted that the last inspection was 23/3/2020
