Fire Risk Assessment

**7-12 Cleton Street
Lodge Street,
Oldbury,
B69 4JE.**

Date Completed: 08/09/2025

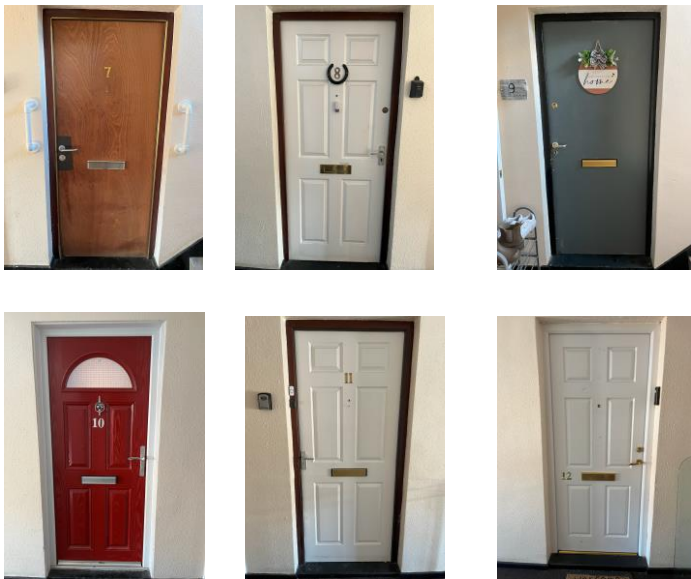
- 1) Individual flat doors appear to be FD30s rated composite fire doors, and original notional timber doors. Original timber doors should be considered for replacement in the future.
