# Fire Risk Assessment

## Holly Grange

Mallin Street, Smethwick,  
B66 1QY

**Date Completed:** 5<sup>th</sup> August 2025

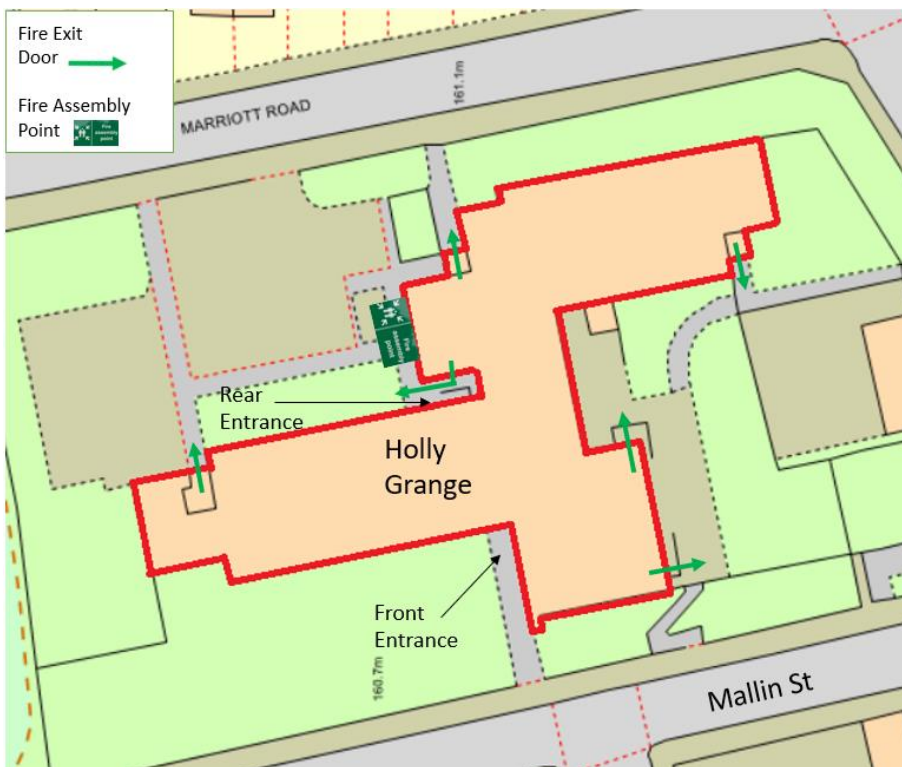
Access to the building can be gained via the Fire Control switch at the front entrance utilising a Drop Latch Key (Mallin Rd). Fireman's drop key switch not working at the time of assessment, CCTV team emailed (06/08/2025). Notified 12/08/2025 that this is now repaired.

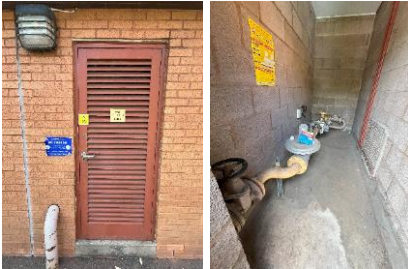
The gas isolation point for the building is accessed externally near the rear entrance & carpark. The louvred door is secured with a suited 54key mortice lock available from staff or security.

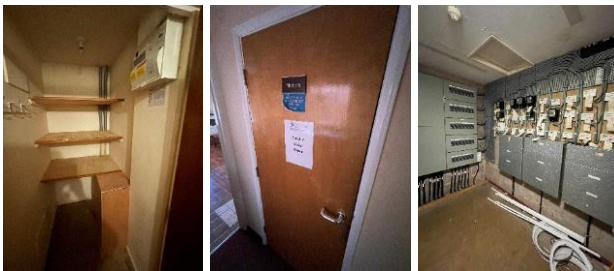
The electricity supply can be isolated within each individual flat. The main incoming supply can be isolated from the ground floor service room adjacent the laundry room.

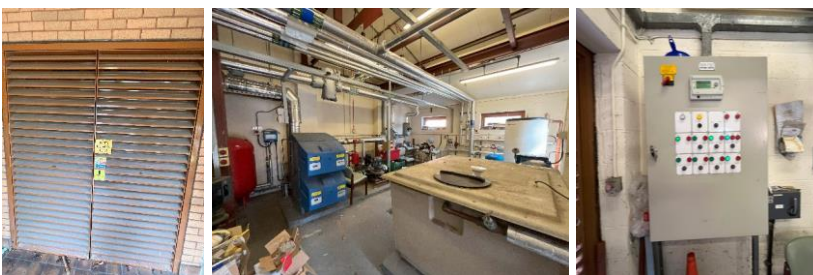
The boiler room is accessed externally from the rear carpark.

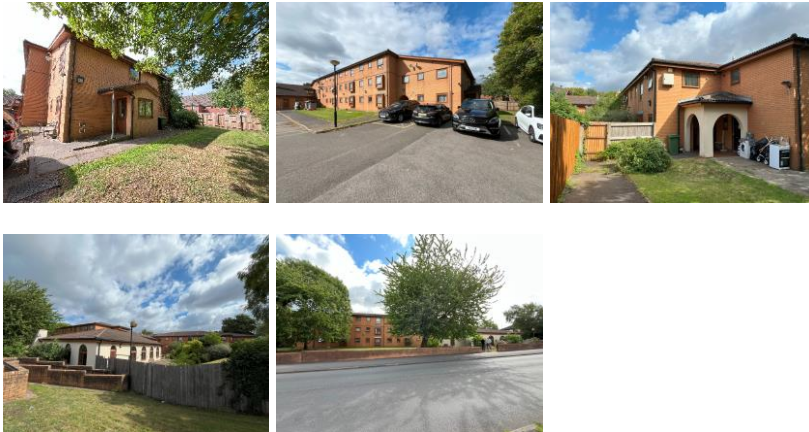
- 1) The building is brick and block cavity so is low risk with UPVC fascia and soffit board.

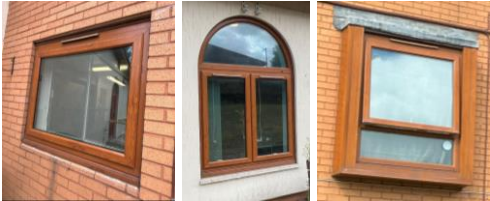
- 3) All windows to the building are uPVC double glazed units.

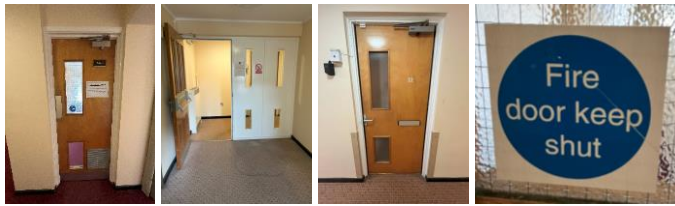
- 5) The means of escape are protected to prevent the spread of fire and smoke. This includes above false ceilings on the upper floors.
- 6) The communal corridors / staircases / landings are protected by use of nominal FD30s timber fire doors with vision panels. Fire door keep shut stickers are on each door.

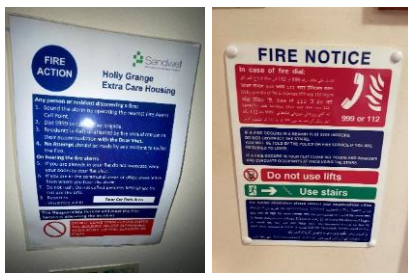
19) The building has sufficient passive controls that provide effective compartmentation to support a Stay Put Unless Policy. Therefore, residents are advised to remain in their flat **unless** they are affected by fire or smoke.

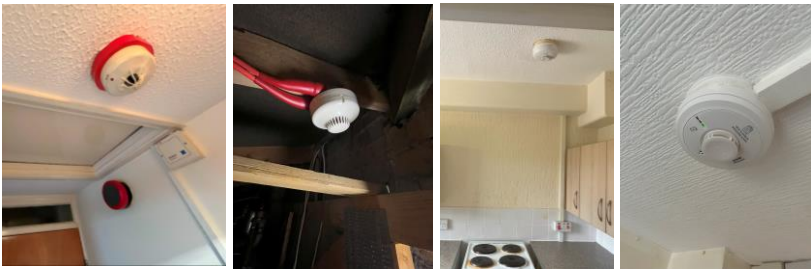
- 5) Smoke / heat detector heads linked to the panel are present within the communal corridors, rooms, kitchen, offices, and roof voids.

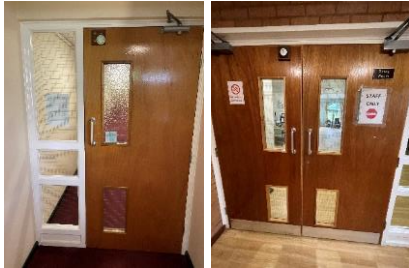
- 5) The corridors / staircases / landings are protected by use of nominal 44mm FD30s timber fire doors with vision panels.

- 6) All communal doors are fitted with automatic closing devices. These doors are held open by magnetic devices that are activated by the fire alarm panel. Automatic fire door stickers are displayed on each door. A number of the electro-magnet devices are defective, but this does not cause any concern with the integrity of the fire doors. This has been reported to the electrical compliance manager.

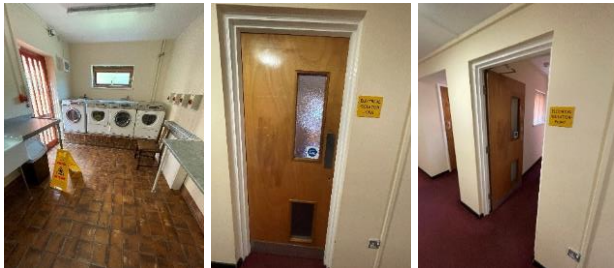
- 11) The door to the laundry room is not a fire rated door however, sufficient compartmentation is achieved by a second door which is a nominal FD30s to the corridor thus creating a small lobby between the laundry room and the corridor. Fire detection is in place.
-

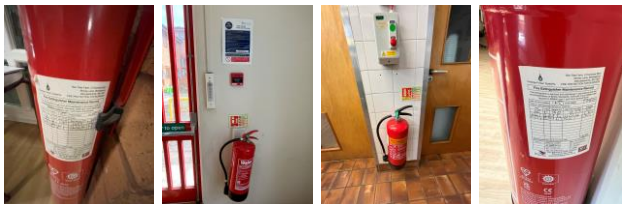
- 2) All extinguishers checked, signed and dated.

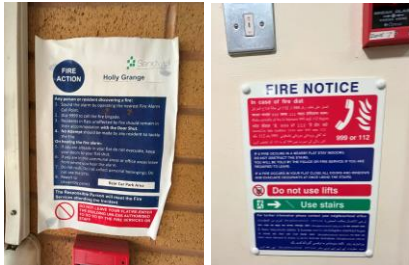
- 2) Fire Action Notices are displayed within communal areas and within resident's flats.

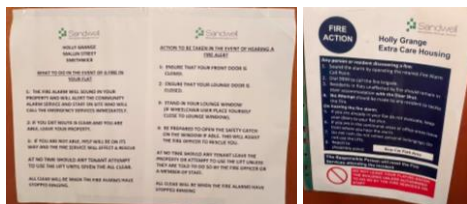
- 7) Information regarding the fire evacuation strategy is provided to residents to the internal flat entrance door leaf and at strategic locations around the building.

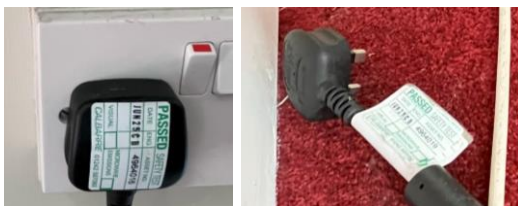
- 2) Hot working is not normally carried out. If essential maintenance requires the use of hot work processes, then corporate policies and procedures are to be followed.
- 3) Portable electrical equipment used as part of the Caretaking / Cleaning regime and is subject to annual PAT Testing. This information is held by the Estate Services Manager.
- 4) Evidence of PAT testing to other small appliances was noted.

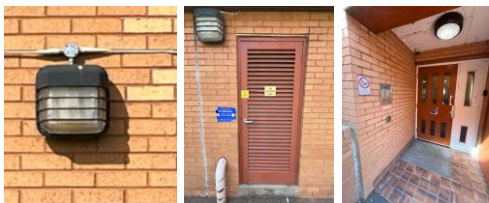
- 4) There is no current evidence of arson.
- 5) The perimeter of the premises is well illuminated.

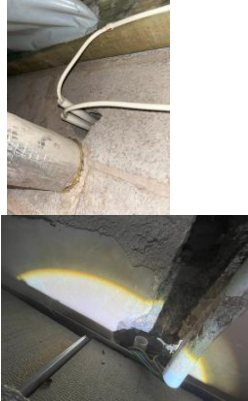
| 10/4 | Fire stop (x 2) where cables penetrate wall in ceiling void above landing door by flat 24 | | P2 | Within 1-3 months<br>Fire Rapid Response | |
