# **Fire Risk Assessment**

## **Compton Grange**

**Whitehall Road,  
Cradley Heath, B64 5BG**

**Date Completed: 13<sup>th</sup> June 2025**

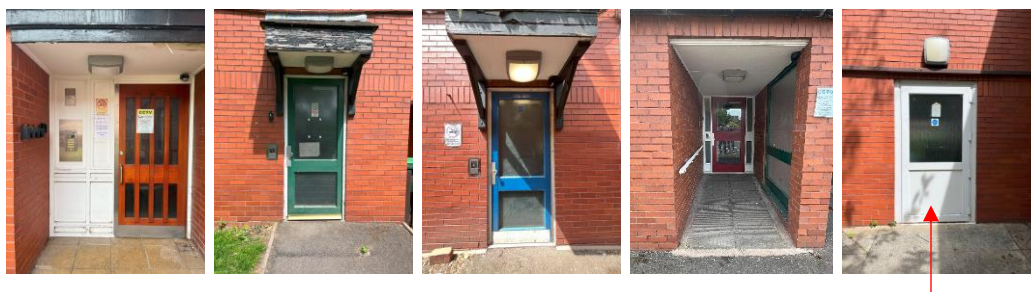
Communal lounge exit

The block has a main entrance to the front elevation and a further three exits located to the rear and both side elevations which lead to ultimate safety. Additionally, there is a further exit from the communal lounge, which also leads to ultimate safety.

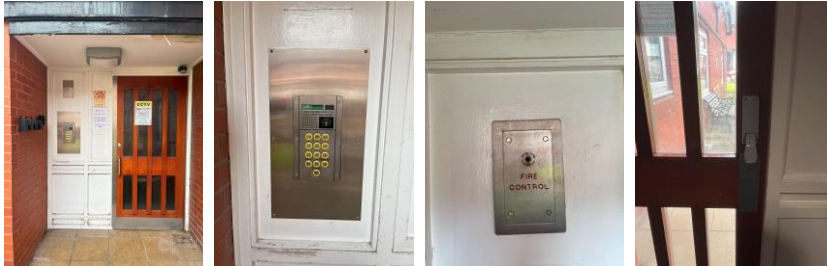
The main front entrance to the building has a door entry system installed with a fob reader, this is combined with a firefighter's override switch. There is a push pad installed for exiting the door.

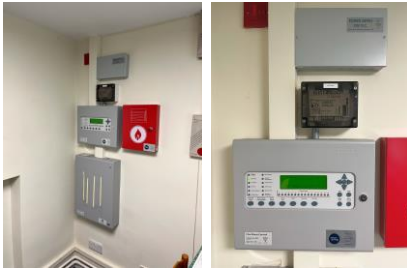
Main fire alarm panel

The fire alarm panel is in a room accessed from the reception lobby. There is also a repeater panel in the main entrance.

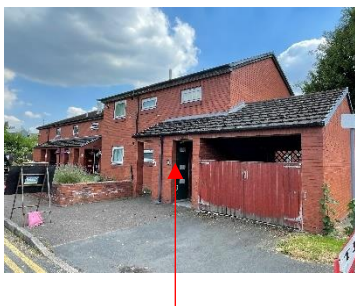
Flat 6, 2 story dwelling

There are 18 dwellings on the ground level, including flats 6, 33, and 34, all of which have external flat entrance doors. The only two-story dwelling on the premises is flat 6 which also has a brick-built car port attached to it, the doors on the front are wood. Rear entrance doors are also present in apartments 2, 4, 6, 7, 8, and 9.

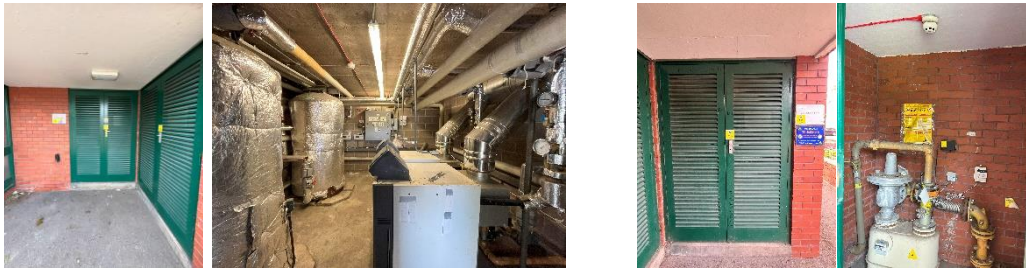
Accessed to the Boiler room & Gas isolation room is accessed via the carpark. Both rooms are secured by a suited 54 key mortice locks.

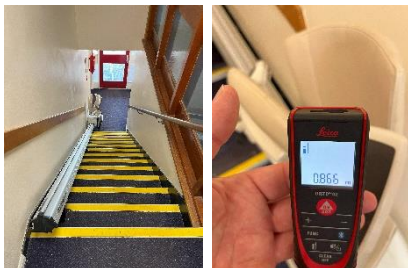
- 2) The width of two staircase's is slightly reduced due to the installation of a stairlift, measured at 0.86m

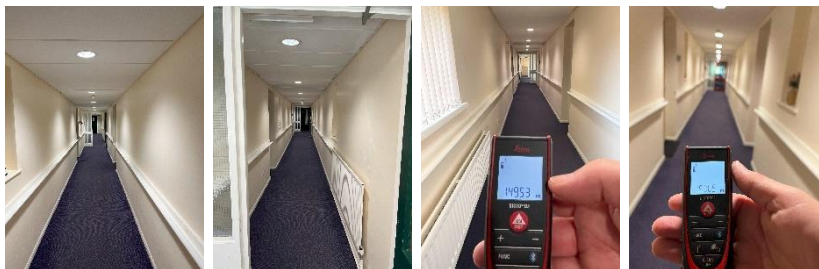
- 3) All corridors are of adequate width (at least 1050mm) and will be maintained clear to that width as a minimum. The distance measured for the length of the corridors is 14.95m and 15.30m

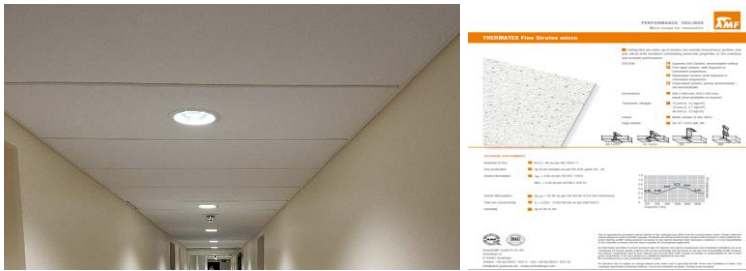
- 4) None of the corridors that form part of the means of escape are dead ends.
- 5) The ceiling tiles within the corridors are Thermatex Fine Stratos micro. They are A2-s1, d0 rated providing up to 60 minutes fire protection as per BS476 parts 20-23.

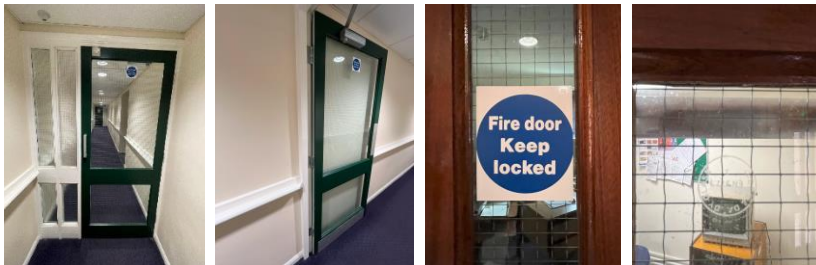
- 6) The means of escape are protected to prevent the spread of fire and smoke.
- 7) The communal corridors & landings / staircases are protected by use of nominal FD30s fire doors with Georgian glass vision panels.

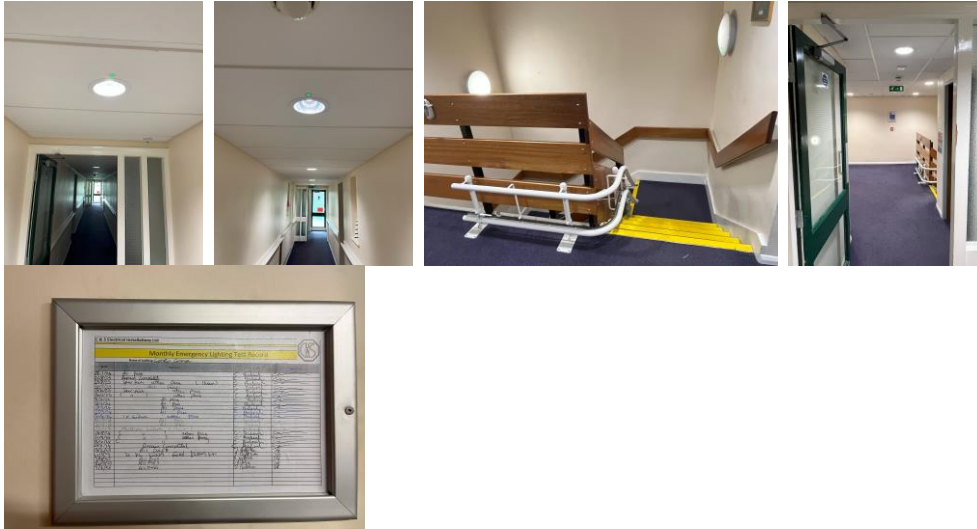
Monthly Checks by SMBC.

- 13) Emergency lighting is provided to communal landings and stairs. Checks are done monthly by Sandwell MBC in house electrical team or approved contractor.

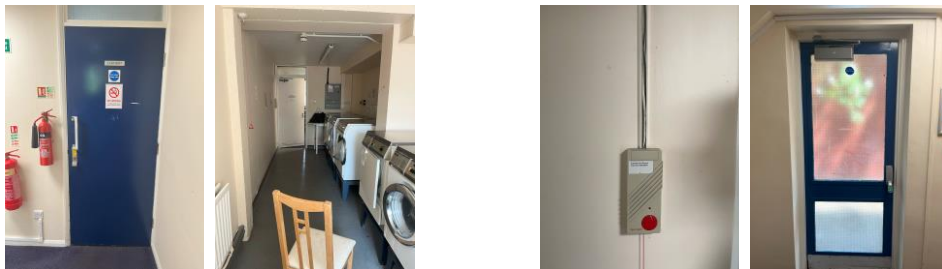
Community alarm link & fire exit

- 21) There is a laundry room located on the ground floor to the rear of the building adjacent the final exit door. This has a nominal FD30s rated door secured by suited 138 mortice lock. There is a link to community alarms within this room.

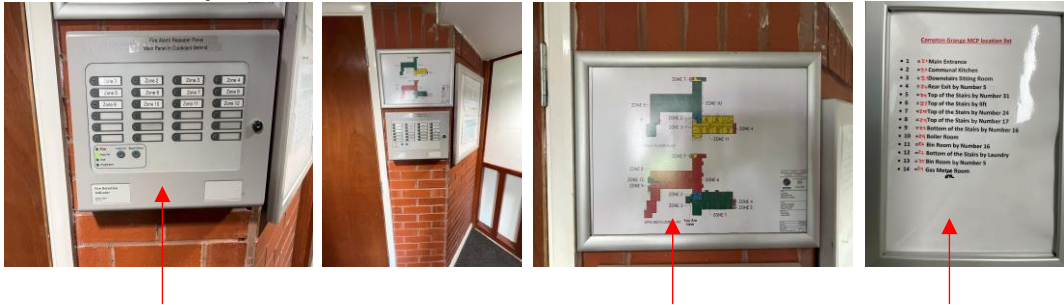
- 2) There is a repeater fire alarm panel within the entrance lobby along with a zone plan.

Repeater panel with a plan of the zones and locations of MCPs covering the building.

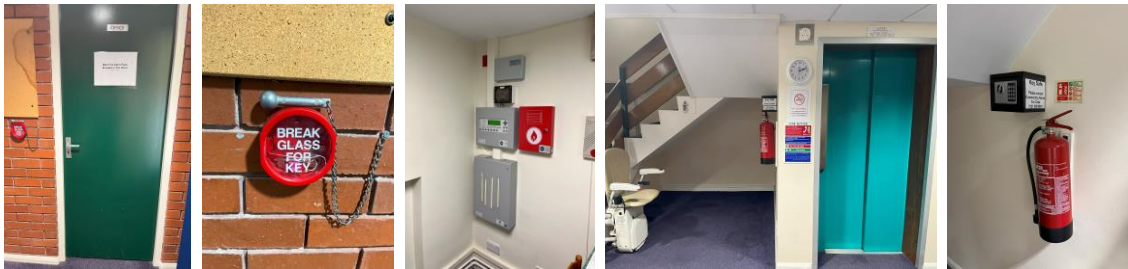
- 3) The main fire alarm panel is located within a locked room / office adjacent the ground floor lift. The key to the room is a suited 54 type and can be found in the break glass box or alternatively in the secured key cabinet in the lobby under the stairs. The access code to the key cabinet can be gained by calling community alarms.

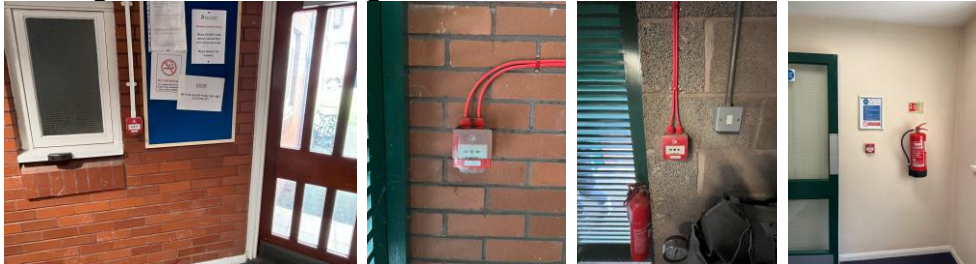
- 4) There are MCPs (Manual Call Points) strategically located throughout the building.

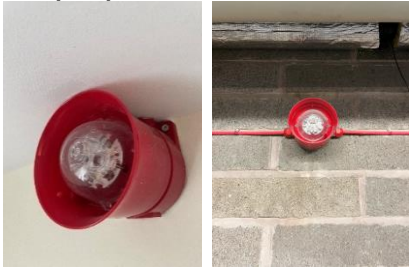
- 5) Warning devices that are in place are by means of sounders (102db output), with central strobe lights.

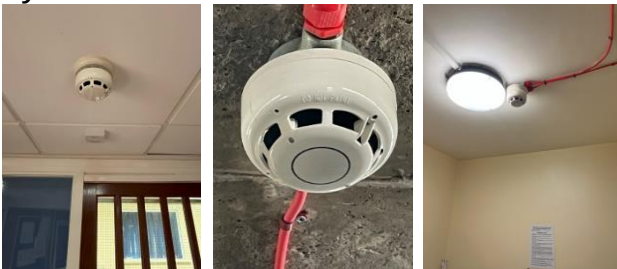
- 6) Hard wired smoke or heat detections are interlinked with the alarm system and are located on both floors.

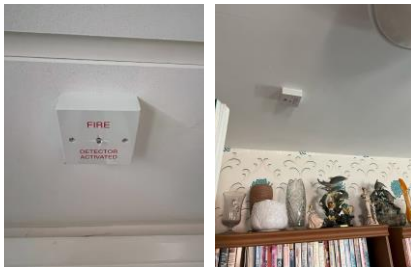
- 7) Each detector located within the roof space is linked to an LED indicator which will illuminate a LED light during an activation.

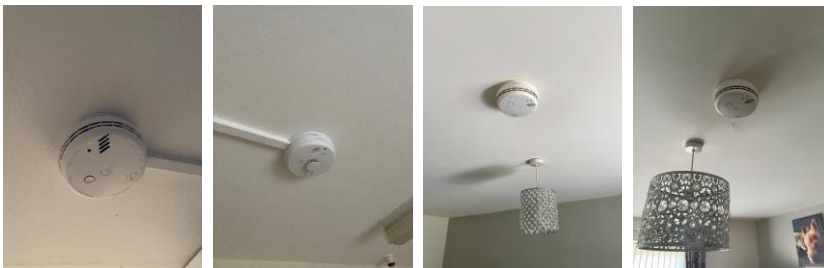
- 8) In addition, each individual flat has hard wired Aico detectors to the hallway, lounge & kitchen installed. Properties sampled during the fire risk assessment were flats, 15, 8

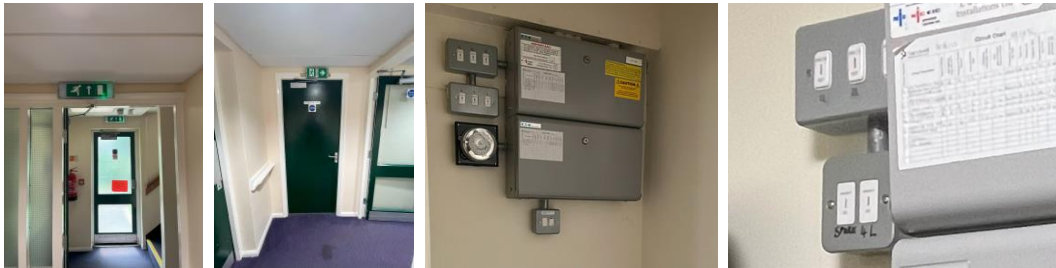
Emergency light flick switches

- 1) The premises have a sufficient emergency / escape lighting system in accordance with BS 5266 and has test points strategically located.

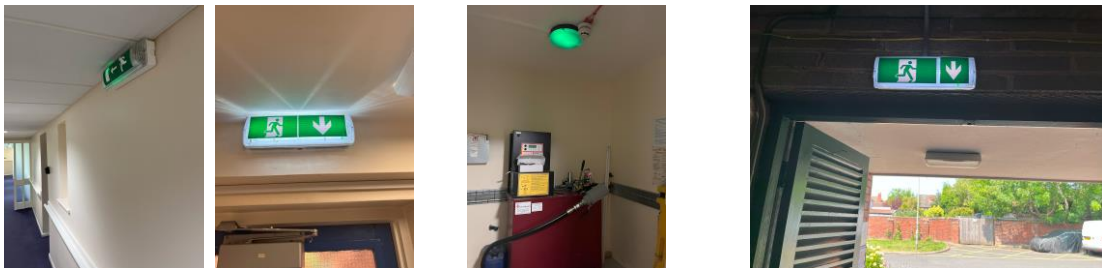
- 2) The self-contained units are provided to the communal landings, stairs and lift motor room and boiler room.

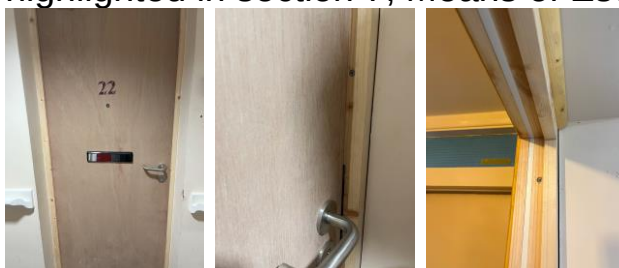
- 6) Flat 22 entrance door has had a temporary timber fire door installed due to a forced entry by Ambulance service, The closure of the door when released does not fully shut into the latch. This has been highlighted in section 7, Means of Escape, point 19.

| Flat 22 – Resident currently has a Temporary timber Nominal FD30 door installed following a forced entry recommendations for this door to be upgraded to a fully certified FD30s Door set. Currently the door is acceptable as a temporary replacement. | |

| 7, 19 | Flat 22 temporary door fitted, requires smoke seals, and adjust self-closing device. | | P2 | 1 – 3 months<br>Fire Rapid Response | |

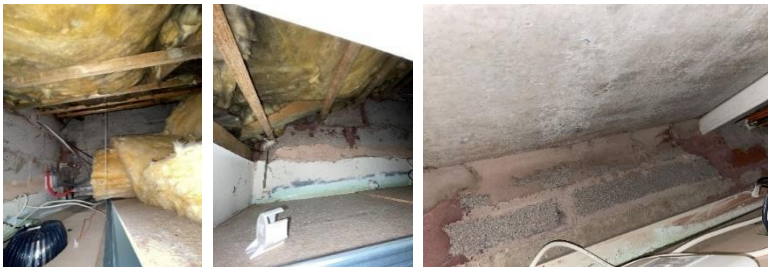
- 8) A sample of ceiling tiles were removed to confirm compartmentation continues above fire doors and flat walls within communal corridors.

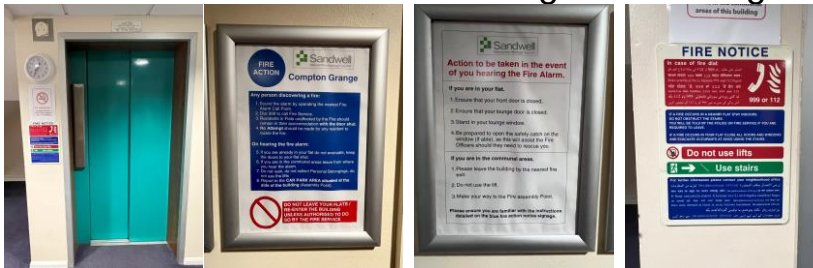
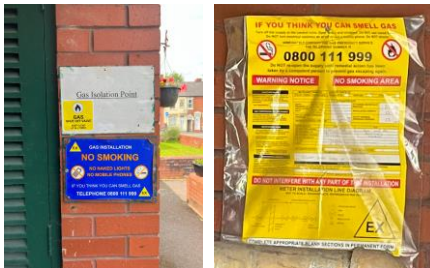
Gas safety fire action notices.

- 2) Fire Action Notices are displayed throughout the building. Also, there are fire action notices in regards to the gas boiler room.

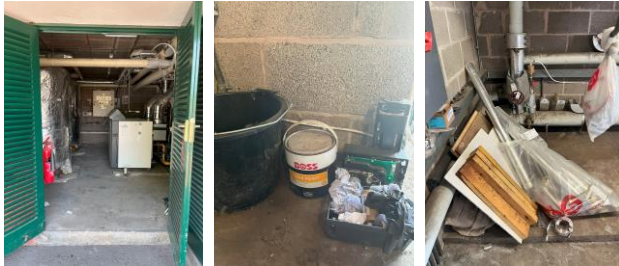
- 11) The boiler room has a few combustibles stored within it. There is a few wooden pieces, dust sheet and a 5 litre tin of gas paint. Email sent to gas team.**

| 14, 11 | Remove Items of combustion left in boiler room | | P2 | 1 – 3 months<br>Caretaking Manager | |

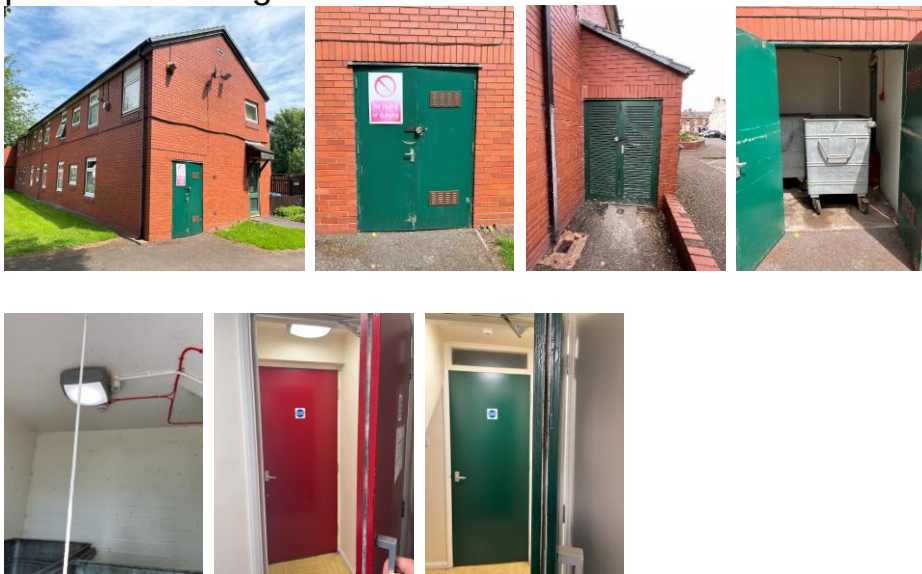
Internal access to bins

- 2) There are two bin stores which benefit from smoke detection and are secured. Refuse containers within are emptied regularly. Access is from both external with the use of a key which is held by authorised persons, residents' access is from the inside of the premises through FD30s fire doors.

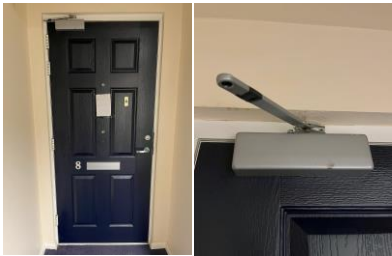
- 17) Flat 8 on investigation it was noted that the self-closure had been removed by the resident due to having difficulty entering and exiting the flat with the use of mobility scooter.

| Question/<br>Ref No | Required Action | Supporting photograph | Priority | Timescale and<br>Person<br>Responsible | Date<br>Completed |
|---|---|---|---|---|---|
| 7, 17 | Flat 8 – Re attached missing self-closing device. | | P2 | 1 – 3 Months<br>Fire Rapid<br>Response | |

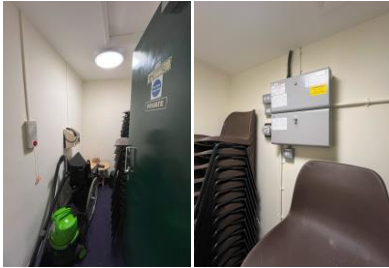
- 7) On the first floor in the telephone room, on inspection it was found that combustibles are being stored, 2 stacks of plastic chairs, wooden table, wheelchair and a Hoover, the room houses a distribution board alongside emergency lighting switches, there is no detection in this room

| 14, 7 | Remove items of combustion stored in telephone room (1 <sup>st</sup> Floor) | | P2 | 1 – 3 months<br>Housing Manager | |
