# Fire Risk Assessment

## Compton Grange

**Whitehall Road,  
Cradley Heath, B64 5BG**

**Date Completed: 04/06/2026**

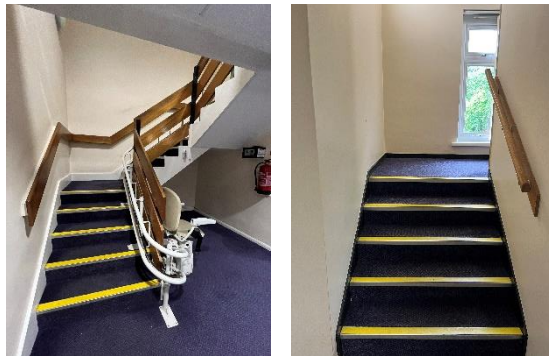
- 1) The site has 4 protected staircases that provide a sufficient means of escape. Each staircase in width is approximately 1m wall to wall. The width of two staircase's is slightly reduced due to the installation of a stairlift, measured at 0.86m.

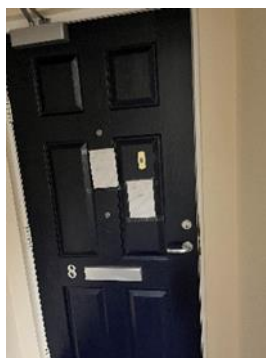
**c) Flat 8 – Flat entrance door is correct.**

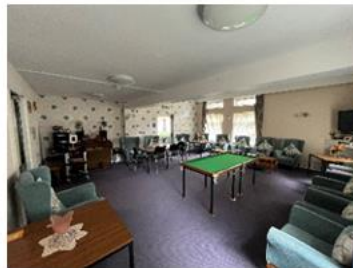
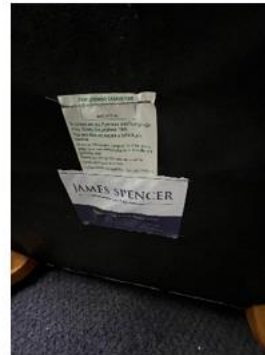
- 13) The ground floor contains a communal lounge with seating for 19 persons accessed through a nominal FD30s door from the corridor. The lounge has a small kitchenette (for preparation of hot drinks only) separated by a nominal FD30s door. The first floor contains a reading room which is a mezzanine opening on to this ground floor communal lounge. Furniture within both rooms is fire retardant and in good condition. There is an emergency exit door within the ground floor lounge leading to ultimate safety.

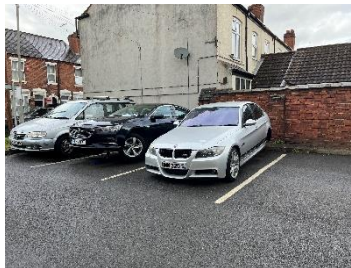
- 16) The assembly point (for those escaping from common areas.) is sited in the main car park. This car park is being used for parking of vehicles by non-residents, some of these vehicles appear to be the subject of mechanical maintenance.

All non-residents' vehicles are to be removed. This will aid fire service access and prevent blockage of the assembly point. An email was sent to the Housing Services Advisor to ensure compliance.

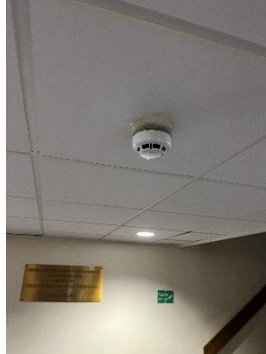
- 3) It is unknown if the noise level of the sounders in the common area would compromise the stay put evacuation policy. The noise level should be checked to ensure they do not wake residents of individual flats and potentially compromising the blocks 'stay put' evacuation policy. See action 8/3.

| 8/3 | It is unknown if the noise level of the sounders in the common area would compromise the stay put evacuation policy. The noise level should be checked to ensure they do not wake residents of individual flats and potentially compromising the blocks 'stay put' evacuation policy. | | P3 | Asset Management.<br>3 – 6 months. | |

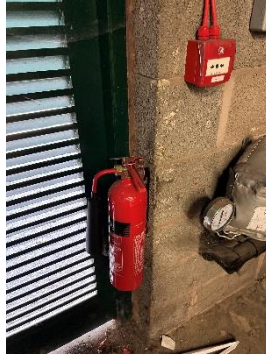
- 3) The CO2 fire extinguisher in the externally accessed heating plant room has no identification signage. Identification signage is required to be fitted. See Action 11/3.

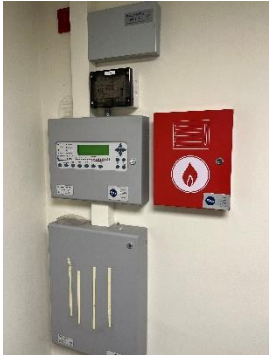
| 8/2 | The common alarm system was not monitored and therefore it is unclear how this AFA system would be re-set in the event of actuation. Management of the common area automatic fire alarm system should be reviewed. | | P3 | Asset Management.<br>3 – 6 months. | |
