Fire Risk Assessment

James Clift House

**Martley Road,
Oldbury,
B69 1EH**

Date Completed: 6th August 2025

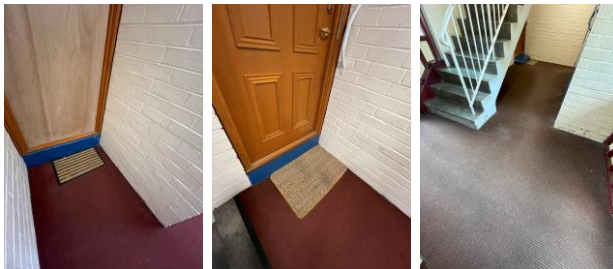
- 1) All flats are equipped with minimum LD3 detection to aid means of escape
- 2) All communal hallway floors are carpeted, the flat entrances have raised step to the door, some have door mats placed over the step, the fire rating is not known for the door mats.

All floors have S.M.B.C. fitted carpet. Due to the fact SMBC specified and managed the installation of the carpets, they are in accordance with BS EN 13501-1

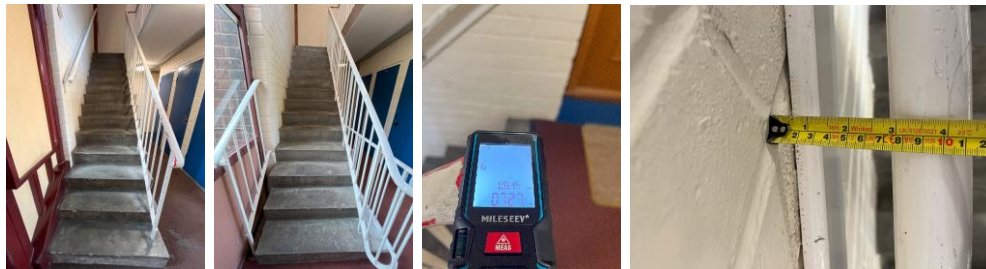
- 5) The premises consists of a single staircase that provides means of escape, this is located as you enter the building, this has been measured and 845mm in width from wall to balustrades and 727mm from balustrade to the second rail on the ground floor stairs. They are kept clear to maintain safe means of escape.

Ground to 1st 1st to 2nd Ground floor rail comes out 110mm from the wall

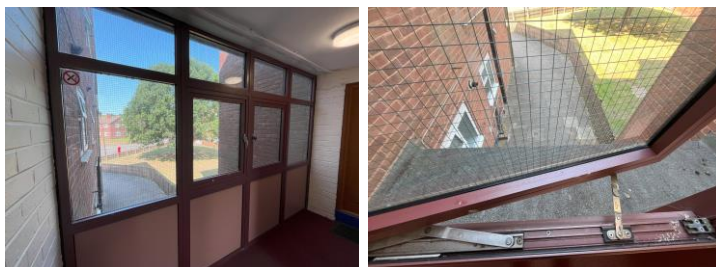
- 6) On the 1st and 2nd floor communal landings, there are a set of aluminium windows with Georgian wired glass, these windows can be opened without the use of a key in the case of escape from the 1st floor, which is to a canopy over the front entrance. This is acceptable as the measurement up to the floor of the 1st floor is within the 4.5m threshold of escape windows. These also allow sufficient airflow. There is no automatic smoke ventilation system installed in this premises.

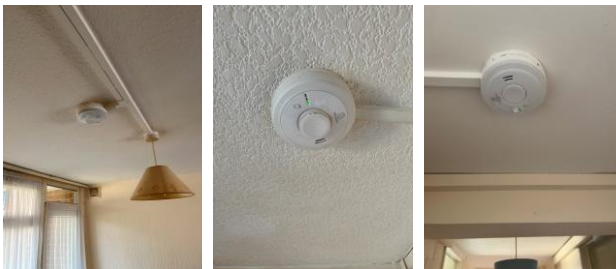
Flat 1 accessed for detection. Hallway, lounge and kitchen has heat detector. LD2 system

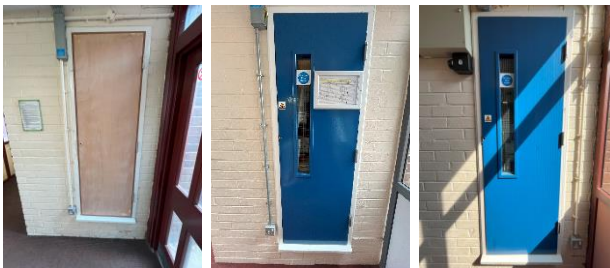
Ground, 1st and 2nd floor electrical cupboards

- 3) All service cupboards on each floor containing residents' meters are lockable with a budget key. Ground floor electrical cupboard door has been fitted with a new solid timber FS30s door.

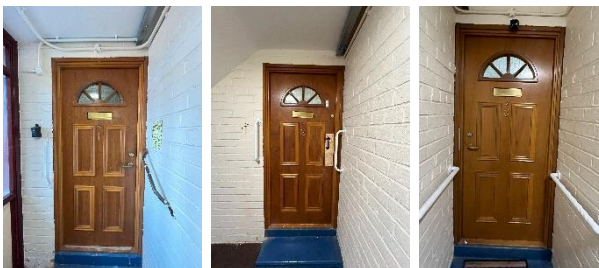
Ground floor flats 1,2,3

- 8) All individual flats are installed with FD30s rated composite doors. flat 6, 8 have solid timber fire door installed. Could not access to inspect the doors internally.**

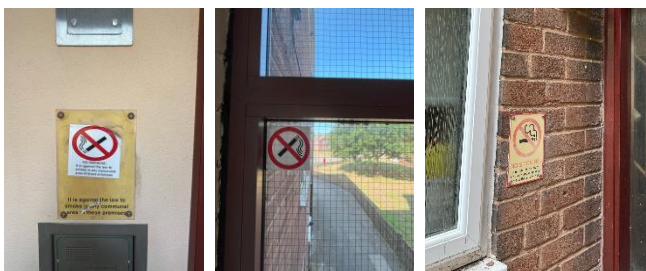
- 2) Fire Action Notices are not displayed throughout the building. The signs are not necessarily due to the building not having a complex layout.
- 3) Yellow LPG warning signs are not displayed within the block. [refer to section 18](#)
- 4) Smoking is prohibited within any communal parts of the building in line with Smoke Free England legislation.

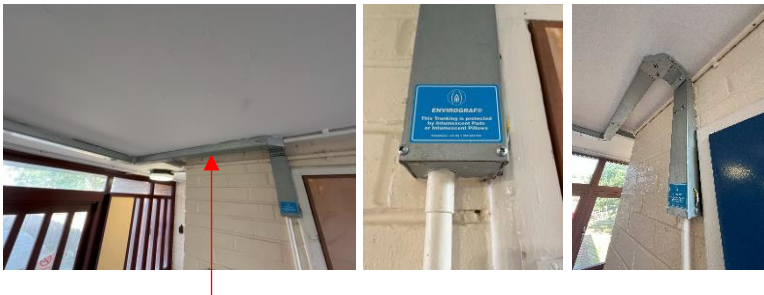
Metal Electrical Trunking

- 11) All electrical cabling feeding supply from electrical risers to residents' flats and other units within the communal areas are channelled through secure metal box trunking that is securely install across the upper walls and ceilings. All electrical trunking is protected by Envirograf Intumescent Pillows or Pads.
