# Fire Risk Assessment

**10-20 Martley Road**  
**Martley Road,**  
**Oldbury,**  
**B69 1DZ**

**Date Completed:** 04/08/2025

**Current Risk Rating = Tolerable**

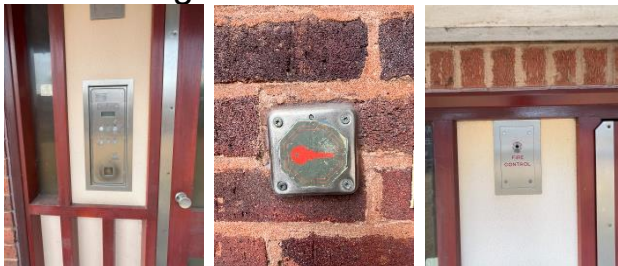
Front entrance      Rear entrance key fob      Firefighter override

The block has a front entrance, that has a door entry system, and a fob reader installed. There is a rear access door, leading to a rear courtyard area. Both escape routes lead to an ultimate place of safety. The Front and rear entrance points utilise a door entry system with a fob reader installed with a firefighter override switch.

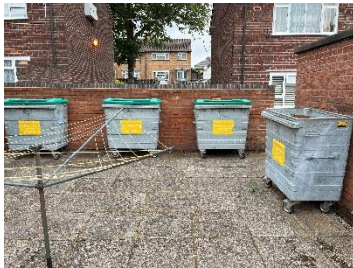
There is a dedicated area within the rear yard where bins are stored.

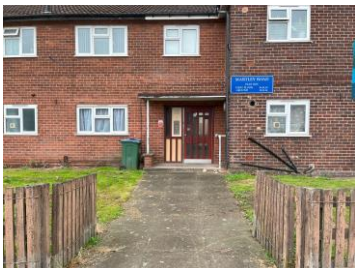
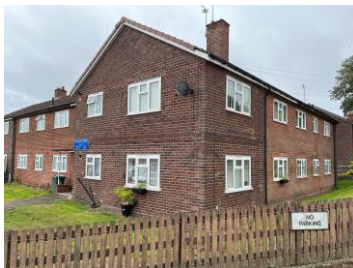
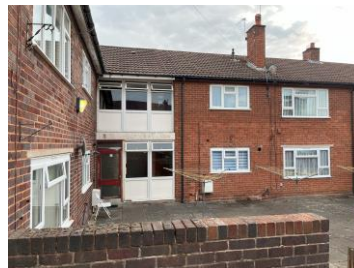
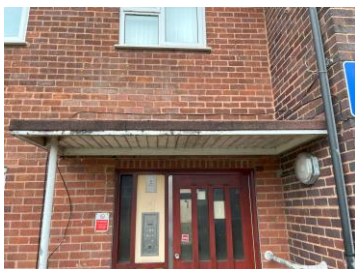
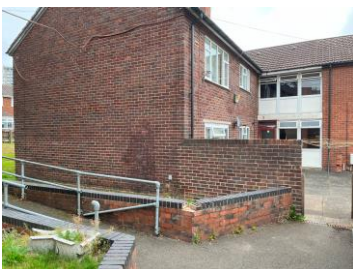
- 1) The external construction of the building is predominantly brick with UPVC and wooden facia, the roof is a tiled pitched type. There is a canopy that is constructed over the front entrance, the underside of this canopy is constructed in timber tongue and groove, this is below a 1<sup>st</sup> floor window.

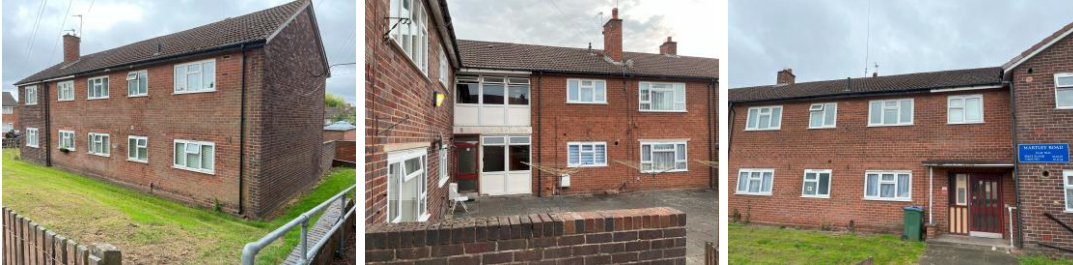
2) UPVC double glazed units have been installed to each flat

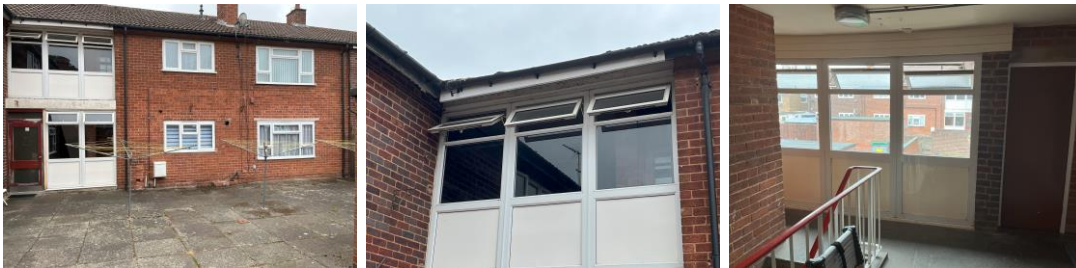
3) On the rear of the building Spandrel panels have been installed, under the UPVC windows on the ground floor and on the first floor.

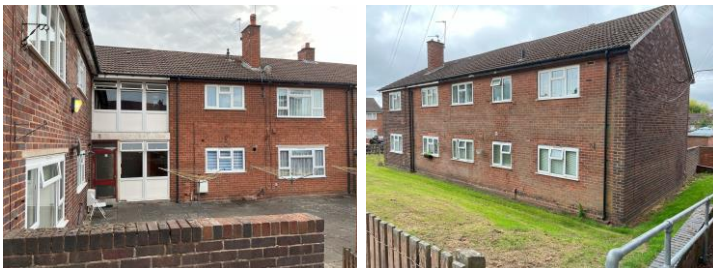
4) On the rear of the building there are two chimney stacks, it is not known if these are in use.

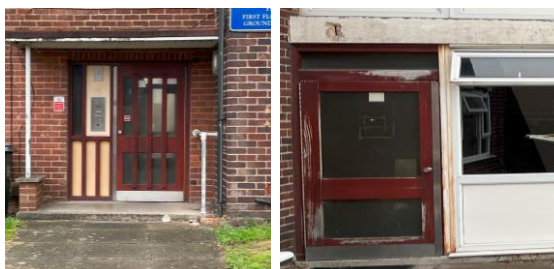
5) The front and rear final exit doors are timber construction.

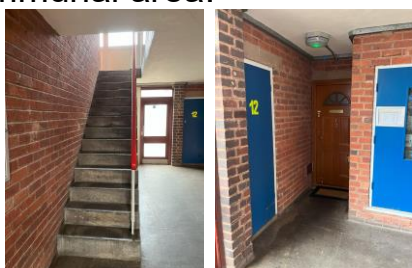
- 1) All flats are equipped with a standard minimum LD3 detection to aid means of escape.
- 2) Internal walls are of exposed brick work which is throughout the communal area.

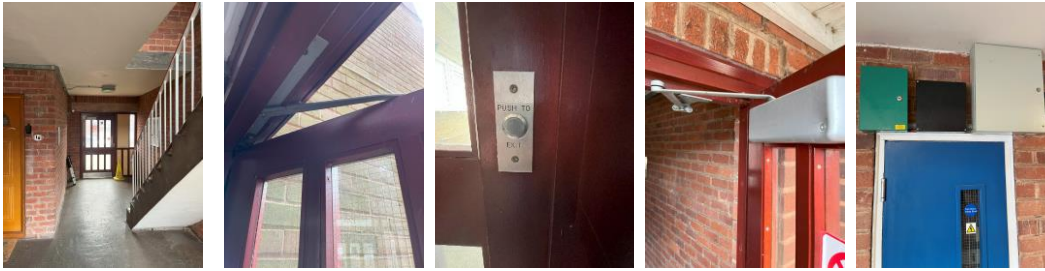
- 4) The only communal doors within the block are the final exit doors, which are fitted with automatic closing devices that are checked on a regular basis by caretaking teams as part of their checks. Defective closing devices are replaced either by the Caretaking Team(s) or the in-house repairs team(s). The final exit doors have door entry systems installed. These systems are designed to fail safe i.e. door unlocked in the event of a power failure. This prevents residents being locked in or out of the building.
-

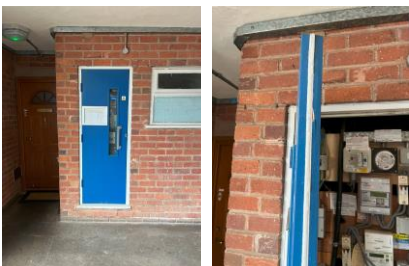
9) There is an electrical cupboard on each floor with a FD30 rated door fitted with cold smoke seal fitted, these are lockable with a budget key.

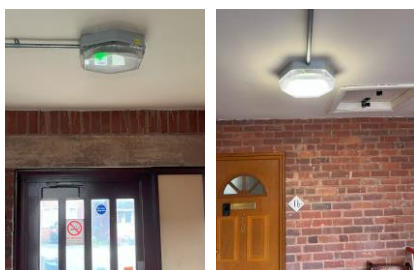
- 11) Emergency lighting is provided to communal landings. One emergency lighting unit is situated on the ground and 1<sup>st</sup> floor, Checks are done monthly by Sandwell MBC in house electrical team or approved contractor. ([Refer to section 9](#))

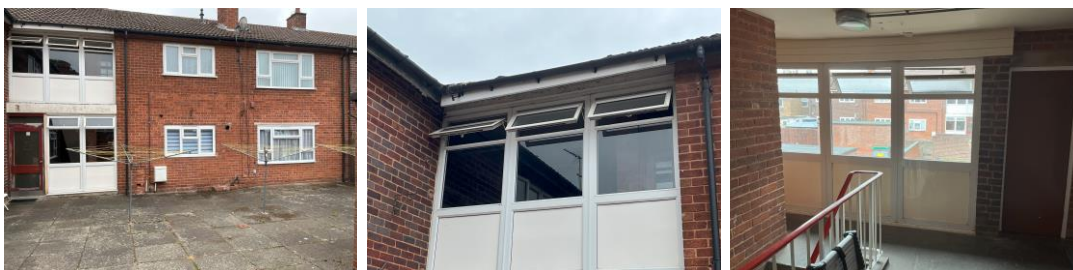
- 12) On the ground and 1st floor communal landings, there are a set of UPVC windows, these windows can be opened without the use of a key, these allow sufficient airflow. There is no automatic smoke ventilation system installed in this premise.

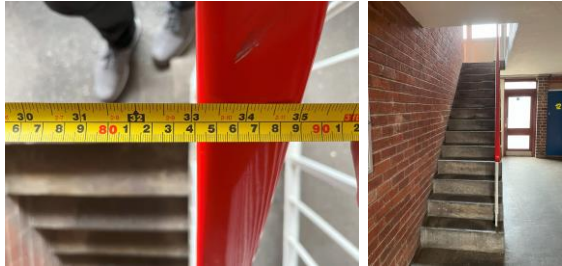
13)The premise has a single staircase that provides means of escape from the first floor and is 840mm in width.

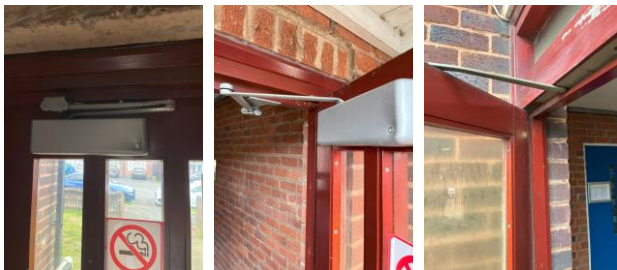
- 1) The building is designed to provide as a minimum 1-hour vertical and 1-hour horizontal fire resistance. This is not possible in the communal areas due to open plan staircase.
- 2) The communal area do not have sufficient compartmentation to limit the travel and effect of smoke and flame in the event of a fire in communal areas due to open plan staircase.
- 3) The front and rear exit doors are fitted with automatic closing devices. These are checked on a regular basis by Caretaking Teams as part of their checks. Defective closing devices are replaced either by the Caretaking Team(s) or the in-house repairs team(s).

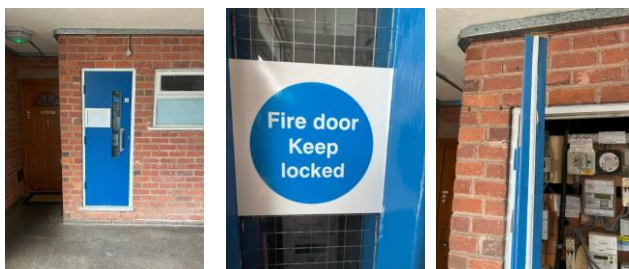
- 4) All service cupboards to communal landings are FD30s rated and lockable with budget locks and include a fire door Keep locked sticker and smoke seals.

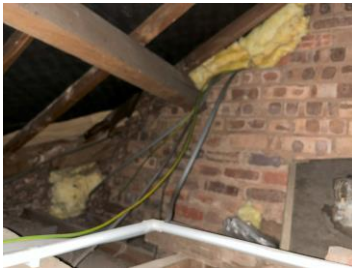
- 13) The roof space was viewed in the survey and adequate compartmentation was identified up to the roof line.

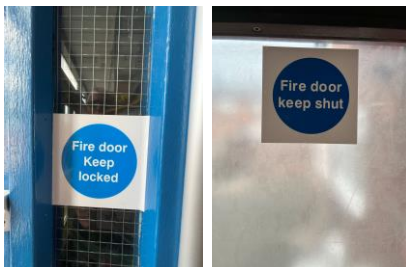
- 1) Fire door keep shut signs are displayed where appropriate. All resident meter cupboards display "Fire Door Keep Locked" sign.

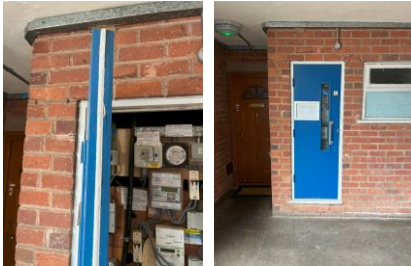
- 7) All Residents service cupboards on each floor are housed behind a FD30s fire rated doors. All cupboards are free from any combustibles.

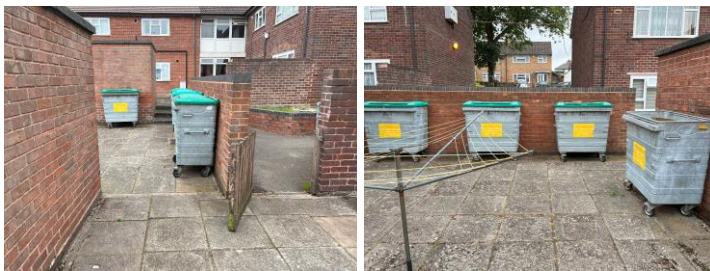
- 1) There is a regular Cleaning Service to the premises.
- 2) Refuse bins are stored to the rear of the building. Bins Are regularly emptied by site services.

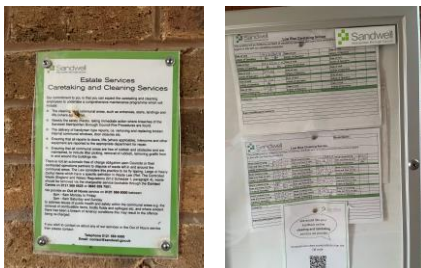
- 3) Regular checks by Caretakers minimise risk of waste accumulation.

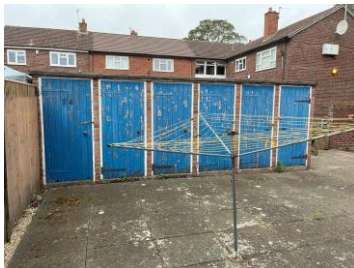
- 1) Residents instructed not to bring L.P.G cylinders into block.
- 2) The tenancy conditions, Section 7 – Condition 5.6 stipulates “If you live in a flat or maisonette, you, people living with you and any visitors to your property must not keep or use paraffin oil, petrol, bottled gas appliances or any other explosive, FLAMMABLE or dangerous material in the property. This restriction also applies to any storage facility situated in or attached to the block, which has been provided for your use.”
- 3) No Flammable liquids stored on site by Caretakers / cleaners.
- 4) Residents have individual storage cupboards internally and externally which they keep secured by means of own keys.
