Fire Risk Assessment

Martley Road 36-46

**Martley Road, Oldbury,
B69 1DZ**

Date Completed: 4th August 2025

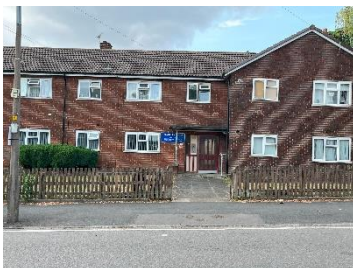
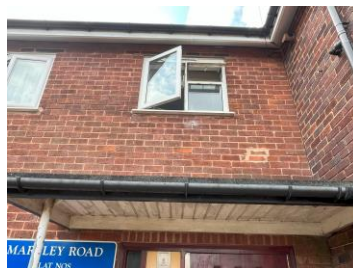
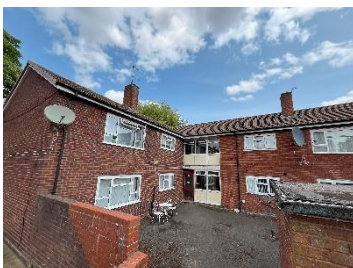
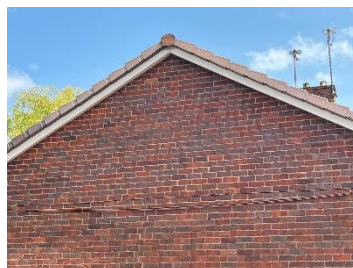
- 1) The external construction of the building is predominantly brick with UPVC fascia just before the roof, the block roof is a tiled pitched type. There is a canopy that is constructed over the front entrance, the underside of this canopy is clad in timber tongue and groove, this is below a 1st floor window.

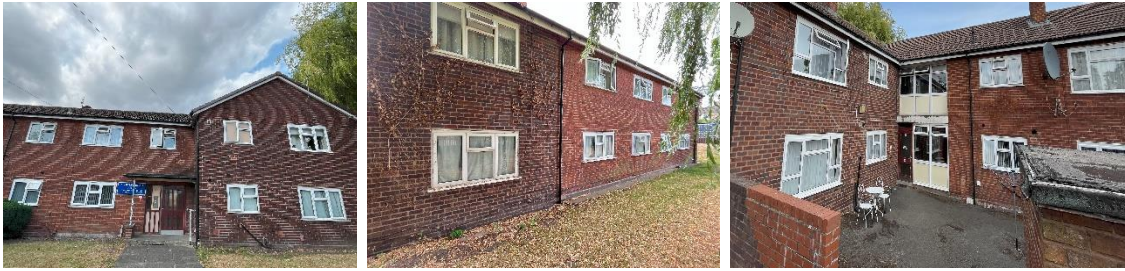
- 2) UPVC double glazed units have been installed to each flat.
-

UPVC Units to the front, side and rear of the building

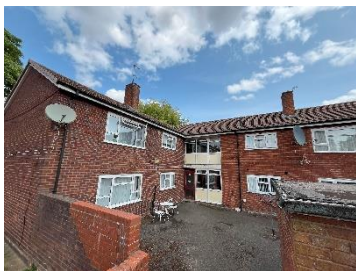
- 4) On the rear of the building there are two chimney stacks, it is not known if these are in use.

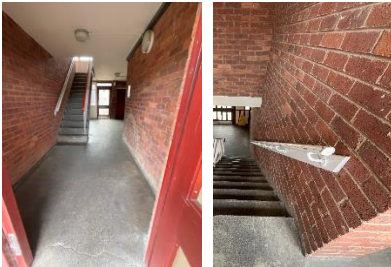
- 1) All flats are equipped with a standard minimum LD3 detection to aid means of escape.
- 2) Internal walls are of exposed brick work which are throughout the communal block.

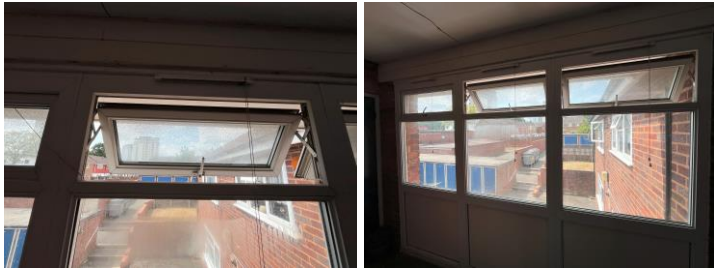
- 9) On the 1st floor communal landings, there are a set of UPVC windows these windows can be opened without the use of a key, these allow sufficient airflow. There is no automatic smoke ventilation system installed in this premises.

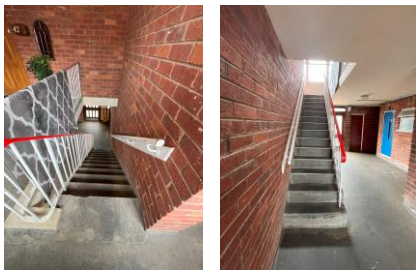
- 10) The premises consists of a single staircase that provides means of escape, this is located as you enter the building, The stairs have a secondary handrail installed on the wall narrowing its initial width, it has been measured and 750mm in width which is acceptable.

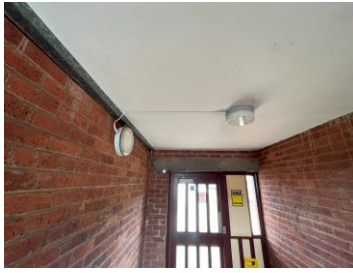
- 12) Emergency lighting is not present in the block, this is due to the block being no more than 2 floors, the block has standard lighting installed in the communal hallway, covering the stairs and landing.

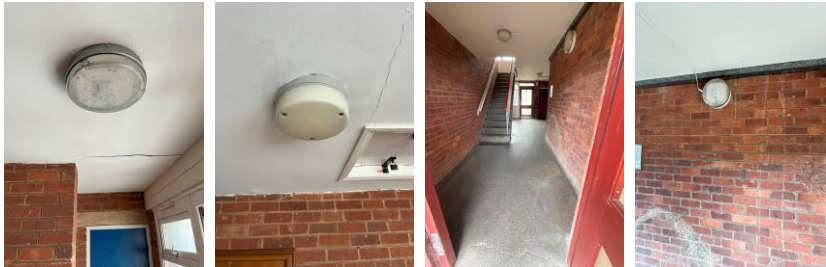
- 1) The premises does not have a sufficient emergency / escape lighting system in accordance with BS 5266. This is due to the block being no more than 2 floors, there is standard lighting present in communal hallway, over the stairs and landing.

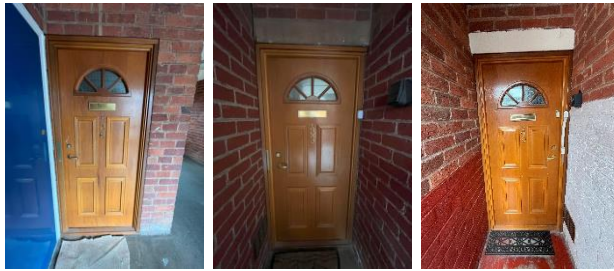
Ground floor flats 36,38,40

6) All individual flats are installed with FD30s rated composite doors.

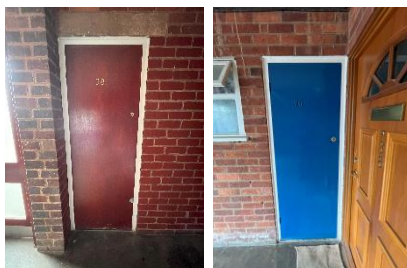
7) Resident internal cupboards are secured by a notional non fire rated doors, these doors are secured by keys that are kept by residents.

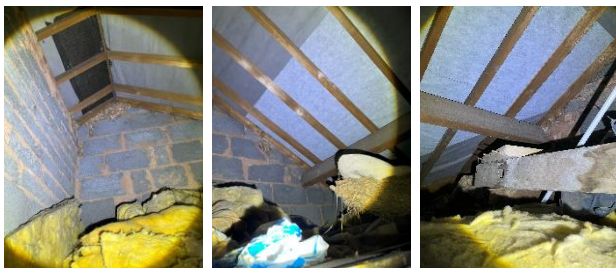
- 10) Roof space investigated for compartmentation, there is suitable compartmentation in the form of block work, which is intact along the roofline, there are no other visible cavities or breaks in the compartmentation.

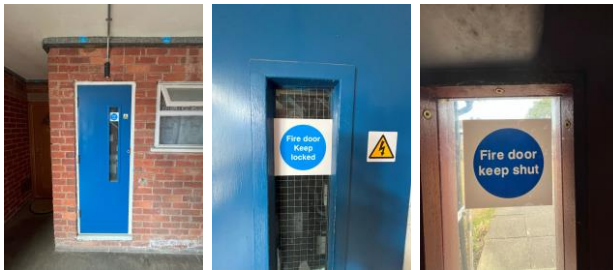
- 1) Fire door keep shut signs are displayed where appropriate. All resident meter cupboards display "Fire Door Keep Locked" sign.

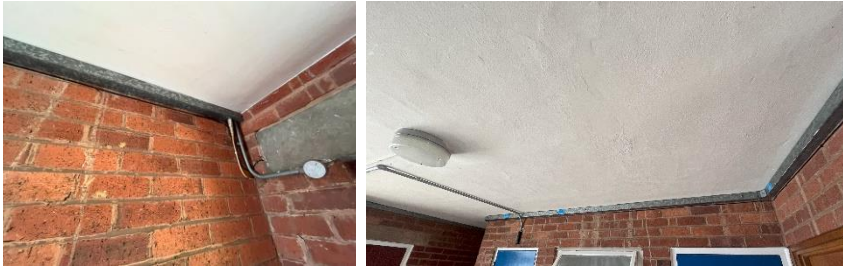
- 6) All electrical cable supplying power to flats via the electrical risers are encased in metal boxed trunking which is installed on the ceiling away.

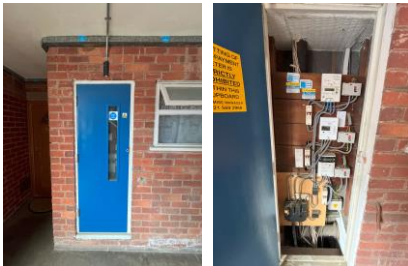
- 7) Portable heaters are not allowed in any common parts of the premises.
- 8) Gas appliances and pipework (where installed) are subject to annual testing and certification. This cyclical contract is managed by the in-house Gas Team.
- 9) All Residents service cupboards on each floor are housed behind a FD30s fire rated doors. All cupboards are free from any combustibles.

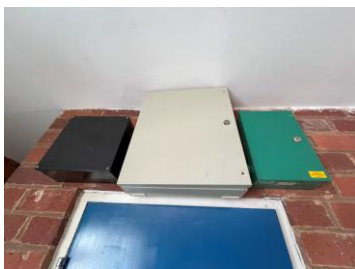
- 10) Gas appliances and pipework (where installed) are subject to annual testing and certification. This contract is managed by the in-house Gas team. Gas supply to this premises is internal.
- 11) 1st floor has door entry system power supply unit installed on the wall; this was not secured shut at the time of FRA. Email has been sent to the door access control team to have these units made secure.

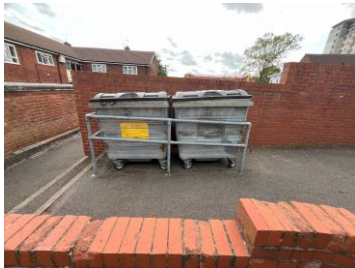
- 1) There is a regular Cleaning Service to the premises.
- 2) There is no record of daily cleaning or caretakers visiting the site. Emailed Estate Services to query scheduled site cleaning.
- 3) Refuse bins are stored to the rear of the building. Bins Are regularly emptied.

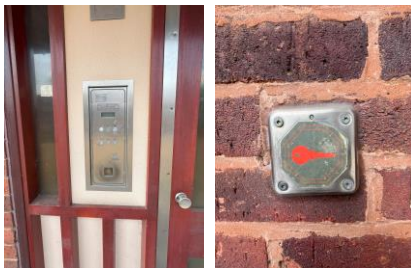
- 1) Regular checks are undertaken by Caretakers / Cleaning Team(s) 365 days per year which helps reduce the risk of arson.
- 2) Restricted access to the premises by means of a door entry system to the front and the rear.

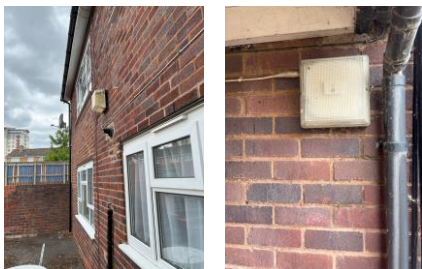
Front lighting Rear lighting

- 3) There was no current evidence of arson when the FRA was carried out.
- 4) The perimeter of the premises is well illuminated with wall lighting to both front and rear.

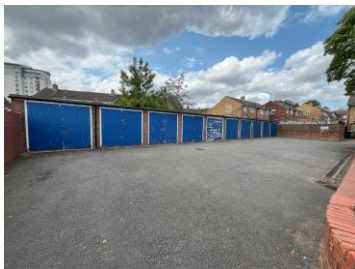
External garages & stores

- 1) Residents instructed not to bring L.P.G cylinders into block.
- 2) The tenancy conditions, Section 7 – Condition 5.6 stipulates “If you live in a flat or maisonette, you, people living with you and any visitors to your property must not keep or use paraffin oil, petrol, bottled gas appliances or any other explosive, FLAMMABLE or dangerous material in the property. This restriction also applies to any storage facility situated in or attached to the block, which has been provided for your use.”
- 3) No Flammable liquids stored on site by Caretakers / cleaners.
- 4) There are no flammable liquids or gas cylinders stored on site.
- 5) Residents have individual storage cupboard internally and externally which they keep secured by means of own keys.
