Fire Risk Assessment

1-6

**Applewood Grove,
Cradley Heath,
B64 6EG.**

Date Completed: 01/11/2025

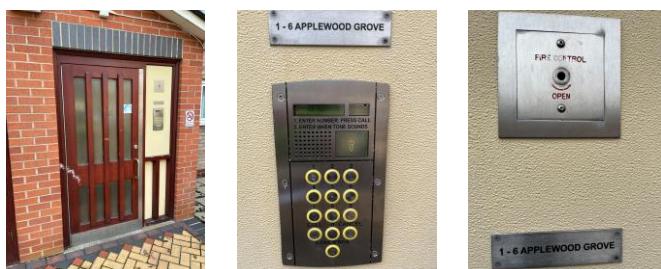
The block has a front entrance, that has a door entry system with a fob reader installed. There is a rear access door, leading to a rear courtyard area has a fob reader to enter the building. Both escape routes lead to an ultimate place of safety. The Front final exit door has a firefighter override switch operated by drop-latch key.

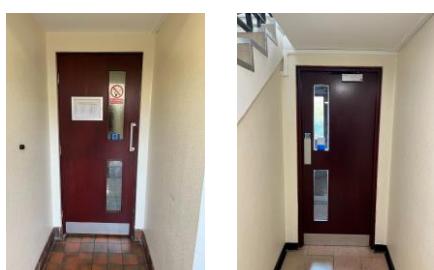
All entrances lead through a further door which is an FD30S with vision panel before entering the ground floor lobby area.

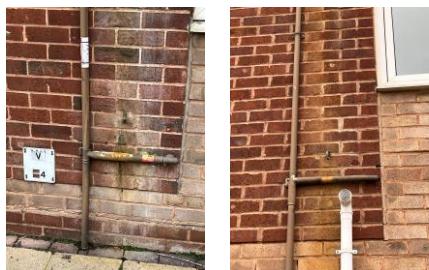
The gas is supplied externally to flats.

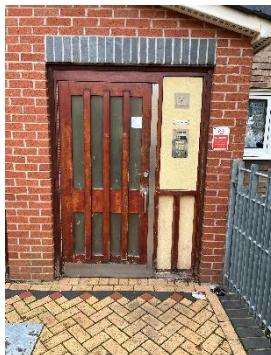
9) Access is gained to all flats from the ground floor using the main access door that leads to the staircase area, further egress is available via the rear access door. Both access doors are solid timber with a fob access system.

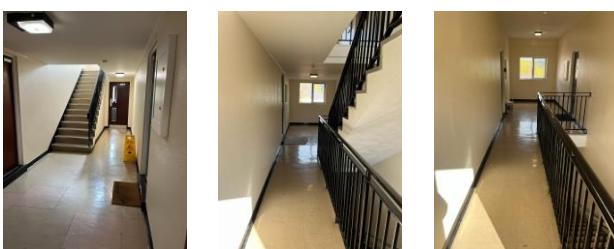
13) The means of escape is an open plan landing and stairs construction over three floors.

14) The landings are kept clear to maintain safe means of escape.

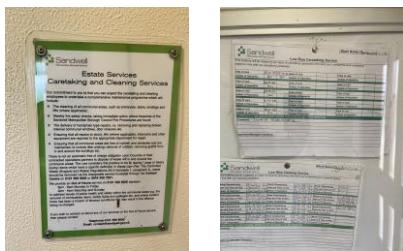
16) The communal area is kept free of flammable items. The communal areas should be checked on a regular basis by Caretaking / Cleaning teams and all items of rubbish removed.

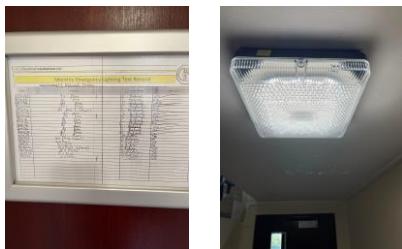
20) Emergency lighting is provided to communal landings and stairs. Checks are done monthly by Sandwell MBC in house electrical team or approved contractor.

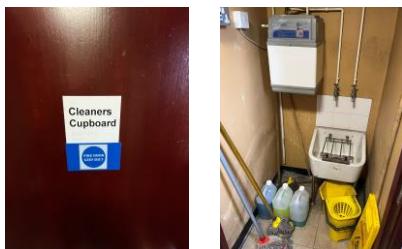
21) The cleaners store cupboard is protected by an FD30 fire door. The door is secured by a suited type 54 mortice lock and key.

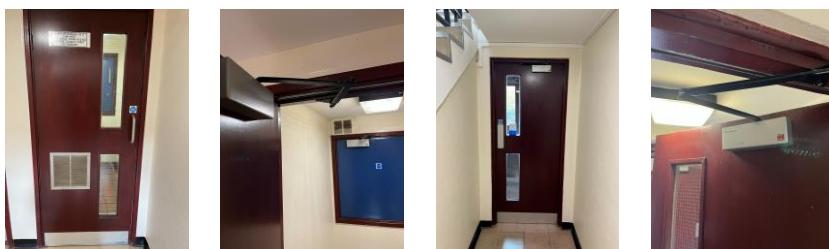
22) All communal doors are fitted with self closing devices that are checked on a regular basis by caretaking teams as part of their check. Defective closing devices are replaced either by the caretaking team or in house repair team.

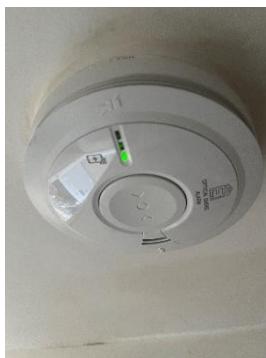
Flat 6 was accessed and was seen to be LD1 standard.

Flat 3 was accessed and was seen to be LD2 standard.

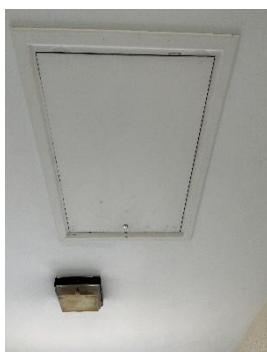
- 8) Service cupboard on the ground floor is accessible at the rear of the building and contains the electrical intake.
- 9) The door on the service cupboard is a notional timber fire door with smoke seals and intumescent strips and lockable with a 54 mortice lock the door is in poor condition see observations.

- 10) All individual flats are installed with FD30s rated fire doors.
- 11) The block has a Pitched roof with a loft access panel on the second-floor landing. Access was not possible during this survey; however, the assessor will return once suitable access equipment is available. This FRA will then be reviewed.

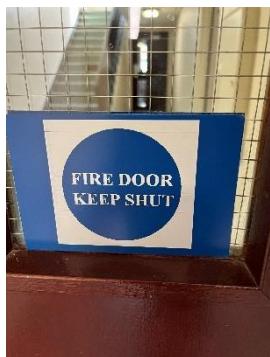
- 1) Appropriate signage is displayed throughout the building.

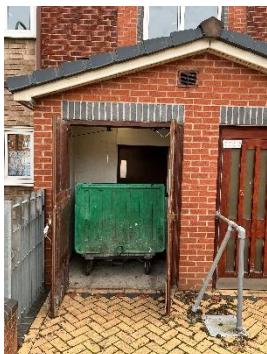
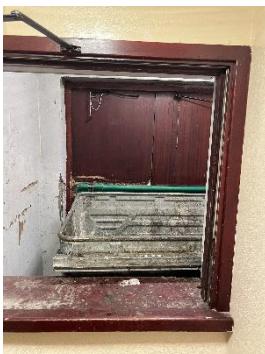
- 1) There is a regular Cleaning Service to the premises.
- 2) Refuse bins are stored to the front of the building in a purpose-built store. Bins Are regularly emptied.

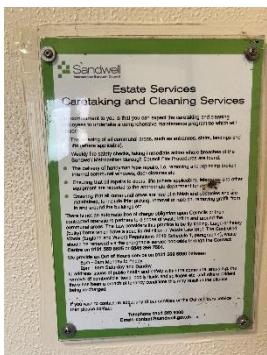
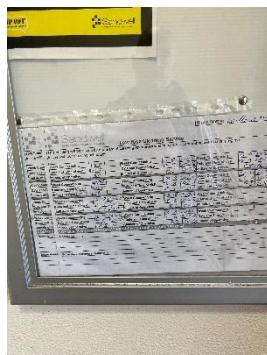
- 3) Regular checks by Caretakers minimise risk of waste accumulation.

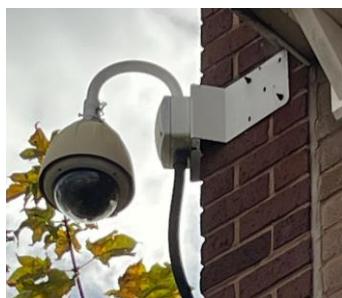
- 3) There is no current evidence of arson.
- 4) The Block also has CCTV fitted.
