Fire Risk Assessment

1-12

**Blue Rock Place,
Tividale,
B69 1PB**

Date Completed: 05/05/2026

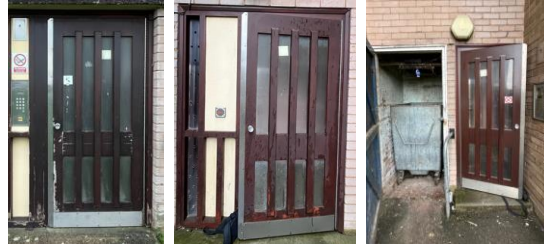
Next to the one exit/entrance door is situated a bin storage room secured behind a timber door, within this room is a large waste bin serving the blocks bin chute. This room is not secured by a lock; the latch to keep it closed is missing, new one required to keep the room closed. See section 15

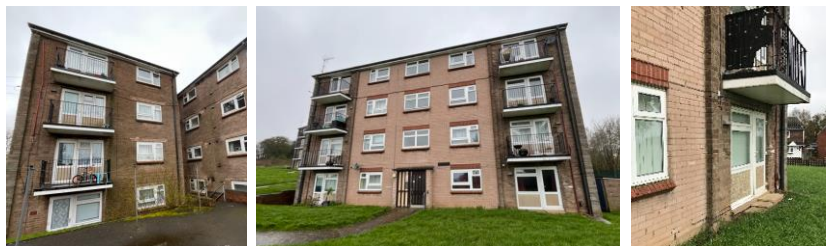
The flats on the first, second and third floor each have a small balcony. The balconies consist of a concrete floor and are fitted with ironwork railings. Ground floor flats have an external door giving them another point of egress from the block.

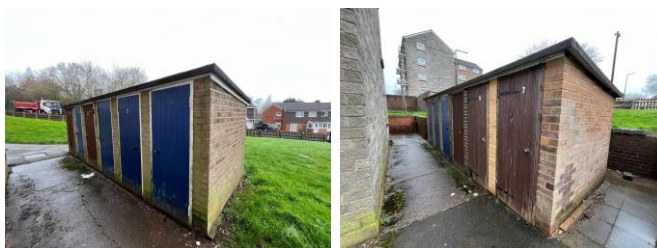
A number of detached storage units are located externally within the grounds. These are used by tenants for personal storage and remain locked at all times, with access provided only through the residents' own keys.

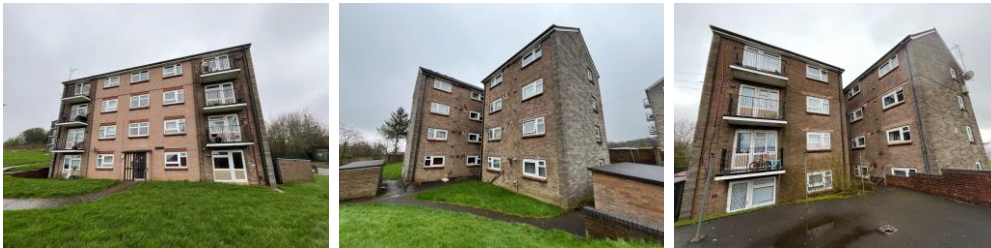
- 1) The external surface of the building is predominantly brick structure with uPVC soffits and fascia. The roof is pitched and fitted with concrete interlocking roof tiles are fitted on the roof.

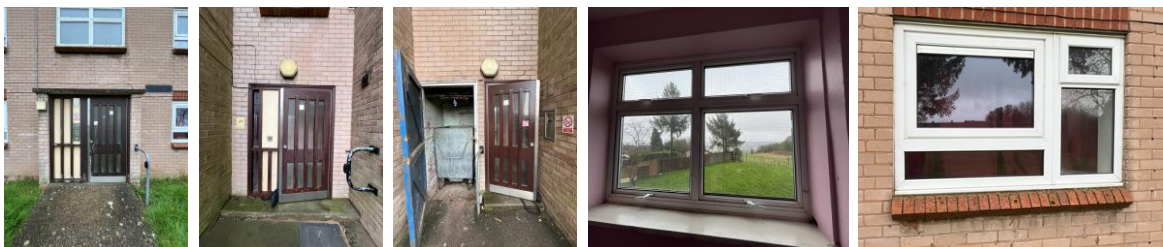
- 2) uPVC double glazed units have been installed to each flat and communal stairway. Communal windows are Georgian wired glazed. Entrance doors (x3) are mainly timber and glass units, with two doors having a small section of spandrel panelling within the side frame.

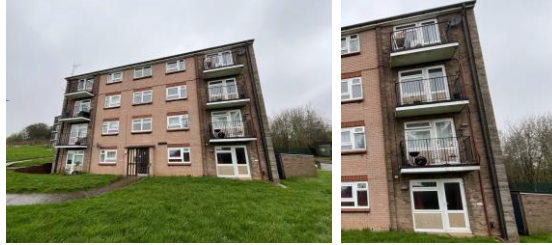
- 3) The flats on the first, second and third floors each have a small balcony. Each balcony consists of a reinforced concrete floor slab supported by the main building structure. The outer edge is fitted with metal balustrade railings, which provide fall protection while maintaining an open, non-combustible boundary.

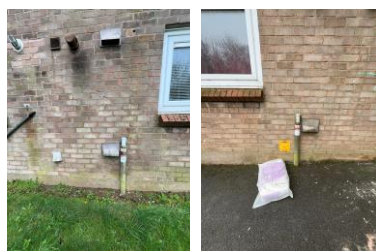
- 5) There are a small number of external gas service pipes fixed to the façade, feeding the internal gas installations within the flats. The pipework is metallic and non-combustible, with no apparent defects noted at the time of inspection.

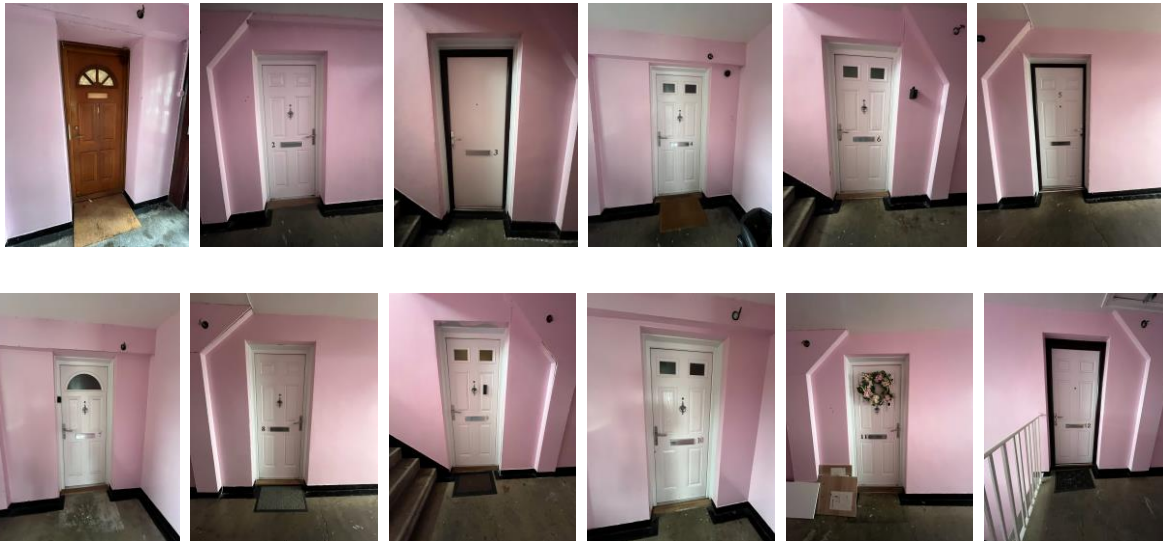
- 1) Each property is fitted with a minimum of an LD3 detection system within the flat. See Section 8
- 2) Individual flat doors appear to be a minimum of FD30 rated; there is a mixture of upgraded notional timber and composite doors sets. Original timber doors should be considered for replacement in the future.

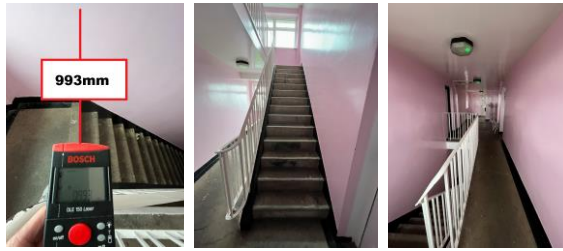
- 5) Within the block each floor is accessed via a single staircase that provides a means of escape and has a width of a minimum of 993mm between the handrails.

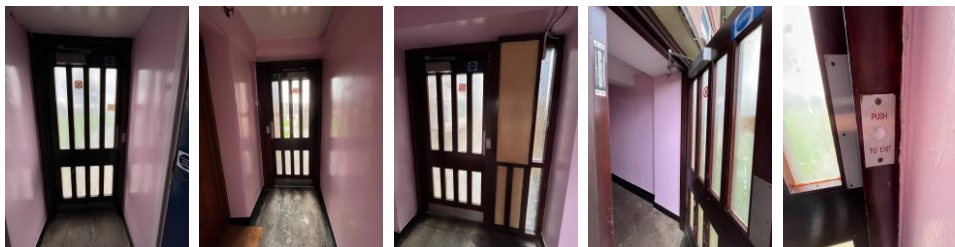
9) The final exit doors (x3) are fitted with automatic closing devices. To exit the doors, you do so by using a push button. These are checked on a regular basis by caretaking teams as part of their checks. Defective closing devices are replaced either by the Caretaking Team(s) or the in-house repairs team(s). These systems are designed to fail safe i.e. door unlocked in the event of a power failure. This prevents residents being locked in or out of the building.

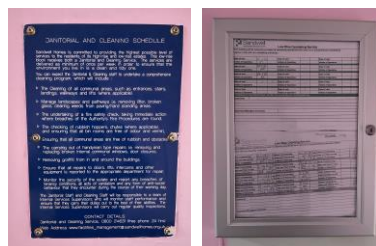
10) Communal areas are kept free of flammable items. The communal areas are checked on a regular basis by Caretaking / Cleaning teams 365 days per year and all items of rubbish are immediately removed. There is also an out of hour's service that allows combustible items of furniture / rubbish to be removed.

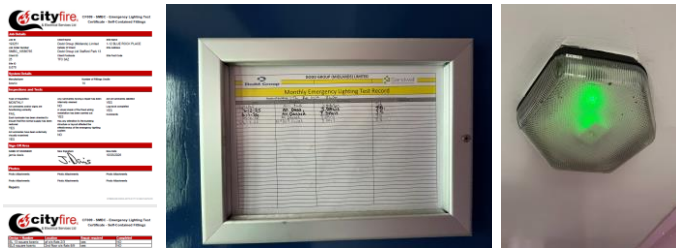
1) These premises have emergency lighting fitted on each floor. Three emergency light units are fitted on each floor. All installed equipment is checked and tested on a monthly basis by Sandwell MBC in house electrical team or approved contractor, in accordance with current standards.

a) One emergency light unit on the ground floor was not working at the time of the Fire Risk Assessment, this had been picked up by CityFire check on the 10th March 2026. Email has been sent to electrical team to follow up on the repair (29/04/2026).

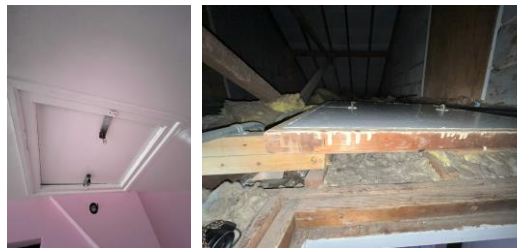
- 7) Individual flat doors appear to be a mixture of notional timber, and composite FD30 doors sets. Original timber doors should be considered for replacement in the future.
- 8) On the top floor, access to the loft space is provided via a solid timber loft hatch. The fire rating of this hatch is unknown, and it is recommended that it be upgraded during future refurbishment works. Given that the communal area is maintained as a sterile zone, the current arrangement presents a low level of risk. The loft hatch must remain padlocked at all times. During the Fire Risk Assessment, the loft areas were inspected and found to have appropriate fire-stopping in place throughout the space.

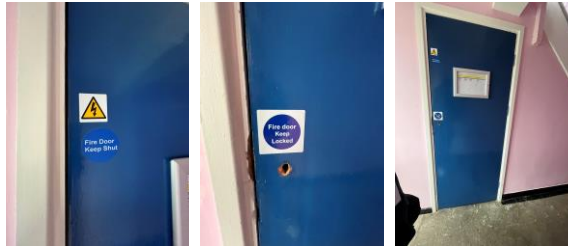
- 1) The service cupboard displays “Fire Door Keep locked” also an electrical warning sign.

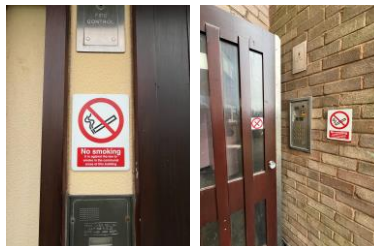
- a) Smoking is prohibited within any communal parts of the building in line with Smoke Free England legislation. Signage is displayed around the building

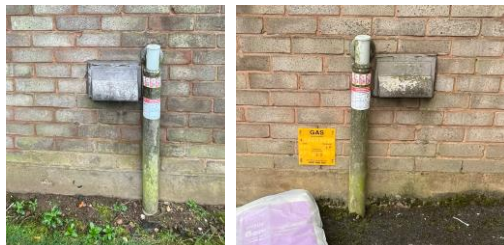
- 5) Portable heaters are not allowed in any common parts of the premises.
- 6) Gas appliances and pipework (where installed) are subject to annual testing and certification. This cyclical contract is managed by the in-house Gas Team. There are external gas risers on the property.

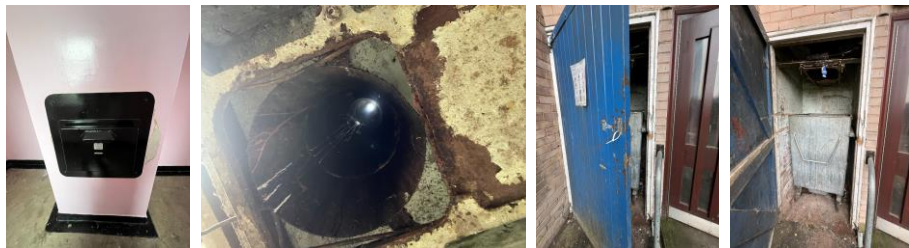
- 1) There is a regular Cleaning Service to the premises.
- 2) The blocks refuse is deposited via a bin chute accessed on all of the upper floors via the hopper door. Ground floor flats can place their bags directly into the bin via the bin room that is accessed from at the rear of the block.

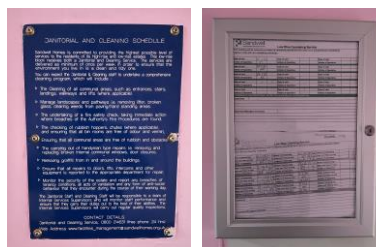
- 4) Regular checks are carried out by Caretakers to minimise risk of waste accumulation.

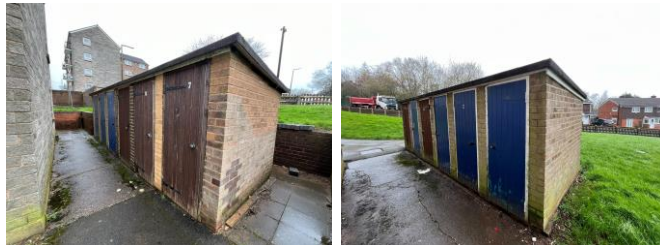
- 1) Residents instructed not to bring L.P.G cylinders into block.
- 2) The tenancy conditions, Section 7 – Condition 5.6 stipulates “If you live in a flat or maisonette, you, people living with you and any visitors to your property must not keep or use paraffin oil, petrol, bottled gas appliances or any other explosive, FLAMMABLE or dangerous material in the property. This restriction also applies to any storage facility situated in or attached to the block, which has been provided for your use.”
- 3) Residents should not store flammable liquids or gas cylinders on site.
- 4) No Flammable liquids stored on site by Caretakers / Cleaners.
- 5) Residents have individual storage cupboard externally which they keep secured by means of own keys.
