Fire Risk Assessment

13-24

**Blue Rock Place,
Tividale,
B69 1PB**

Date Completed: 15/05/2026

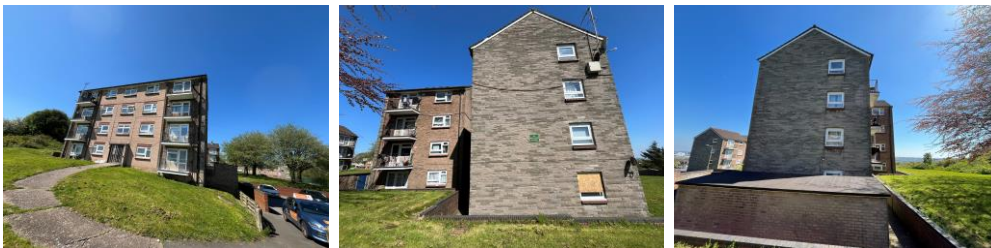
- 1) The external surface of the building is predominantly brick structure with uPVC soffits and fascia. The roof is pitched and fitted with concrete interlocking roof tiles are fitted on the roof.

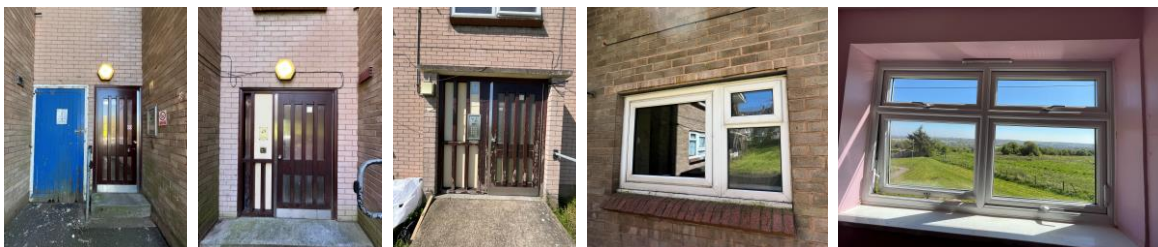
- 2) uPVC double glazed units have been installed to each flat and communal stairway. Communal windows are Georgian wired glazed. Entrance doors (x3) are mainly timber and glass units, with two doors having a small section of spandrel panelling within the side frame.

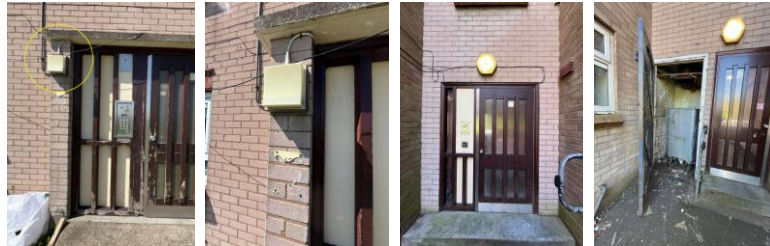
- 4) Externally, lighting units are fitted near the entrance doorways. These provide illumination for resident access and contribute to overall safety and security during hours of darkness.

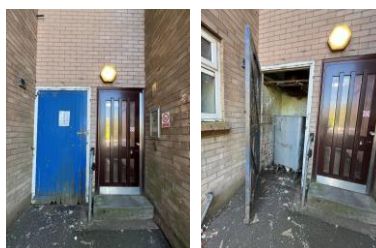
- 6) The bin room is accessible from outside through a timber door. This door is to be kept shut when not in use.

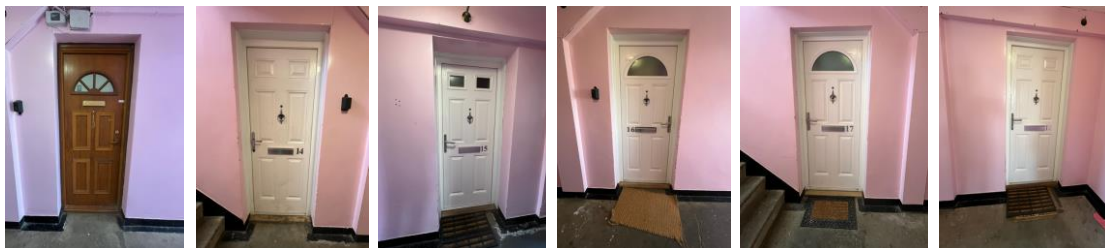
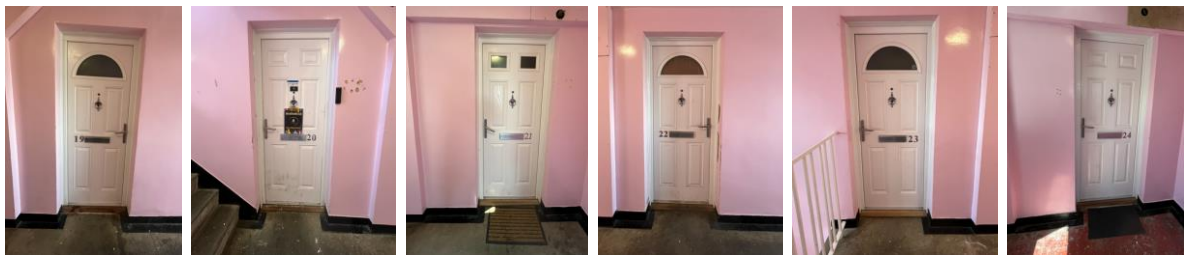
- 1) Each property is fitted with a minimum of an LD3 detection system within the flat. See Section 8
- 2) Individual flat doors appear to be a minimum of FD30 rated; there is a mixture of timber and composite doors sets.

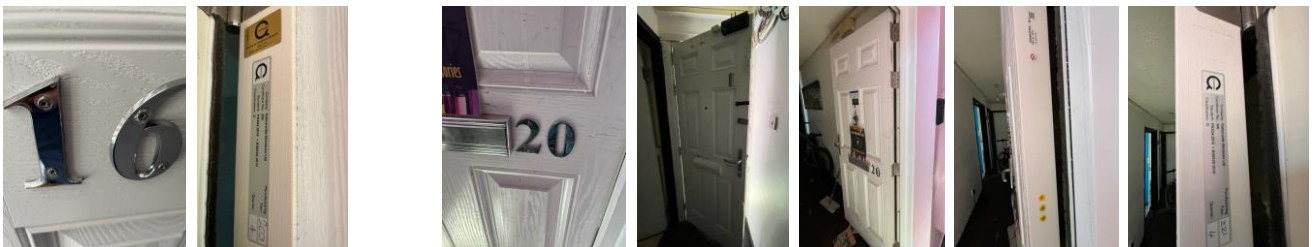
- 3) Access was attempted to a sample some of the properties as part of the risk assessment. This was to ensure the doors have not been tampered with by residents.
- a) Flat 13: No Answer
 - b) Flat 14: No answer
 - c) Flat 15: No answer
 - d) Flat 16: The flat entrance door is in good condition, fully operational, and fitted with all required safety furniture. All components function correctly at the time of the fire risk assessment.
 - e) Flat 17: No answer
 - f) Flat 18: No answer
 - g) Flat 19: No answer
 - h) Flat 20: At the time of the fire risk assessment, the flat entrance door was not fitted with a self-closing device. In addition, several non-standard items had been affixed to the internal face of the door, which may compromise its fire-resisting performance.**
 - i) Flat 21: No answer
 - j) Flat 22: No answer
 - k) Flat 23: No answer
 - l) Flat 24: No Answer

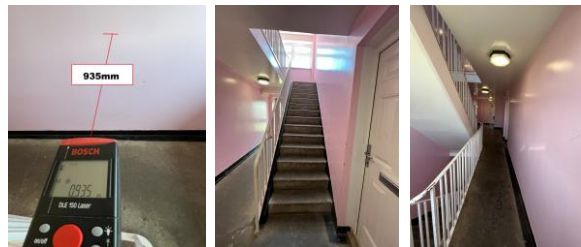
- 5) Within the block each floor is accessed via a single staircase that provides a means of escape and has a width of a minimum of 993mm between the handrails.

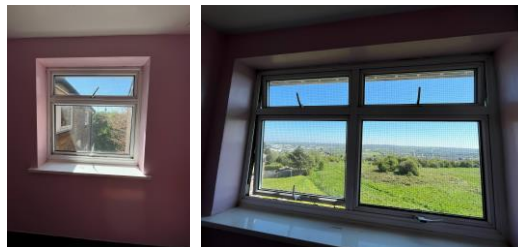
- a)** Third Floor: Installed upon the floor is a double and a single unit fitted with top and bottom openers. All the units were fully working at the time of the fire risk assessment.

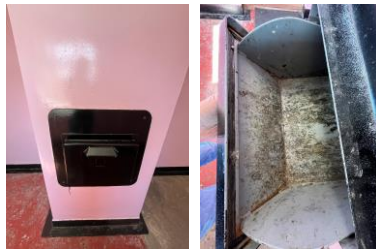
- c) Third Floor:** The bin chute hopper located adjacent to Flat 24 was inspected and found to be operating correctly at the time of the assessment. All seals were intact, and no defects were observed. Ongoing maintenance and regular checks are essential to ensure the hopper continues to function effectively and does not compromise fire safety within the protected escape route.

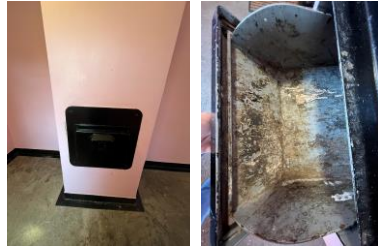
- e) Second Floor: The bin chute hopper located adjacent to Flat 21 was inspected and found to be operating correctly at the time of the assessment. All seals were intact, and no defects were observed. Ongoing maintenance and regular checks are essential to ensure the hopper continues to function effectively and does not compromise fire safety within the protected escape route.

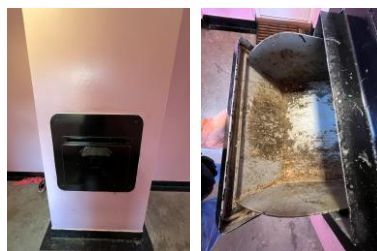
- g) First Floor: The bin chute hopper located adjacent to Flat 18 was inspected and found to be operating correctly at the time of the assessment. All seals were intact, and no defects were observed. Ongoing maintenance and regular checks are essential to ensure the hopper continues to function effectively and does not compromise fire safety within the protected escape route.

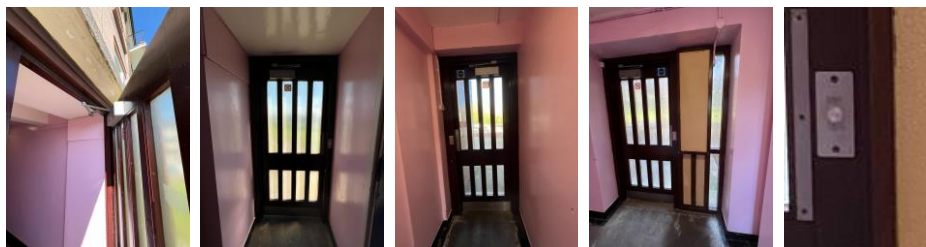
- 9) The final exit doors (x3) are fitted with automatic closing devices. To exit the doors, you do so by using a push button. These are checked on a regular basis by caretaking teams as part of their checks. Defective closing devices are replaced either by the Caretaking Team(s) or the in-house repairs team(s). These systems are designed to fail safe i.e. door unlocked in the event of a power failure. This prevents residents being locked in or out of the building.

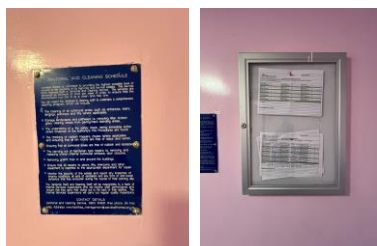
- 10) Communal areas are kept free of flammable items. The communal areas are checked on a regular basis by Caretaking / Cleaning teams 365 days per year, and all items of rubbish are immediately removed. There is also an out of hour's service that allows combustible items of furniture / rubbish to be removed.

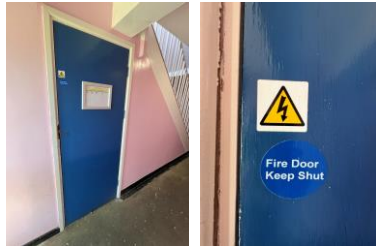
- 1) The service cupboard displays “Fire Door Keep locked” also an electrical warning sign.

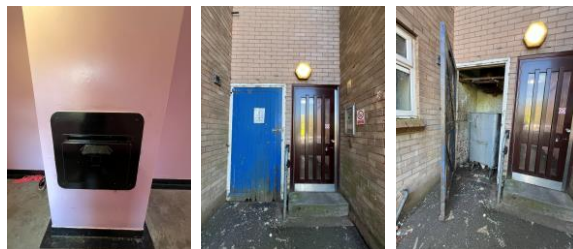
- 1) There is a regular Cleaning Service to the premises.
- 2) The blocks refuse is deposited via a bin chute accessed on all of the upper floors via the hopper door. Ground floor flats can place their bags directly into the bin via the bin room that is accessed from at the rear of the block.

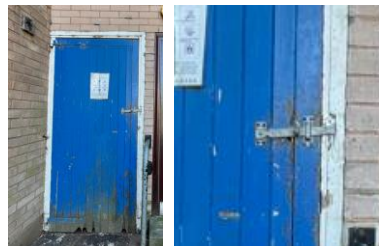
- 3) The bin room is accessible from outside through a timber door.

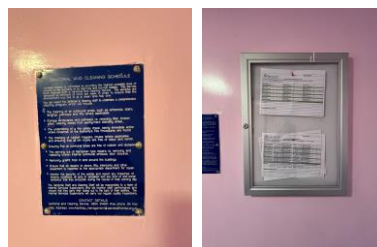
- 4) Regular checks are carried out by Caretakers to minimise risk of waste accumulation.

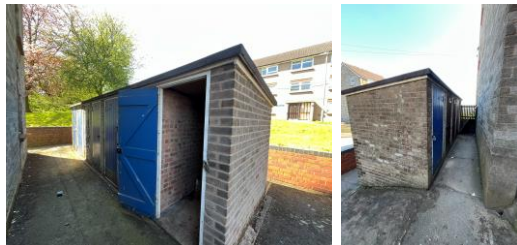
- 1) Residents instructed not to bring L.P.G cylinders into block.
- 2) The tenancy conditions, Section 7 – Condition 5.6 stipulates “If you live in a flat or maisonette, you, people living with you and any visitors to your property must not keep or use paraffin oil, petrol, bottled gas appliances or any other explosive, FLAMMABLE or dangerous material in the property. This restriction also applies to any storage facility situated in or attached to the block, which has been provided for your use.”
- 3) Residents should not store flammable liquids or gas cylinders on site.
- 4) No Flammable liquids stored on site by Caretakers / Cleaners.
- 5) Residents have individual storage cupboard externally which they keep secured by means of own keys.
