Fire Risk Assessment

Macauley House

**Glover Street,
West Bromwich, B70 6DY**

Date Completed: 05th December 2025

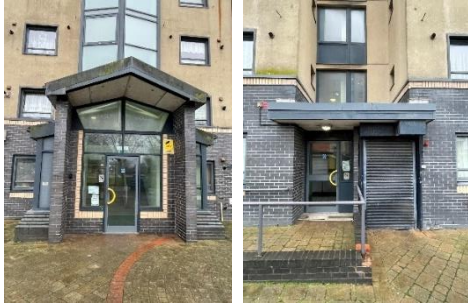
The block has a main entrance/exit to the front elevation, and a further entrance/exit located on the rear elevation.

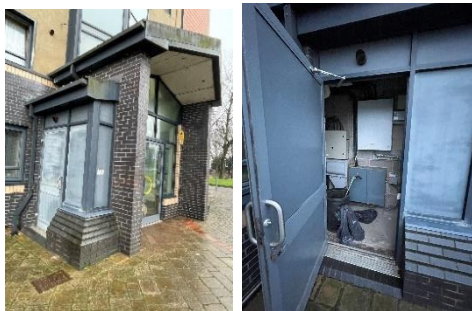
There is an external service cupboard adjacent the front entrance (electrical installation).

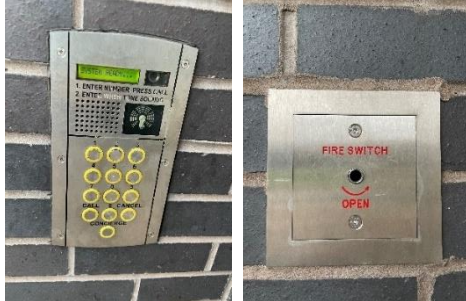
The main entrance to the front elevation has a door entry system with a fob reader installed. The entrance to the rear elevation is accessed by the installed fob reader. The front entrance only, has a firefighter override by use of a drop latch key.

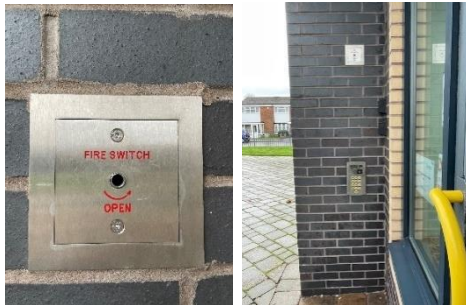
Access to the building is gained via the firefighter's door override switch utilising the drop latch key from the white box.

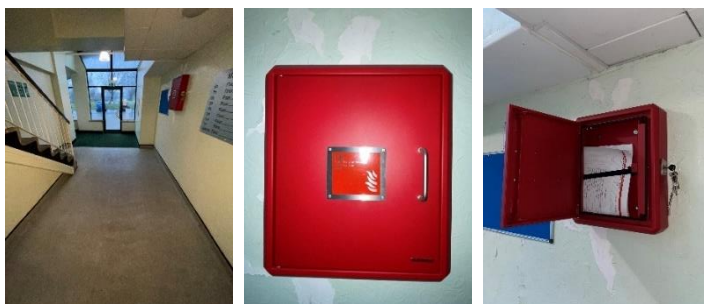
There's a Secure Premise Information Box (SIB) located in the ground floor front entrance lobby. It is a Gerda box that utilises a standard WMFS suited key held on each fire appliance.

The PIB contains floor plans, vertical plans, orientation plans, information for WMFS and documents for those with vulnerabilities who may require additional consideration if there is a fire incident (PEEP).

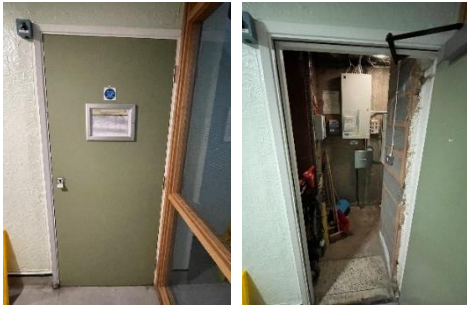
There's an electrical service cupboard in the ground floor lobby area.

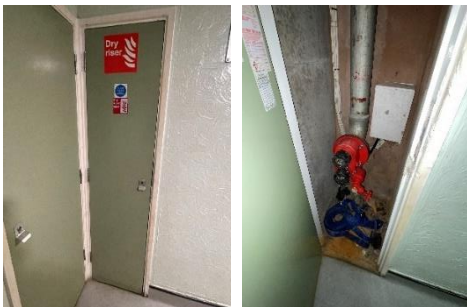
The dry riser inlet is internal and adjacent the ground floor lift car. It is accessed utilising a suited 54 key mortice lock.

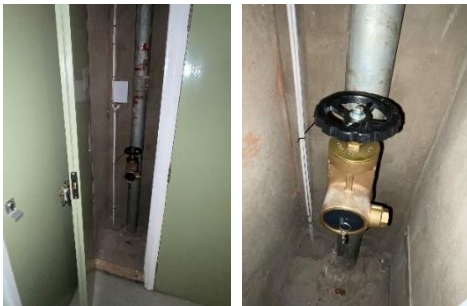
Dry riser outlets are available on each floor in the lift lobby. Each outlet is within a riser cupboard accessed with a suited 54 key.

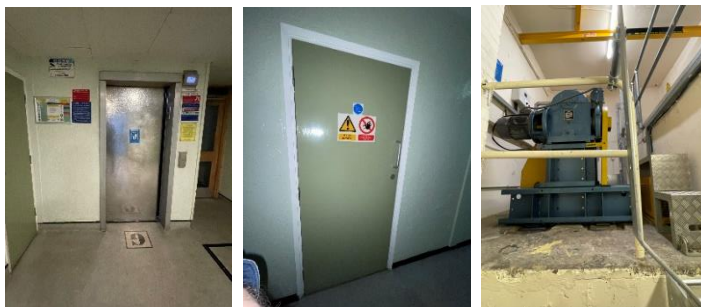
A single lift serves floors up to the 7th floor. The lift motor room is on the 8th floor.

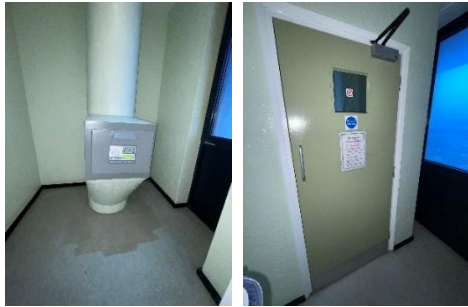
There's a refuse chute installed to the building with access to a hopper on each floor in a dedicated chute room. There's an openable window in each chute room.

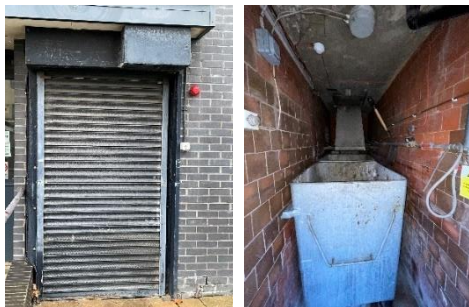
The refuse chute connects to a bin store adjacent the rear exit to the building. The bin store is secured with a motorised roller shutter door.

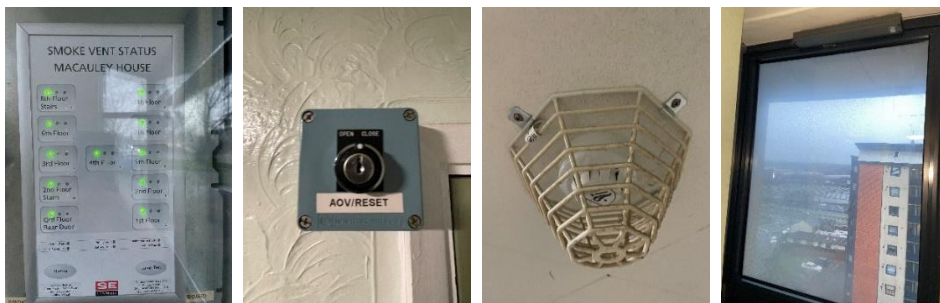
Automatic opening vents are installed on all floors from the ground (lobby door & rear door) to 8th in dead end corridors and, the 2nd & 8th floors in the stairwell.

The information panel is in the front entrance foyer and there's a reset switch next to the ground floor service cupboard in the lift lobby. Smoke detectors for the system are throughout the building.

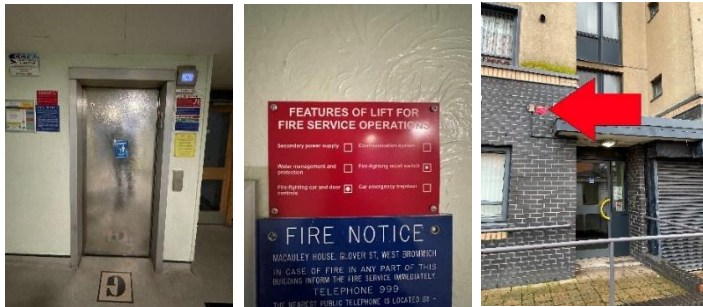
There's a firefighter's lift override switch for the lift. The switch is external to the left hand side of the rear entrance.

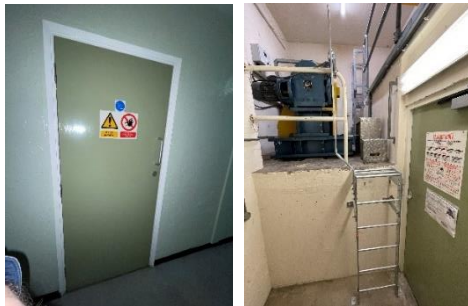
The lift motor room is accessed on the 8th floor. The door is secured with suited 54 key mortice lock.

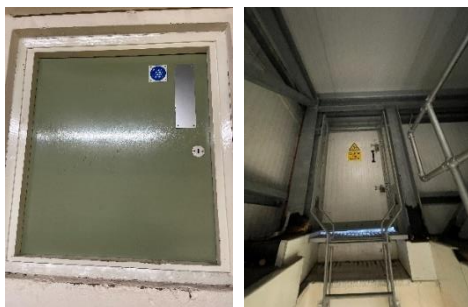
The roof void can be accessed via a half door from the lift motor (suited 54 key). The external roof can be accessed via a full height metal door also from the lift motor room (key in firefighters' box).

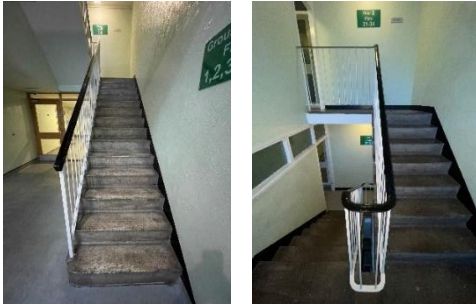
- 1) The site has a single staircase that measures a width of 1000mm, this provides a sufficient means of escape.

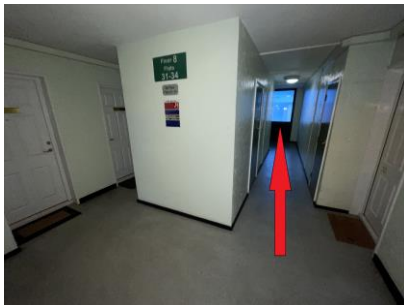
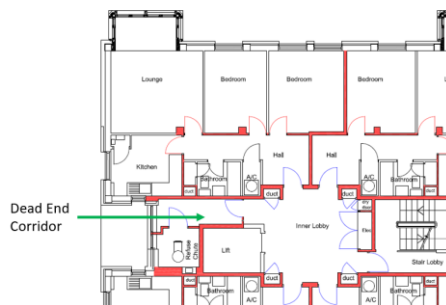
- 2) All corridors are of adequate width (at least 960mm) and will be maintained clear to that width as a minimum.
- 3) There are dead end corridors on all floors from the 1st to 8th. The dead end corridors are between the lift lobbies and the chute room. All are 1050mm wide, 6 metres long and benefit from an Automatic Opening Vent therefore are acceptable.

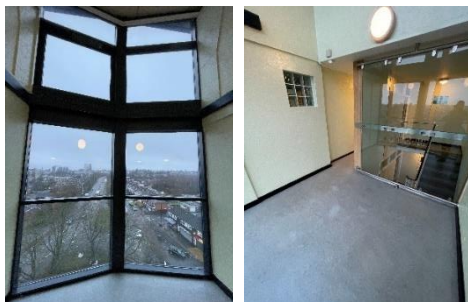
- 4) The building, on all floors, has an extended landings / atrium type space off the communal stairs.

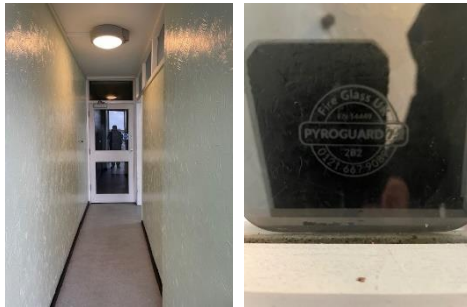
- 5) The means of escape are protected to prevent the spread of fire and smoke.
- 6) The communal landing / staircases are protected by use of self-closing 44mm timber 30-minute fire doors with vision panels & intumescent strips / cold smoke seals. The doors to the staircase have recently been replaced as identified in the previous FRA.

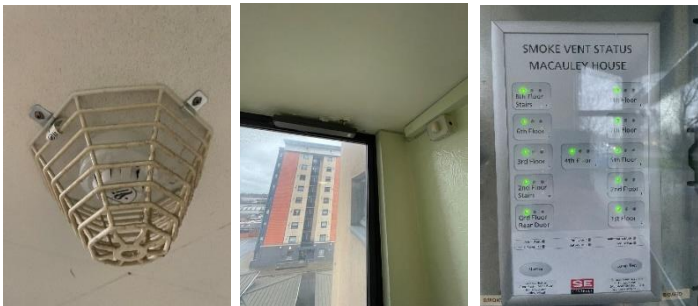
Automatic opening vents are installed on all floors from the ground (lobby door & rear door) to 8th in dead end corridors. Also on the 2nd & 8th floors in the stairwell.

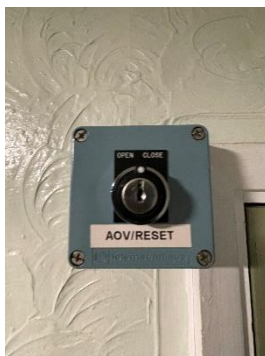
- 12) There is a master reset key switch in the ground floor lift lobby.

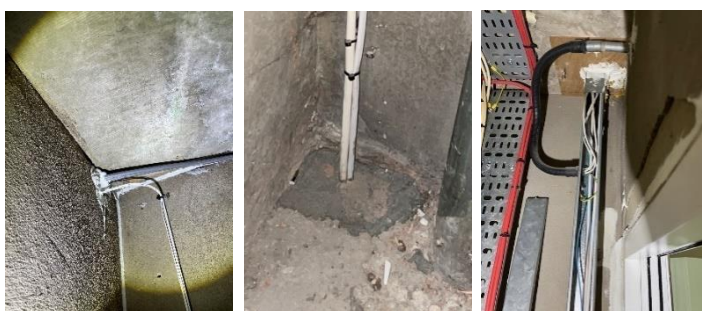
- 5) A variety of methods / materials have been used to achieve fire-stopping including Rockwool, fire rated sponge, fibre cement board and intumescent mastic.

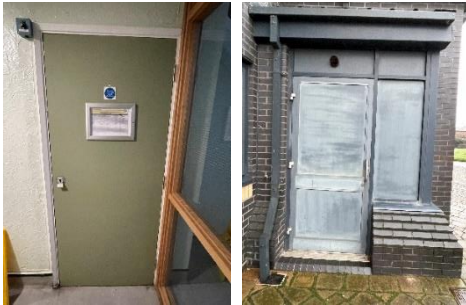
- 7) All communal fire doors are subject to a 12-week check by the Fire Safety Rapid Response Team.
- 8) SMBC commissioned a survey of all fire doors to flat entrances, communal corridor doors, landing doors and service cupboard doors. Firntec Building Compliance Ltd and their subsidiary company Ventro Fire Compliance have carried out this work and remedial actions reported to SMBC.
- 9) All service cupboards to communal areas are lockable.
- 10) Ground floor service cupboard is secured with a nominal 44mm FD30s door secured with a suited 54 key mortice lock. There is also an external ground floor service secured behind a nominal steel fire door secured with a cylinder lock.

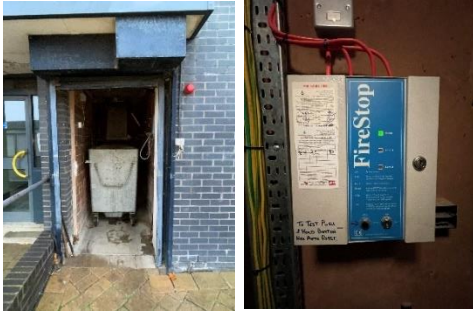
- 7) Bin room is protected by fire suppression system, this system is serviced and maintained every six months.

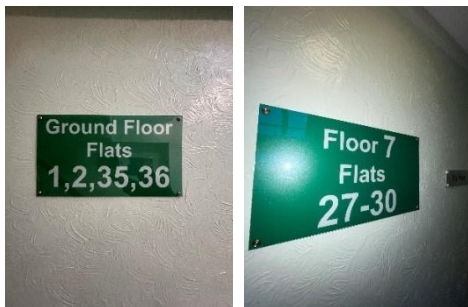
- 5) Photoluminescent wayfinding signage illustrating floor level and flat numbers are fitted to the walls on all floors adjacent the lift car's and to the wall of each landing on the communal staircase. This signage meets the requirements of ADB and Fire Safety (England) Regulations 2022.

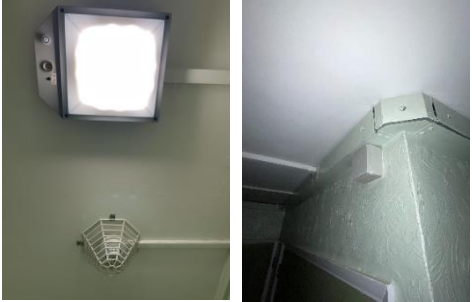
- 19) Cabling is generally housed in metal trunking however, small amounts of plastic trunking noted in the building's stairwell and corridors near lift motor room.

P3	Repairs 3-6 Months	
07/22	Ideally, plastic trunking should not be used in common areas and means of escape. Confirmation is required that secure metal clips/fixings have been used to ensure cables in plastic trunking are not released in a fire situation.

P2	Electrical 1-3 Months
