Fire Risk Assessment

Holly Court

**Acacia Avenue, Yew Tree Estate,
WS5 4BN**

Date Completed: 05/03/2026.

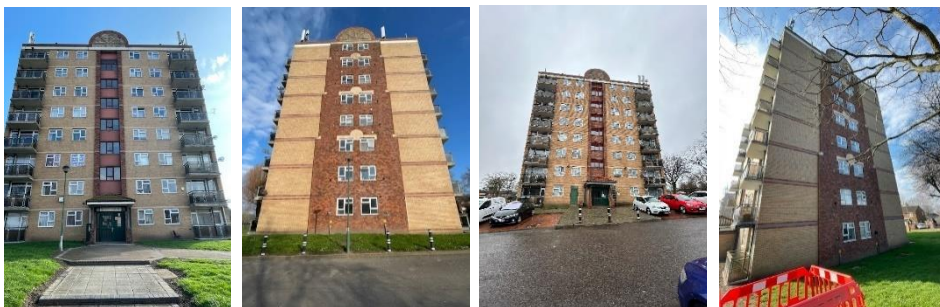
The typical structure is constructed as a reinforced concrete frame which was cast in-situ with a RC slab supported off cast in-situ RC walls/columns which stack vertically throughout. The concrete beams and columns are at regular centres and distributed evenly across the building. The typical floor slab was measured between 150- 200mm thick.

There are balconies at each level which are formed of cantilevered RC slabs tied into the main frame. The balconies would benefit from a refurbishment.

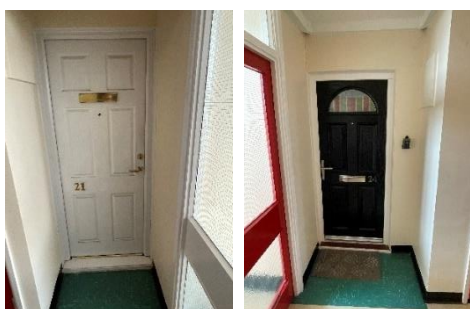
- 8) Individual flat entrance doors are predominantly nominal 44mm timber/composite fire door sets with intumescent strips, cold smoke seals and self-closing devices of a Permadoor construction. Noted there are a combination of timber and composite fire doors.
