Fire Risk Assessment

Mountford House

**1-66, Glover Street,
West Bromwich, B70 6DS**

Date Completed: 01/12/2025

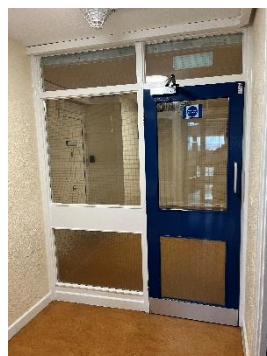
- 2) All corridors are of adequate width (at least 1050mm) and will be maintained clear to that width as a minimum.
- 3) None of the corridors that form part of the means of escape from the flats are dead ends.
- 4) The means of escape are protected to prevent the spread of fire and smoke.
- 5) The communal landing / staircases are protected by use of notional self-closing 44mm 30-minute timber fire doors with vision panels. All doors have been upgraded with intumescent strips / cold smoke seals.

Some communal notional fire doors show signs of wear and tear due to age. Consideration should be given to upgrade with certified FD30s door sets & combination frames as part of a future programme.

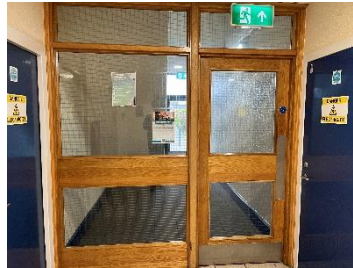
- 6) The ground floor lobby is protected by use of nominal 54mm FD60s doors and combination frames. These doors were installed during the 2009/10 refurbishment.

- 6) Service cupboards to the ground floor containing the gas and water risers are nominal 54mm timber FD60 doors secured with a suited 54 key mortice lock. The ground floor lobby fire door leaf separating the lift lobby from the stairwell fails to close into its frame correctly. This door leaf has loose fixing screws at the middle and lower hinge sets and requires adjustment for the leaf to close into the frame correctly. See action 10/6

P2	Electrical. 1 – 3 months.	
10/6	The ground floor lobby fire door leaf separating the lift lobby from the stairwell, fails to close into its frame correctly. This door leaf has loose fixing screws at the middle and lower hinge sets and requires adjustment for the leaf to close into the frame correctly.

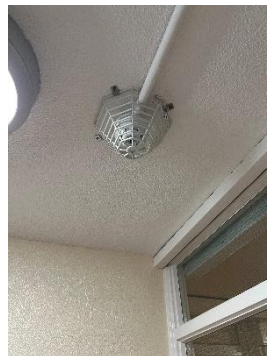
- 11) AOV have been installed to the stairwell between the 1st/2nd, 6th/7th and the 16th floors. Smoke detectors for AOV actuation are installed to the lobby, stairwell landing & stairwell lobby / stairwell & chute room doors on floors 1 to 16. The control panel and override switch has been installed to the ground floor lift lobby. With an alternative override switch has been installed to the 16th floor stairwell landing.

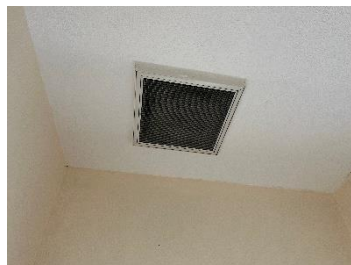
- 12) A ventilation grill was noted to the head of the staircase.

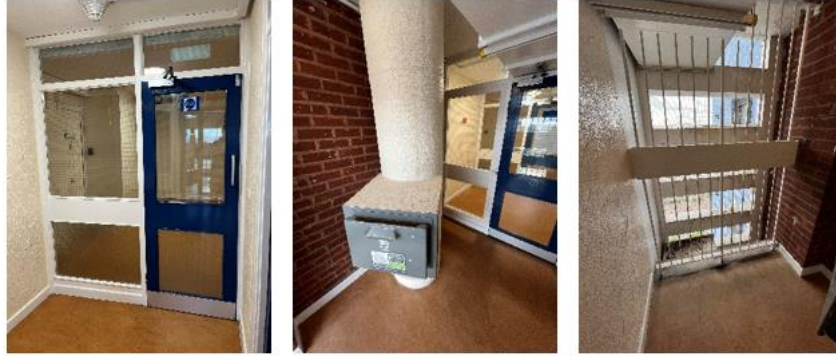
- 13) The waste disposal chute room doors on each floor are 44mm notional 30-minute fire doors with combined intumescent strips & cold smoke seals and overhead self-closing devices. The chute rooms benefit from natural ventilation.

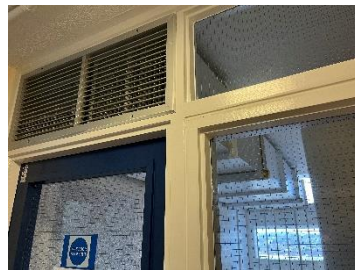
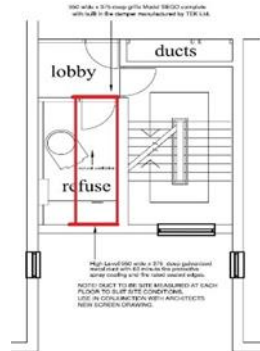
- 14) A high-level metal duct provides ventilation to stairwell lobbies on each floor. The duct has been installed with a grill with built in fire damper and has been coated with a 60-minute fire protective coating.

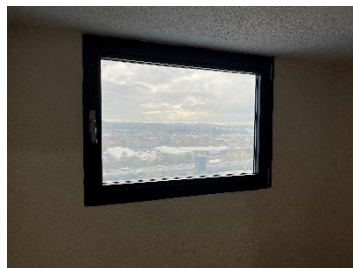
- 15) Communal windows in the stairwell are openable.

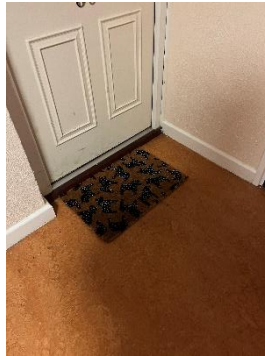
- 18) Individual floor mats were noted outside some flats. Fire rating of the mats is unknown but deemed to be of low risk.

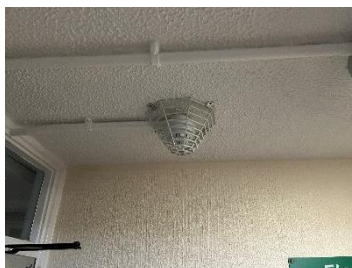
- 3) There is no effective means for detecting an outbreak of fire to the remaining communal areas. Automatic fire alarm systems are not usually required in the common areas of residential blocks as this can compromise the 'Stay Put' evacuation policy.
- 4) Smoke detectors linked to the Automatic Opening Vent have been installed on stairwell and landing lobbies. The vent will automatically open when smoke has been detected.

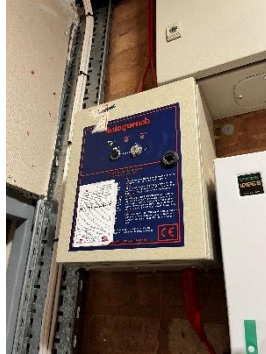
- 5) A deluge system is provided to the refuse chute bin store. An approved contractor maintains the system. The frequency for the maintenance checks is twice per year (April and October). The control panel for the system is located in the ground floor lobby electrical cupboard.

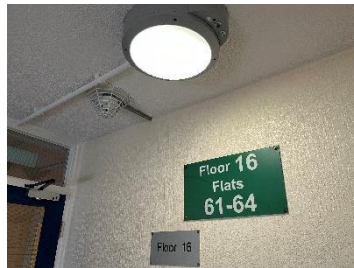
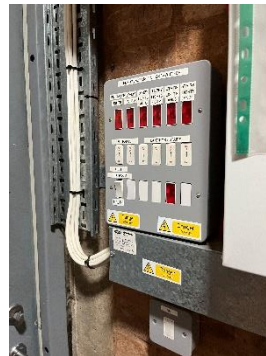
- 1) The premises has a sufficient emergency / escape lighting system in accordance with BS 5266 and has test points located within electrical cupboards.

- 2) The self-contained units are provided to the communal landings, stairs, and lift motor room.
- 3) **The lighting in the lift lobby on the 7th floor was not fully operational and requires rectification. See action 9/3.**

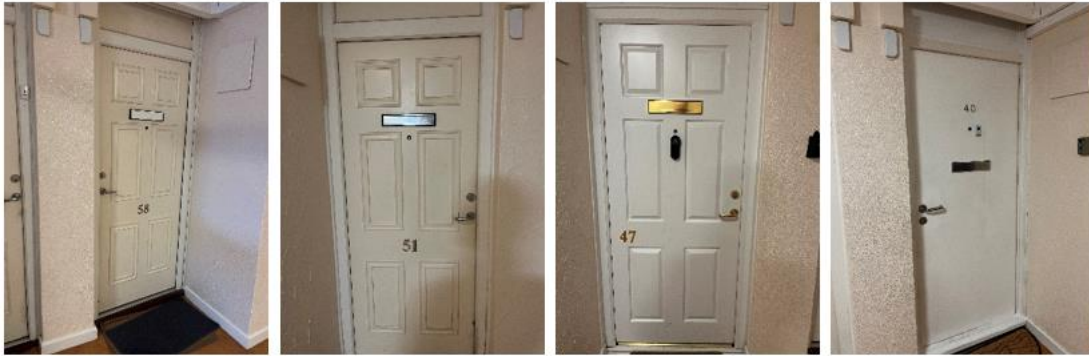
- 7) Individual flat doors are nominal FD30s composite fire door sets with intumescent strips, cold smoke seals and self-closing devices. The doors are predominantly manufactured by Permadoor. Flat 40 has a nominal timber flush FD30s door set.

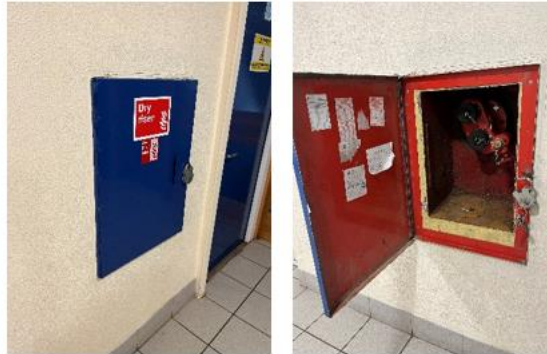
- 1) The dry riser inlet is located within the ground floor lift lobby, inside a cupboard secured with a fire service bridge door padlock.

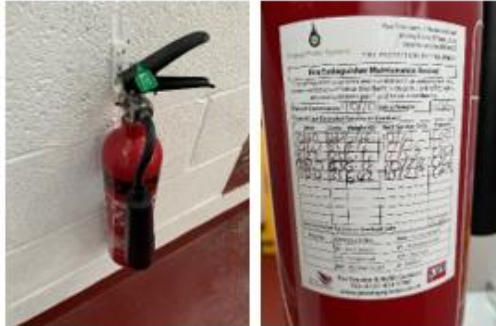
- 5) A portable fire extinguisher (CO2) is provided to the lift motor room. Maintenance contracts in place for maintenance of the extinguisher. The frequency for the maintenance checks is once (October) of each calendar year.
