# Fire Risk Assessment

## Braybrook House 356-422

**Moor street, West Bromwich,  
B70 7AU.**

**Date Completed:** 6th January 2026

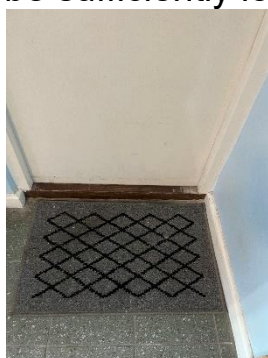
- 4) Ramps were noted outside flats 400, 376, 364. The ramps have been installed by the tenants who rely on mobility aids to assist passage over the threshold. It is deemed the ramps represent a sufficient low risk.

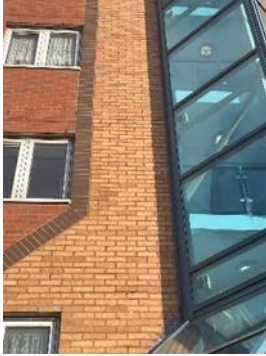
- 16) Glazing noted within 1.8m of staircase. Sprinkler roll out programme should therefore be considered as part of future refurbishments. (Recommended in section 19 Observations)

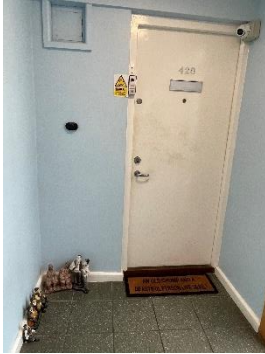
- 19) 8<sup>th</sup> floor lift lobby – Ornaments displayed on floor outside flat 420.**

It is recommended that the Housing Officer, Resident Engagement Officer (fire) and Building Safety Manager, consult with residents to reduce & remove the storage of unnecessary items specifically any soft furnishings that do not conform to the relevant British Standards (BS7176). This recommendation has been recorded in observations and brought to the attention of key stakeholders.

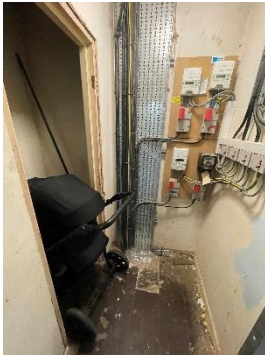
- 20) 7<sup>th</sup> floor – pushchair stored in service cupboard between flats 410 & 414.**

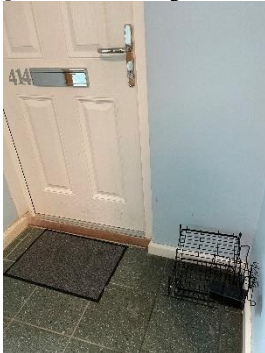
- 21) 7<sup>th</sup> floor lift lobby – Metal rack stored outside flat 414 could potentially be used to store combustible items.**

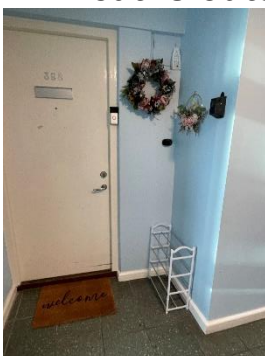
- 25) 5<sup>th</sup> floor lift lobby – A shoe rack & artificial flowers displayed in wreaths outside flat 398.**

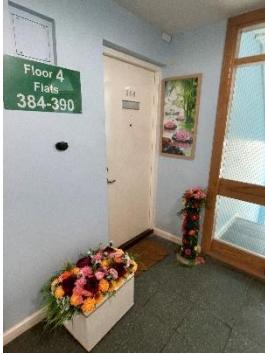
- 26) 4<sup>th</sup> floor lift lobby – Artwork in frame and two artificial flower arrangements displayed outside flat 384.**

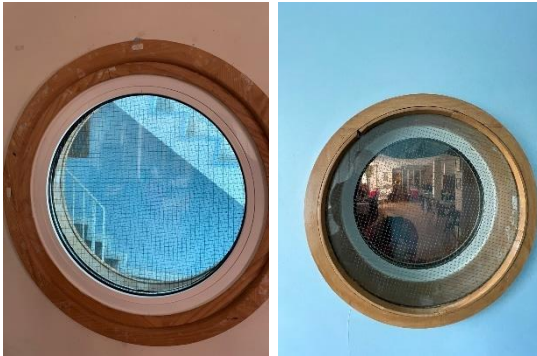
- 10) All communal fire doors are subject to a 12-week check by the Fire Safety Rapid Response Team.
- 11) Access panels to stop taps are fixed to masonry and bedded on Intumescent foam.
- 12) A new fixed Georgian wired window and frame has been installed between the community room and rear staircase to provide 60 minutes fire resistance, following recommendations made in the previous FRA. The new installation is in addition of the original which still remains.

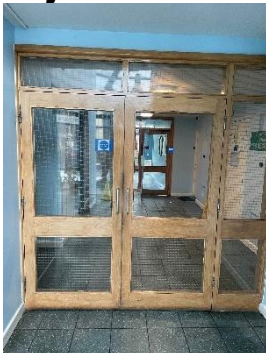
- 14) The double doors in the front ground floor stairwell require adjustment to close the between the doors.

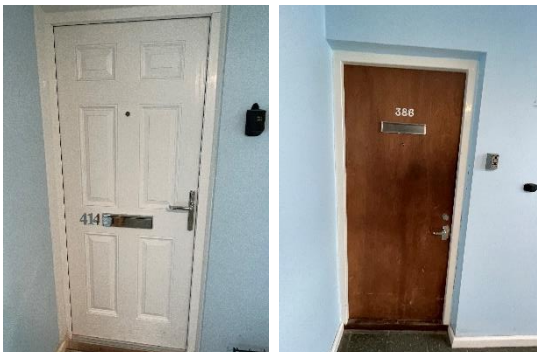
- 18) Individual flat entrance doors are predominately nominal FD30S timber fire doors. Door 414 is a composite door.

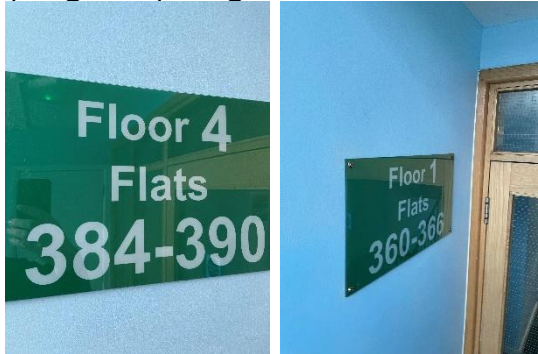
- 5) Photoluminescent wayfinding signage depicting floor level and flat numbers are fitted to the walls on all floors adjacent the lift car's and to the wall of each landing on the communal staircase. Signage that meets the requirement of ADB and Fire Safety (England) Regulations 2022

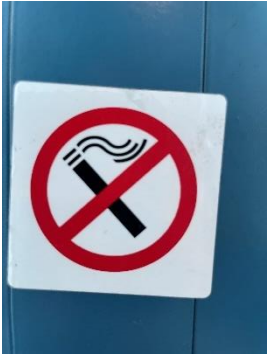
- 1) Smoking is prohibited within any communal parts of the building in line with Smoke Free England legislation.

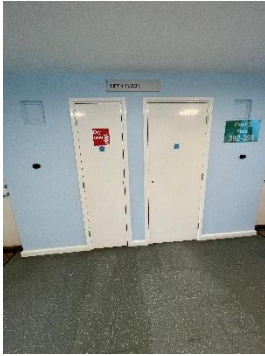
- 5) The electrical installation i.e., risers are contained within dedicated service cupboards that are secure and protected by means of a nominal FD60S door.

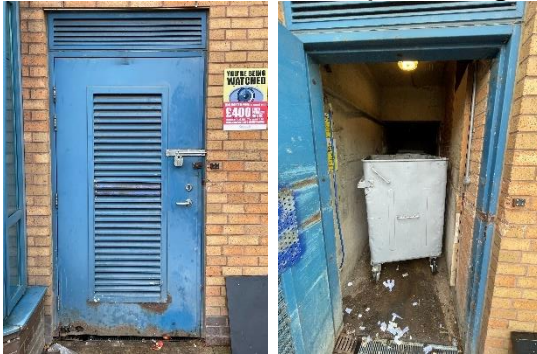
- 1) There is a regular Cleaning Service to the premises.
- 2) Refuse containers emptied regularly.

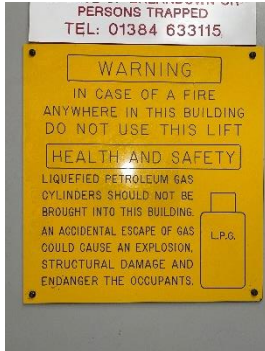
- 1) Residents instructed not to bring L.P.G cylinders into block.

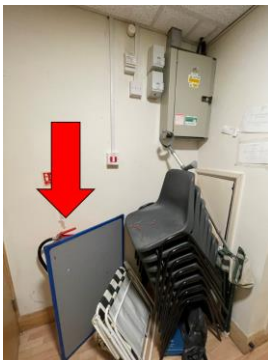
- 2) The tenancy conditions, Section 7 – Condition 5.6 stipulates “If you live in a flat or maisonette, you, people living with you and any visitors to your property must not keep or use paraffin oil, petrol, bottled gas appliances or any other explosive, FLAMMABLE or dangerous material in the property. This restriction also applies to any storage facility situated in or attached to the block, which has been provided for your use.”
- 3) No Flammable liquids stored on site by Caretakers / cleaners.
- 4) All store cupboards are kept locked.
- 5) There are no flammable liquids or gas cylinders stored on site.
- 6) Items stored within the entrance hall of the community room are restricting access to a portable fire extinguisher. **All items stored here should be removed to ensure the portable fire extinguisher is accessible and a sterile means of escape is maintained.**

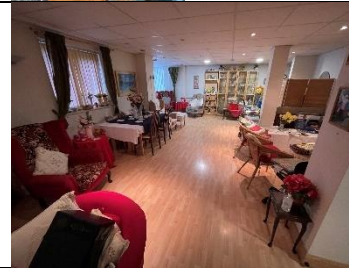
- 7) It appears a large number of personal items to include furniture; fabrics & home appliances have been introduced to the community room. Because the safety, ignitability and combustibility of such items is unknown, there's the potential for excessive fire loading.

All upholstered furniture, curtains, cushions and other soft furnishings, should be fire-retardant, or have been treated with a fire-retardant treatment designed to enhance their fire performance.

It is recommended that the Housing Officer, Resident Engagement Officer (fire) and Building Safety Manager, consult with residents to reduce & remove the storage of unnecessary items specifically any soft furnishings that do not conform to the relevant British Standards (BS7176). This recommendation has been recorded in observations and brought to the attention of key stakeholders.
