# Fire Risk Assessment

## Braybrook House 356-422

**Moor street, West Bromwich,  
B70 7AU.**

**Date Completed:** 6th January 2026

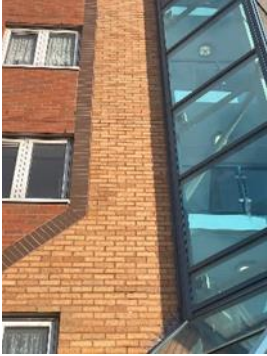
- 16) Glazing noted within 1.8m of staircase. Sprinkler roll out programme should therefore be considered as part of future refurbishments. (Recommended in section 19 Observations)

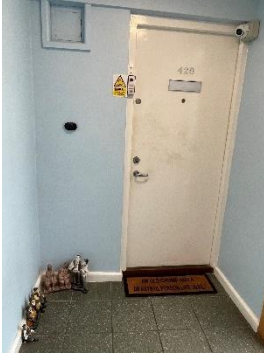
- 19) 8<sup>th</sup> floor lift lobby – Ornaments displayed on floor outside flat 420.**

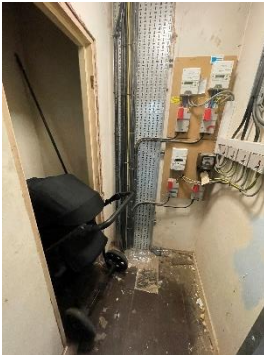
- 20) 7<sup>th</sup> floor – pushchair stored in service cupboard between flats 410 & 414.**

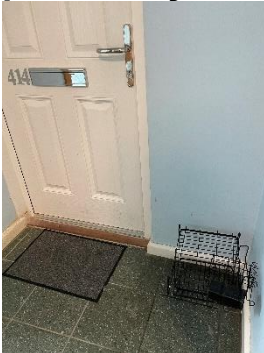
- 21) 7<sup>th</sup> floor lift lobby – Metal rack stored outside flat 414 could potentially be used to store combustible items.**

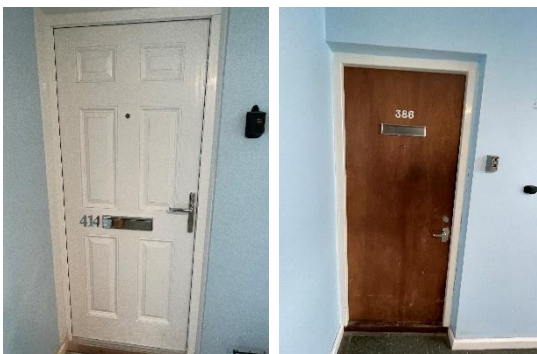
- 18) Individual flat entrance doors are predominately nominal FD30S timber fire doors. Door 414 is a composite door.

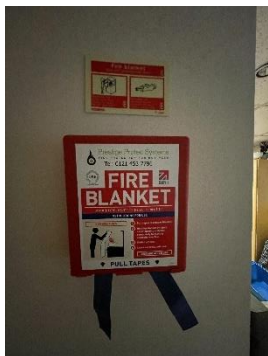
- 5) A fire blanket has been provided to the community room kitchen.

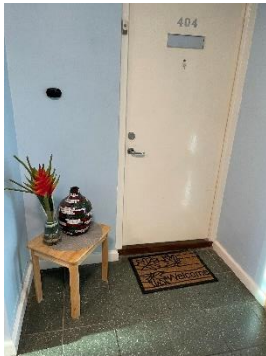
P3	Within 3-6 Months Housing Manager	
7/22	Remove table, vase & artificial plant from outside flat 404 communal area

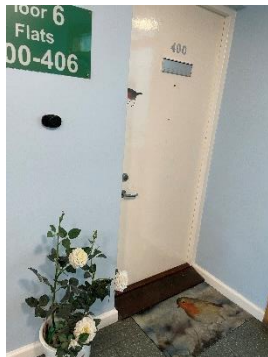
7/23	Remove artificial plant and small rug ( <i>door mat acceptable</i> ) from outside flat 402 communal area.	 	P3	Within 3-6 Months Housing Manager	
7/24	Remove artificial plant from outside flat 400 communal area.

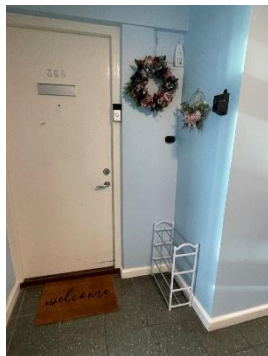
P3	Within 3-6 Months Housing Manager	
7/25	Remove wreaths and shoe rack from outside flat 398 communal area.

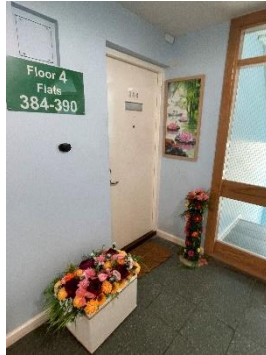
7/26	Remove 2 x artificial flower arrangements and artwork displayed outside flat 384 communal area.

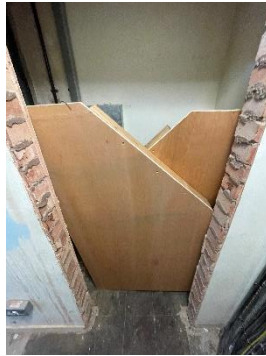
P3	Within 3-6 Months Housing Manager	
7/27	4 <sup>th</sup> floor service cupboard – remove plywood boards

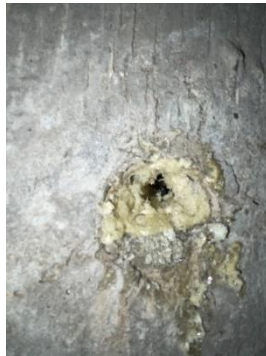
P2	Within 1-3 months Caretakers	
10/5	Ground floor service cupboard – fire stop 2 small holes in left hand wall.

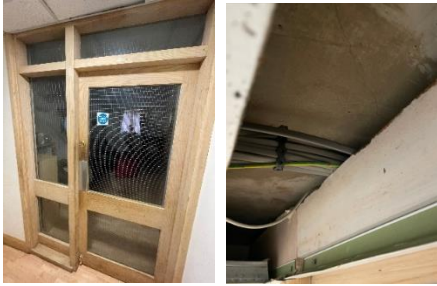
10/6	Firestop above fire door in community room using suitable products and method.

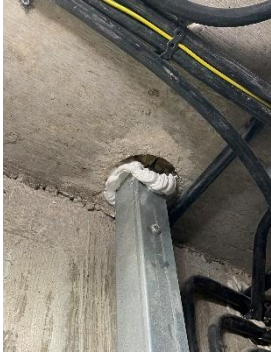
P2	Within 1-3 months Rapid Fire Team <b>JM18694941</b>	27/01/26
10/7	3 <sup>rd</sup> floor service cupboard. Remove and replace intumescent mastic which has moved.

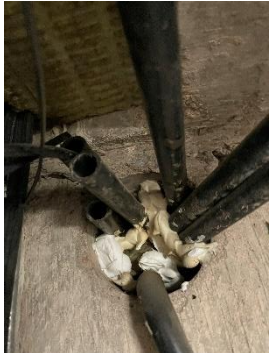
- 8) A variety of methods / materials have been used to achieve fire-stopping including intumescent mastic, intumescent sponge and mineral wool. **It is recommended that all fire stopped penetrations in service cupboards on all floors are, where possible, enhanced further with ablative batt, installed as per the manufacturer's application instructions.**

P2	Within 1-3 months Rapid Fire Team <b>JM18695007</b>	27/01/26
10/8	Where possible enhance all fire stopped penetrations in all service cupboards with ablative batt or other suitable product.

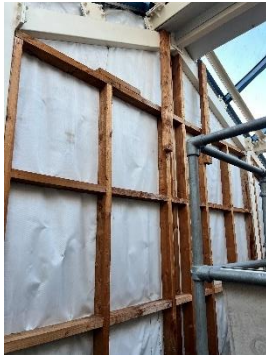
P2	Within 1-3 months Rapid Fire Team <b>JM18695201</b>	27/01/2026
10/20	Appoint a suitable contractor / fire engineer to assess the fire curtains and exposed studwork forming compartment lines in roof void.

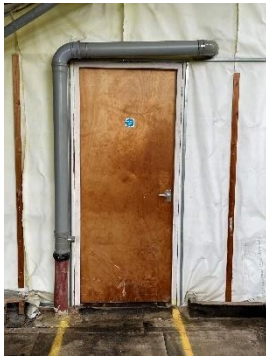
- 21) Nominal fire doors have been installed within the fire curtain walls to the roof void. All 6 doors fit poorly; lipping's have come away and appear to have swollen. It is likely they have been affected by fluctuations in temperature and moisture due to exposure to direct sunlight and heat from the installed solar thermal system. **Therefore, all 6 doors should be replaced with external grade FD30s timber fire doors with self-closing devices and mandatory signage. Door stops should be considered for those which foul on pipework. Update 03/02/26 This work will be completed in conjunction with the recommendation detailed in 10/20.**

P4	Programmed Work Head of Building Safety & Compliance	
10/21	Replace all 6 fire doors installed in roof void fire curtain wall with external grade self-closing FD30s (Where necessary install door stops)

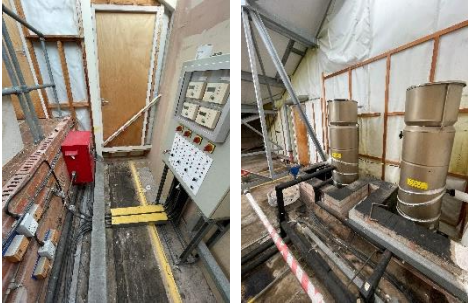
- 7) **There are no service records available for the servicing and maintenance of Solar Equipment provided for this building.** This testing falls under several British Standards. For example: -

14/7	There are no service records available for the servicing and maintenance of Solar Equipment provided for this building. A robust servicing and maintenance programme should be implemented for this equipment.

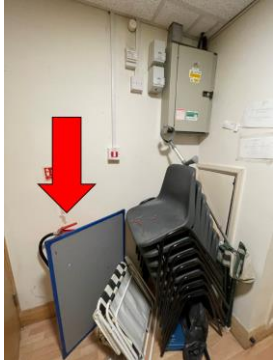
P4	Programmed Work Electrical Compliance Manager.	
18/6	All items to be cleared from community room entrance hall which form the means of escape.
